Prepared for Wyndeham Heron by Strategic Safety Systems Ltd.

**2478 RepE**

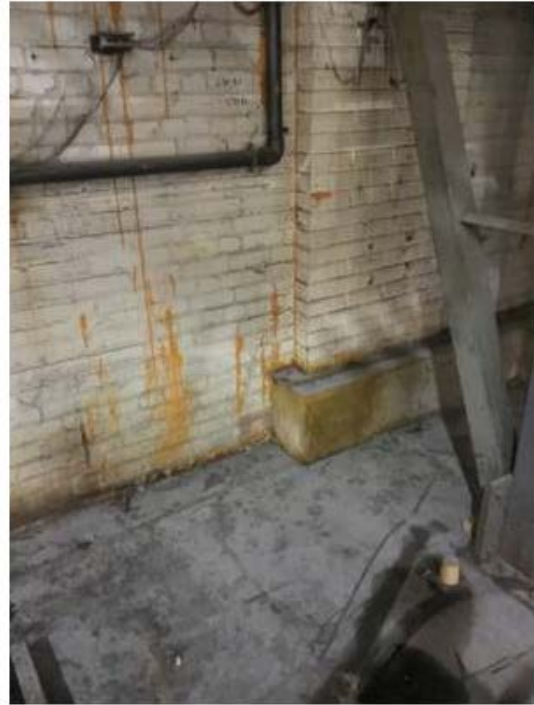
Photo 5 Minor yellow ink staining

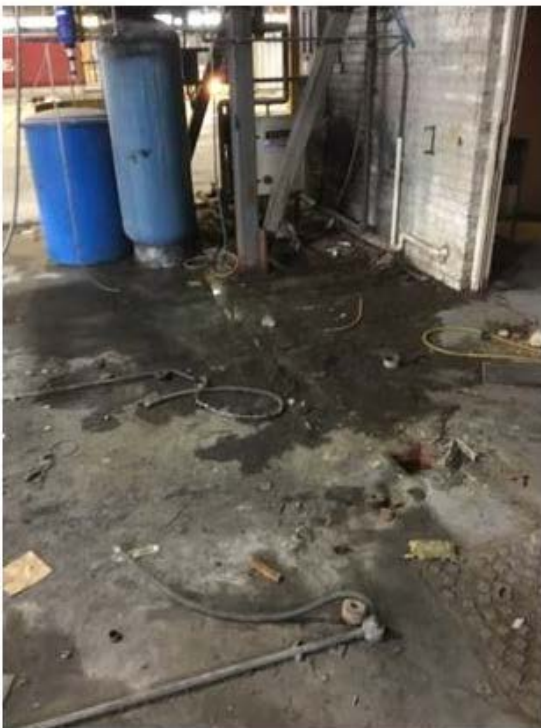
Photo 6 Site of ink storage,  
showing water ingress

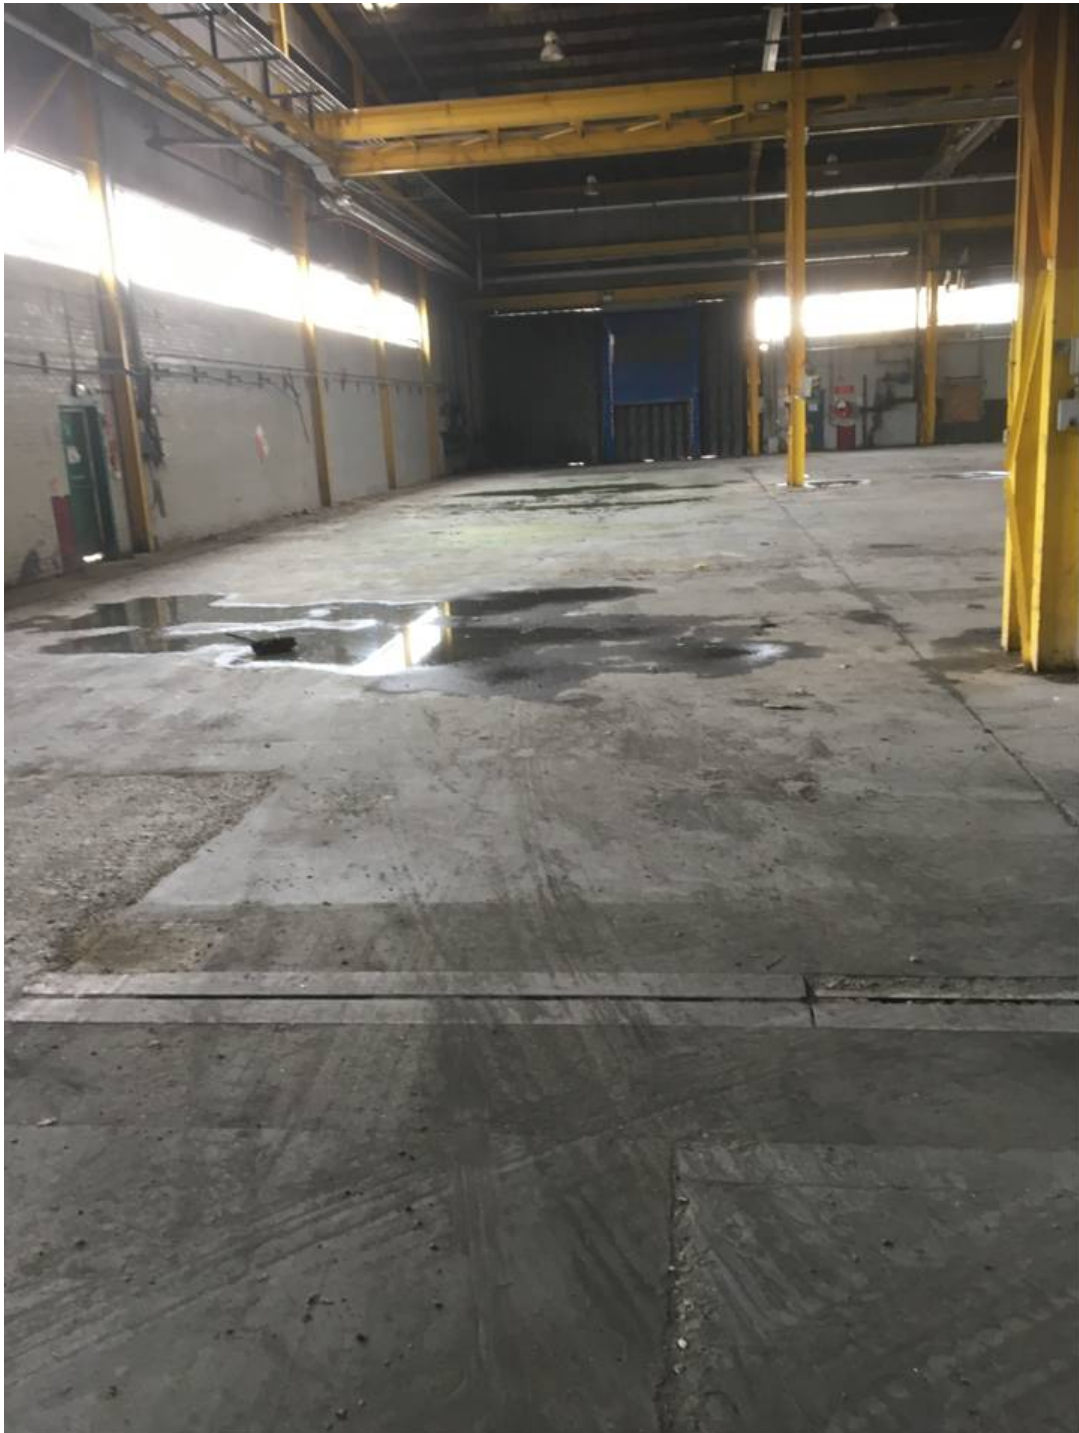
Overview of inside of factory eastern end.  
Note that the puddle is rainwater from damaged roof

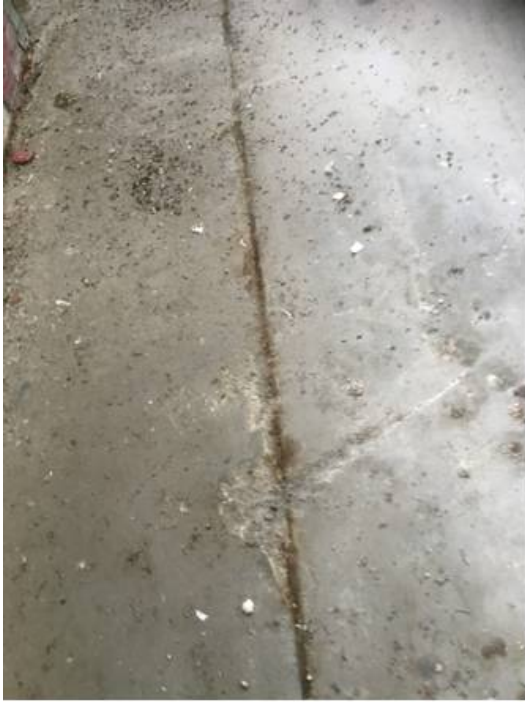
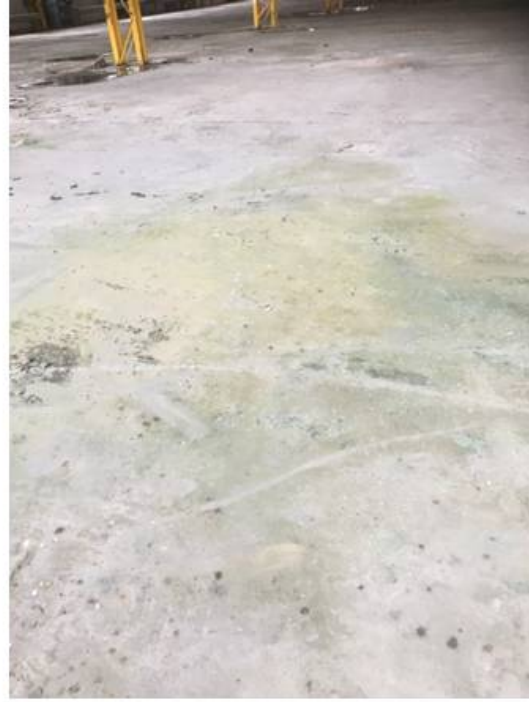
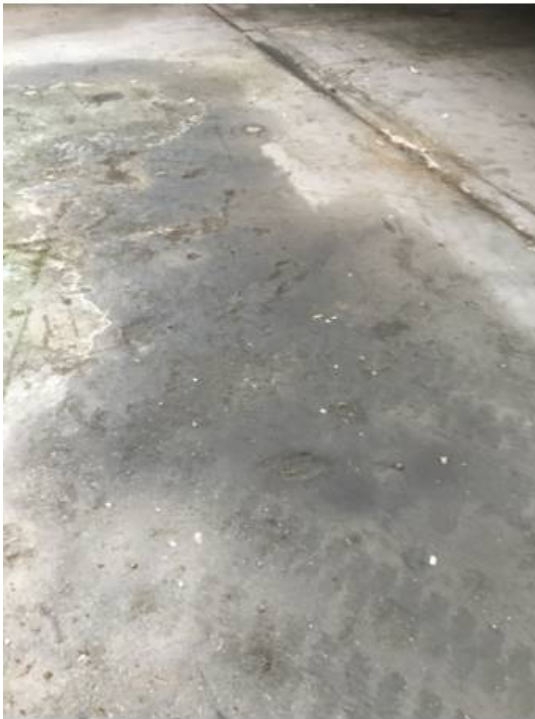
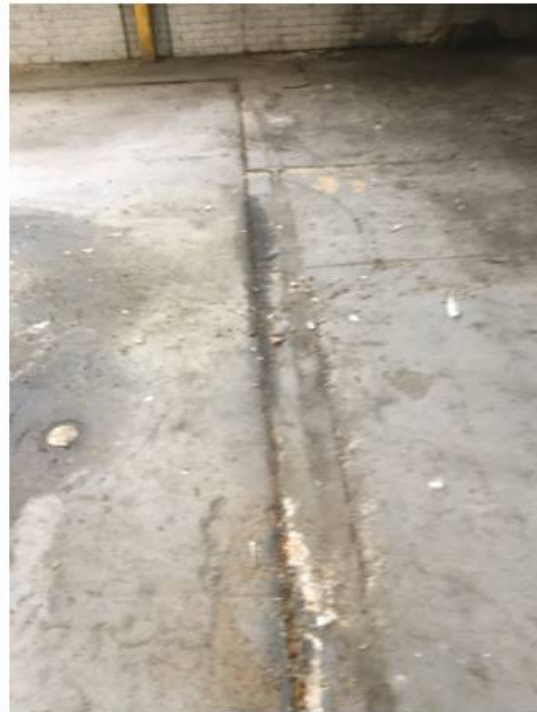
General standard of flooring and joints inside

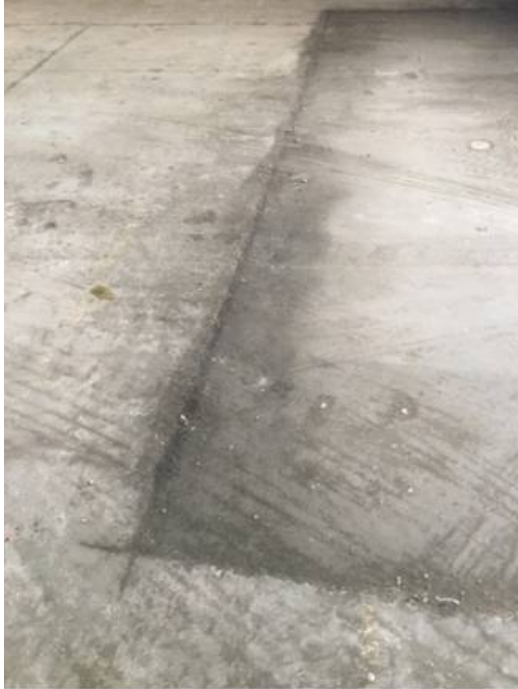
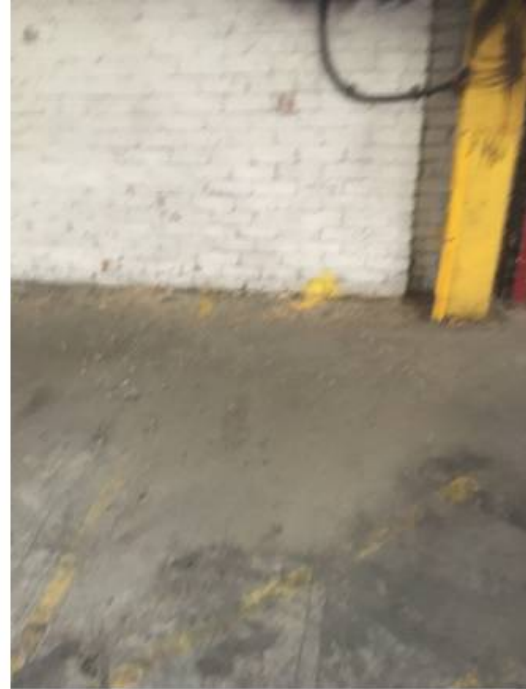
Yellow ink stain on wall. Note that yellow stripes on floor are intentional "keep clear" painted hatching.

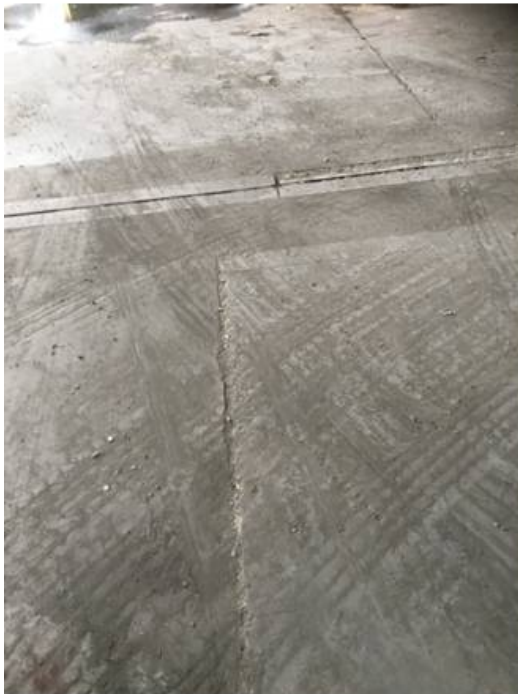
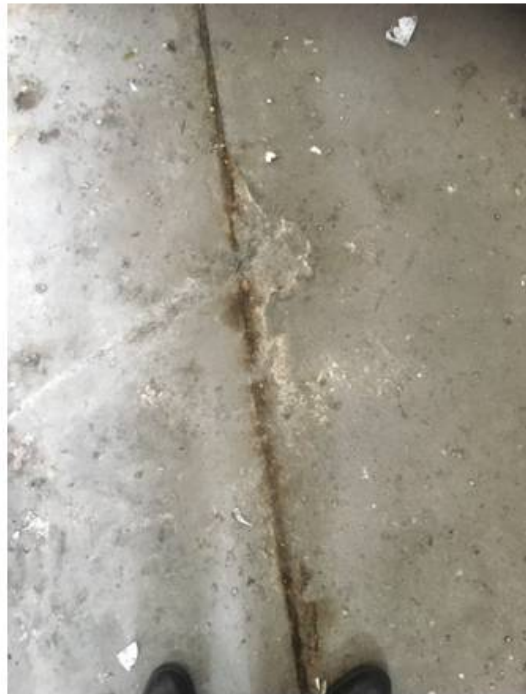
Examples of concrete pad joints
