# LANGFORD

## CONSERVATION AREA APPRAISAL AND MANAGEMENT PLAN

MALDON DISTRICT  
COUNCIL

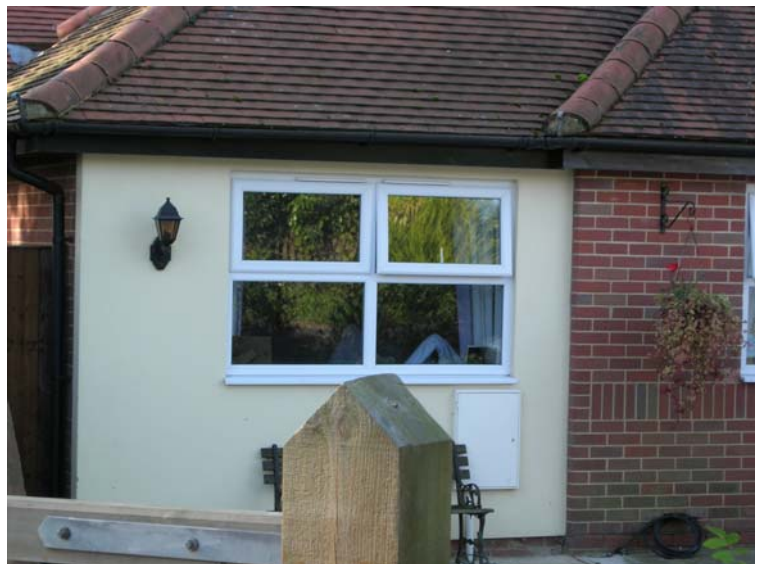
**Fig. 12 UPVC window**

Windows vary with a traditional style of vertically sliding sashes or symmetrical flush casements in the historic buildings and an increasing number of plastic replacements in the modern buildings which harm the appearance of the area due to their flat lifeless appearance and crude alien detailing.

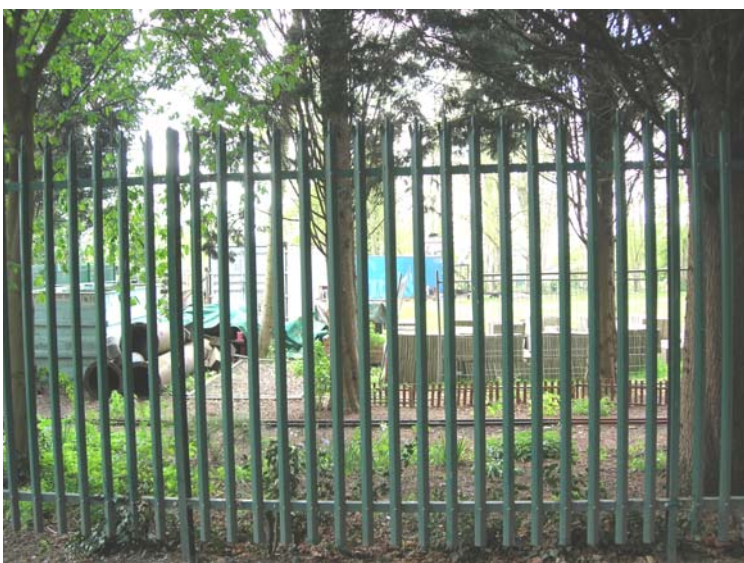
**Fig. 21** *Security fence surrounding the Museum of Power*

To the south side of the road stands **The Museum of Power**, the impressive yellow stock brick building in its own seven acres of picturesque grounds. Langford Water Pumping Station, (scheduled ancient monument county number 220) opened in 1929. The steam pumps supplied treated water to the Southend area up until the 1960s. The buildings and engine became a Scheduled Ancient Monument in 1986. It is now The Museum of Power and is open to the public. The grounds originally had municipal planting, as was the policy of the water company, but now it is run as a museum the mature trees and shrubs are carefully managed for the benefit of the wildlife. Picnics and riverside walks through the wild flowers are encouraged. The museum is financially supported by the Essex and Suffolk Water Company. Sadly for security reasons four years ago the museum had to install high chain link fence and gates to the front boundary and high security railings to the east boundary, which although necessary have a negative impact on the Conservation Area.

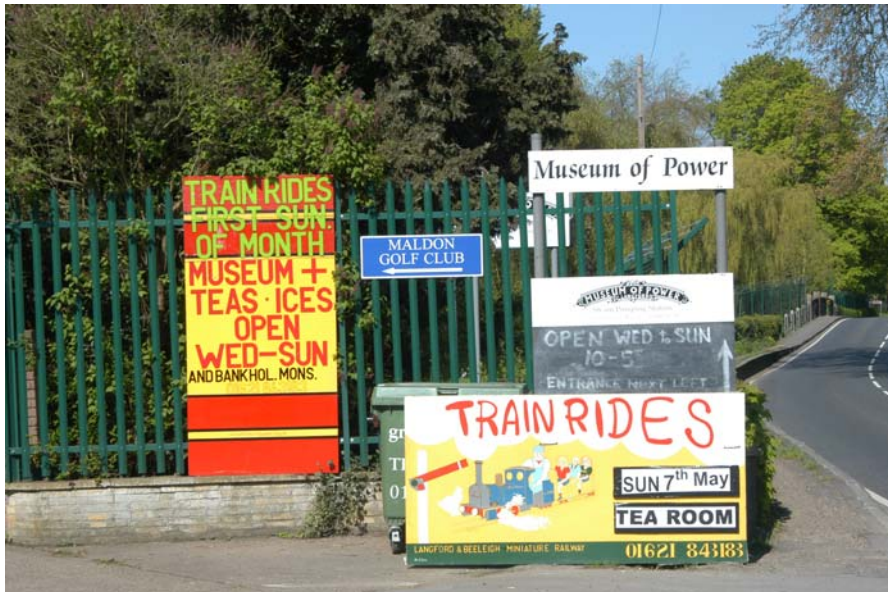
**Fig. 25 Signage at Museum of Power**

The lane running between the museum and Mill Cottage is well used by golfers, and dog walkers, but not well maintained. It has an open green space to both sides of the lane lined with willow trees, but this is inaccessible due to large ditches that have been dug to stop travellers from parking. This may be necessary, but along with the problem of fly tipping along the lane, it ruins the appearance of the green open space that could be more appealing to walkers and tourists visiting the museum. At the entrance to this lane there is a set of gates to the museum. This is not an entrance for the public to use but does have numerous board signs advertising events and opening times of the museum. These are not sympathetic and create visual clutter to the Conservation Area.

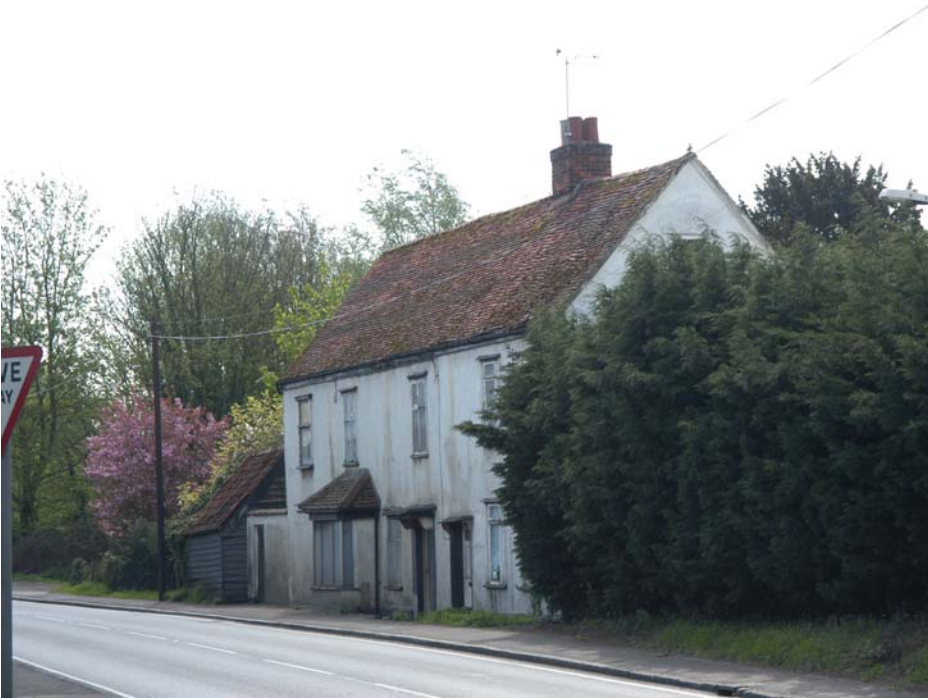
**Fig. 34 The Homestead**

The **Homestead** (south side) is an early 18<sup>th</sup> century building and grade II listed. It was once the village shop with an attached cottage. In 1987 it changed its use to fully residential. This is a vernacular building of rendered timber frame with handmade red plain clay tiles on the roof that reflect the local character, but it is in a very poor condition. The Homestead is unavoidably noticeable at the roadside. This is a listed building and is sadly the poorest maintained building in the Conservation Area. Tiles are missing from the roof and the windows and doors need urgent repair. Maintenance is also needed to the overgrown conifers in the space between The Croft and The Homestead. This building is an ideal enhancement opportunity as it is becoming a strong candidate for Historic Buildings at Risk register.

General building maintenance throughout the Conservation Area is good. The one problem building is The Homestead on the Maldon Road just past the junction with the Witham Road. This building is in urgent need of repair, to the roof windows and doors. **The proposal is that this building be eligible for a Maldon District Council enhancement scheme and should be added to the Essex County Council's Historic Buildings at Risk register.**

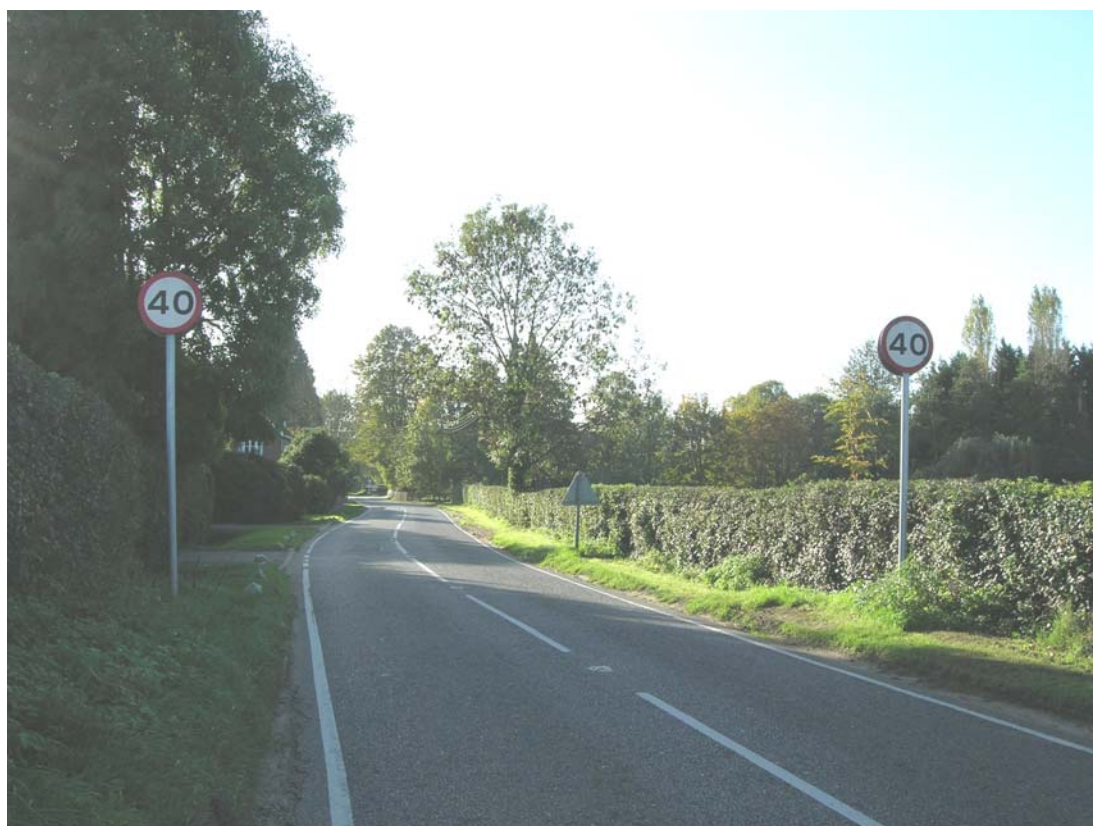
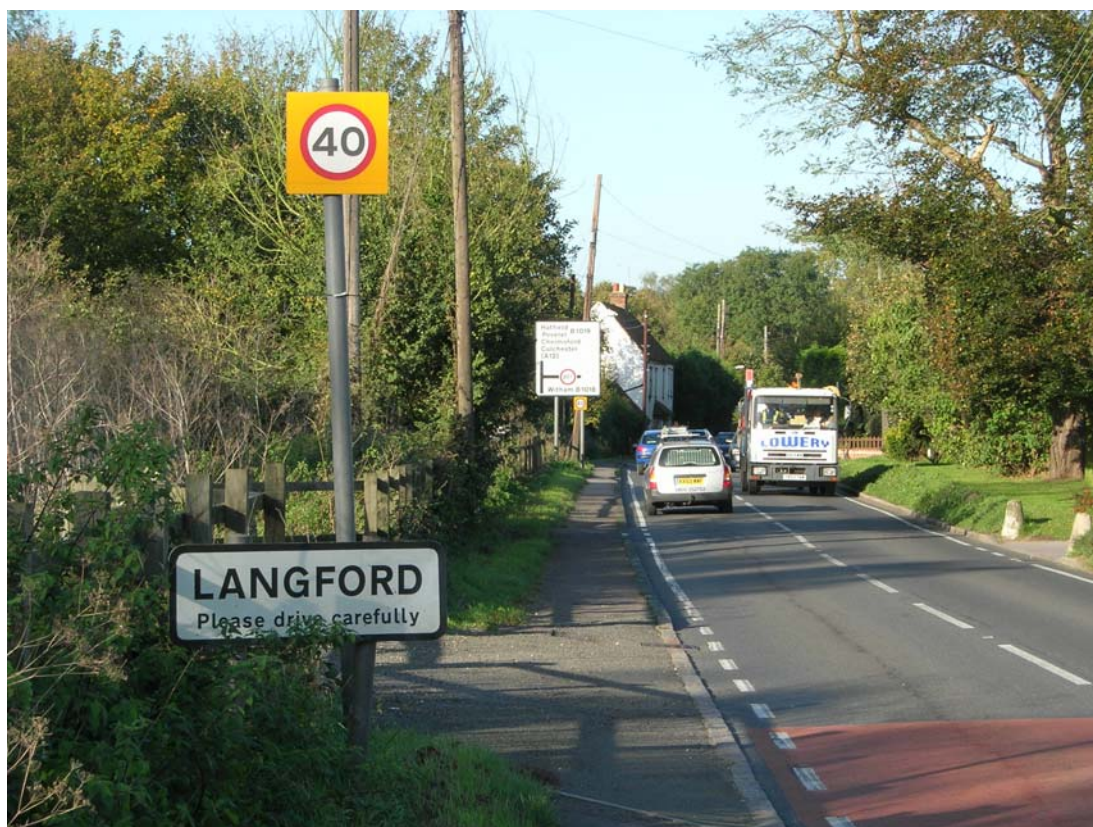
Traffic calming measures have to be put in place through Langford. At present there is a 40 mile an hour limit in operation throughout the village, although there are signs to recommend that traffic slows to 30 miles an hour whilst crossing the railway bridge. The main Maldon Road takes traffic through Langford to join the A12 at Hatfield Peverel and heavy goods vehicles continually pass through, as they are directed to from the roundabout on the Maldon bypass. As Maldon road is relatively straight, traffic does not slow enough to compensate for pedestrians using the footpath. At present it is unsafe for pedestrians to cross from one side of the road to the other. Entering the village on the Witham road where there is no footpath, the national speed limit applies whilst going past Langford Hall. The 40 mile an hour limit does not come into operation until shortly before the junction with the Maldon road. Driving out from the Witham Road onto the Maldon Road is dangerous as visibility is limited and traffic is so fast.

**Fig. 52** Speed signage from Witham Road

**Fig. 53** Speed signage from Maldon Road (east)
