Guidance on preparing  
**HERITAGE STATEMENTS** for  
listed building consent applications

This guidance was originally prepared by the Essex Conservation Officers' Forum for use in the county. Some additional information and illustrations relevant to the Maldon District have been included in this version.

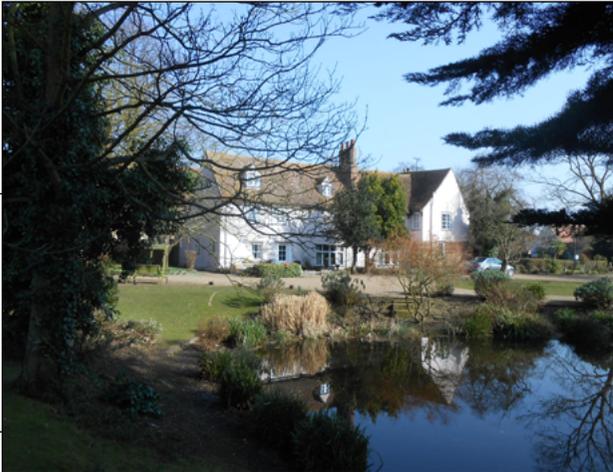
**1a: TOLLESBURY HALL**

Dating from around 1270, this is the oldest house in the Maldon District. It was built as an aisled open hall. The right-hand crosswing is a 15th century replacement. The house is listed grade II\* because of its great age.

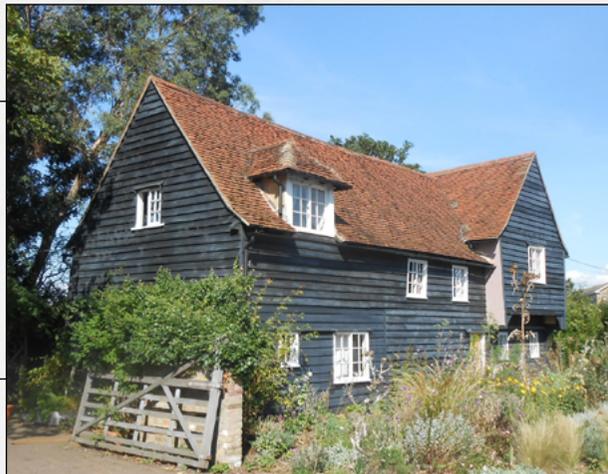
**1b: HEYBRIDGE HALL COTTAGE**

The right-hand crosswing dates from c1400 and the rest of the building dates from the 18th century. It is the medieval wing that is of most interest, but the Georgian elements are also of considerable value. Having evolved organically over time, the house has a picturesque character. It is listed grade II.

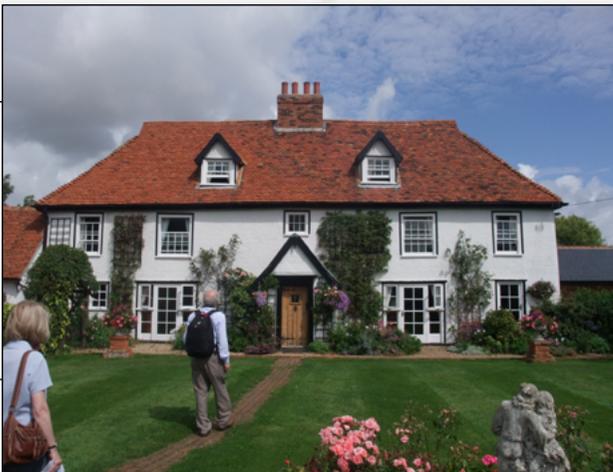
**1c: SHEEPCOATES, SOUTHMINSTER**

Dated by dendrochronology to 1615. This is a remarkably large and well-preserved lobby-entrance house. The current windows on the front elevation are later but correspond with the positions of the original lead-glazed mullion windows. It is listed grade II.

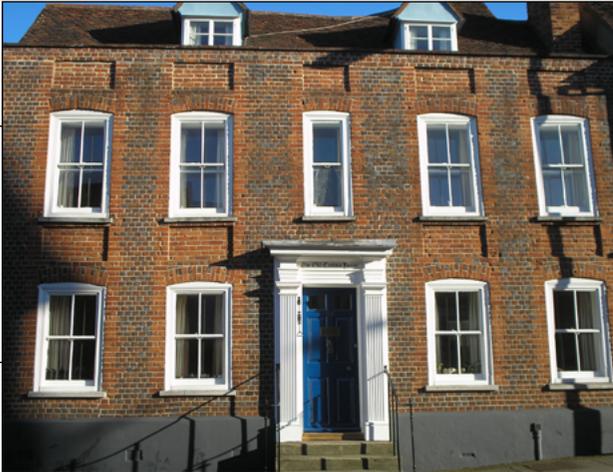
#### **1d: Custom House, Maldon**

This early-18th century house incorporates the remains of a 16th century house, and was altered early in the 19th century. The high quality of its classical brick façade and numerous internal period features justifies its listing at grade II\*.

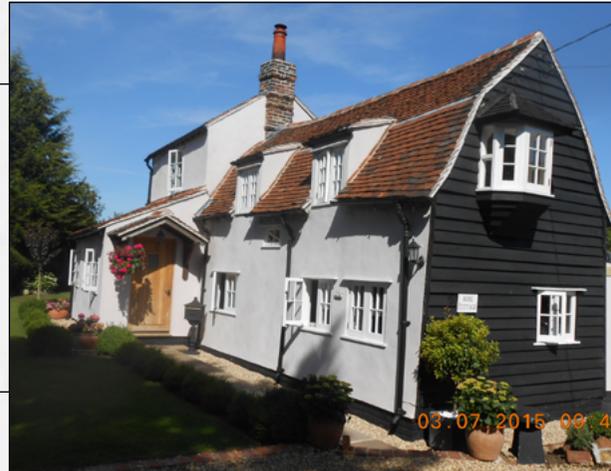
#### **1e: Cameo Cottage, Purleigh**

This house was built in 1778 by James Bowles, husbandman. It is a classic example of a gambrel-roofed Georgian cottage, of which there are many examples across the district. The two-storey range and lean-to in the distance are early 20th-century extensions and, as such, are of little significance. The building is listed grade II.

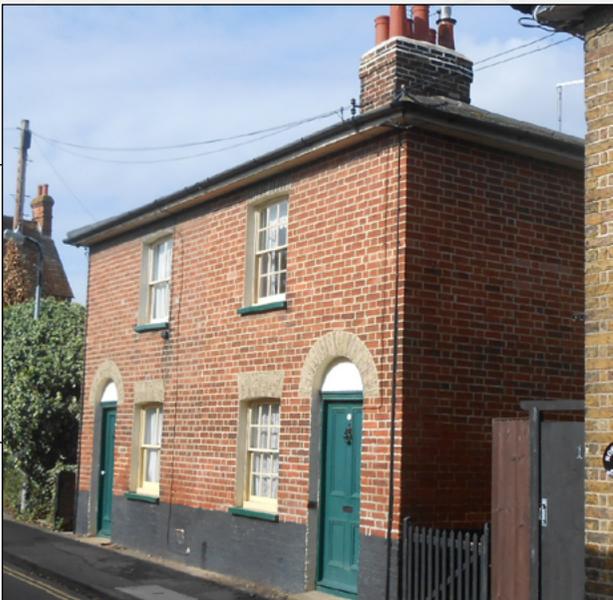
#### **1f: 7&9 Gate Street, Maldon**

This is a mid-19th-century pair of semi-detached cottages. While such houses survive in considerable numbers, this is a very well-preserved example of its type, both internally and externally, and shares group value with other similar buildings in the street. It is listed grade II.

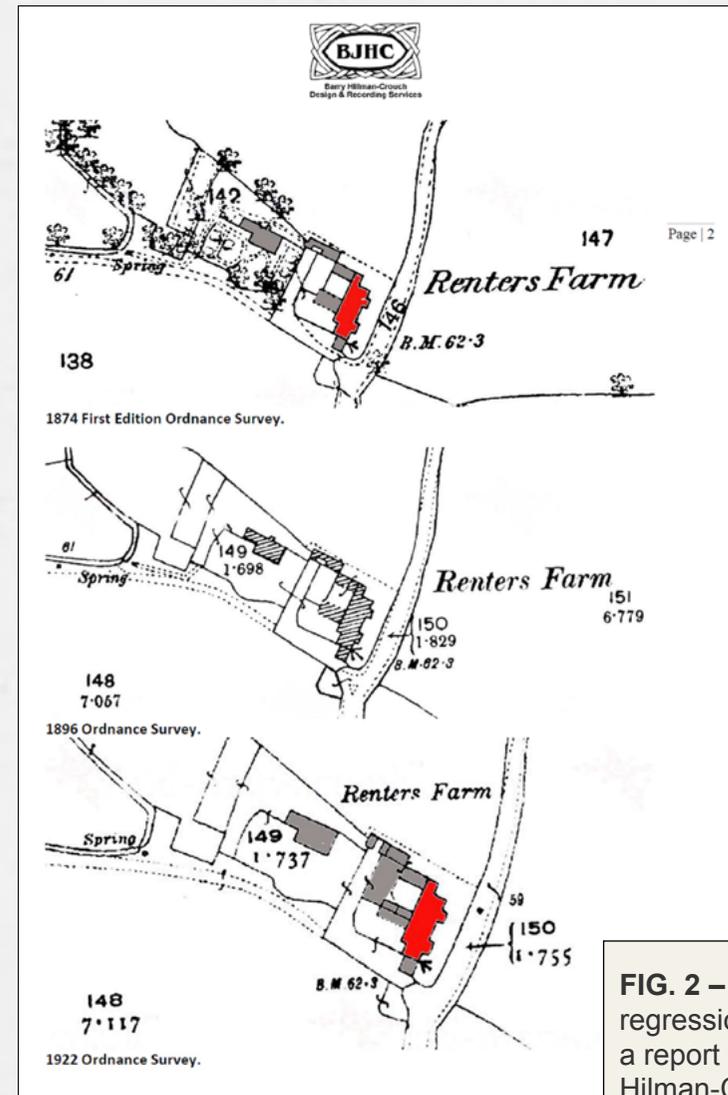
**FIG. 2 –** Map regression from a report by Barry Hilman-Crouch

Map regression (i.e. comparing a sequence of old maps) is usually necessary and will generally require a visit to the Essex Record Office, though some of this material can be found on line (FIG. 2).

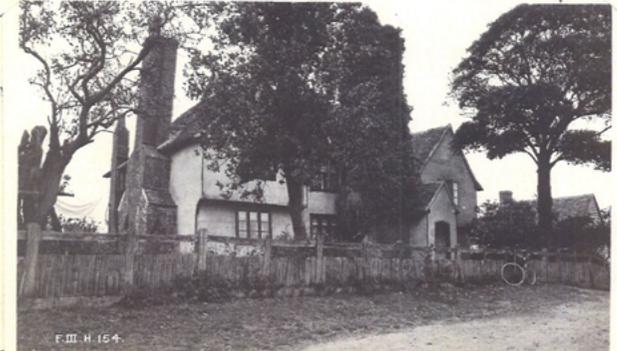
**FIG. 3** — An example of a RCHME Record Card, made in 1914, reproduced by permission of Historic England Archive.

The record cards often include sketch plans, drawings and photographs which can be particularly valuable sources of evidence. The Commission only surveyed buildings thought to pre-date 1714.

3. **Historical development** (with dates and small sketch plan).  
*The house was built in the 15<sup>th</sup> century and had a one storied central hall and two wings projecting towards the south. Late in the 16<sup>th</sup> century a first floor was inserted in the hall, and the roof above was heightened. Various alterations have been made recently with a view to adapting the house to suit two tenements.*

*The upper storeys of the E and W. wings project on the N. side. The end of the bressumer to the overhang of the W. wing projects into the modern porch sufficiently to show that it is carved and moulded. Elsewhere it has been covered with modern cement facing. It is supported by a carved and shaped corbel. The chimney stack on the N. side is very high and apparently elaborate, but is so covered with ivy that it is not possible to see the outline. The stack in the N. end of the E. wing has two conjoined rectangular shafts. The stack adjoining this is modern.*

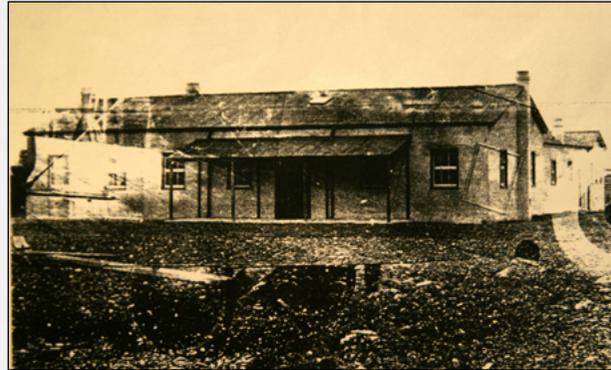
**FIG. 4a: The Officers' Mess at Stow Maries Great War Aerodrome** photographed in 1918.

**FIG. 4b: The Officers' Mess at Stow Maries Great War Aerodrome** photographed in 2016, now listed grade II\*. Consent has been granted to restore this elevation in accordance with the old photograph.

If old photographs, drawings or paintings of the building are available, it may be useful to reproduce these in the statement (FIG 4a). Photographs taken during re-rendering of timber-framed buildings are particularly valuable sources of information (FIG. 5).

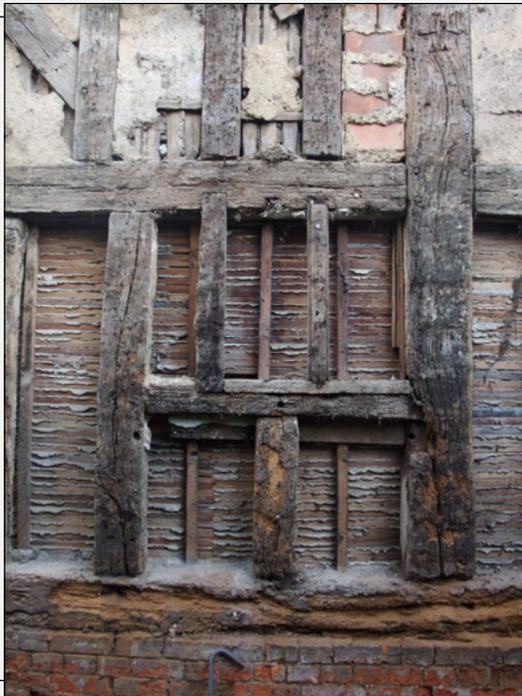
**FIG. 5:**  
**16th-century timber-framed structure exposed during re-rendering at Bridge Farmhouse, Tollesbury.**

Temporary exposure of the structure of an old building can provide a valuable opportunity to learn about its history.

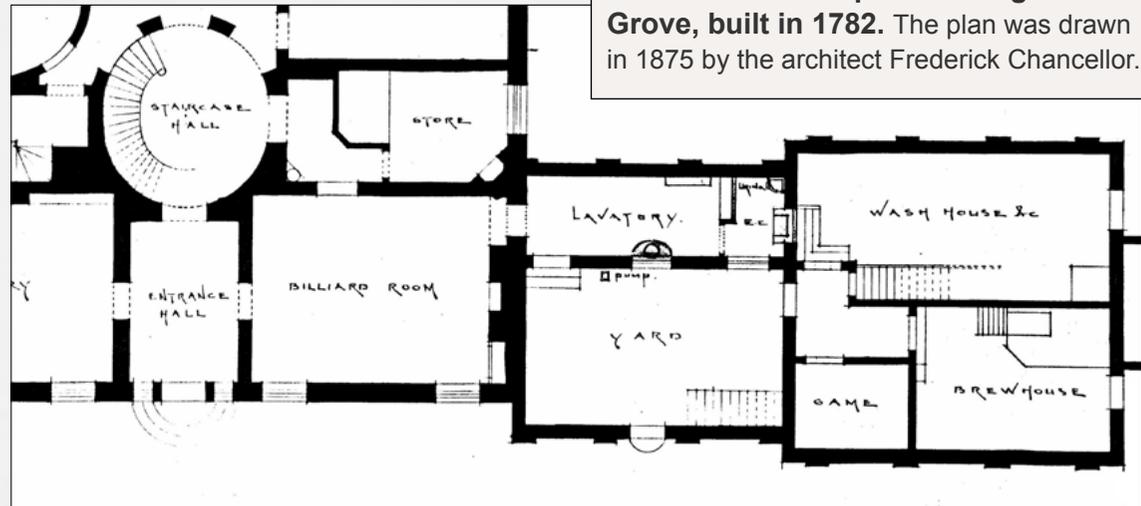
**FIG. 6: Detail of a plan of Langford Grove, built in 1782.** The plan was drawn in 1875 by the architect Frederick Chancellor.

For later and higher status buildings, architect's and surveyor's drawings might survive (FIG. 6). Local historians may be willing to help, particularly if the opportunity to study the building or old deeds aids their own research.

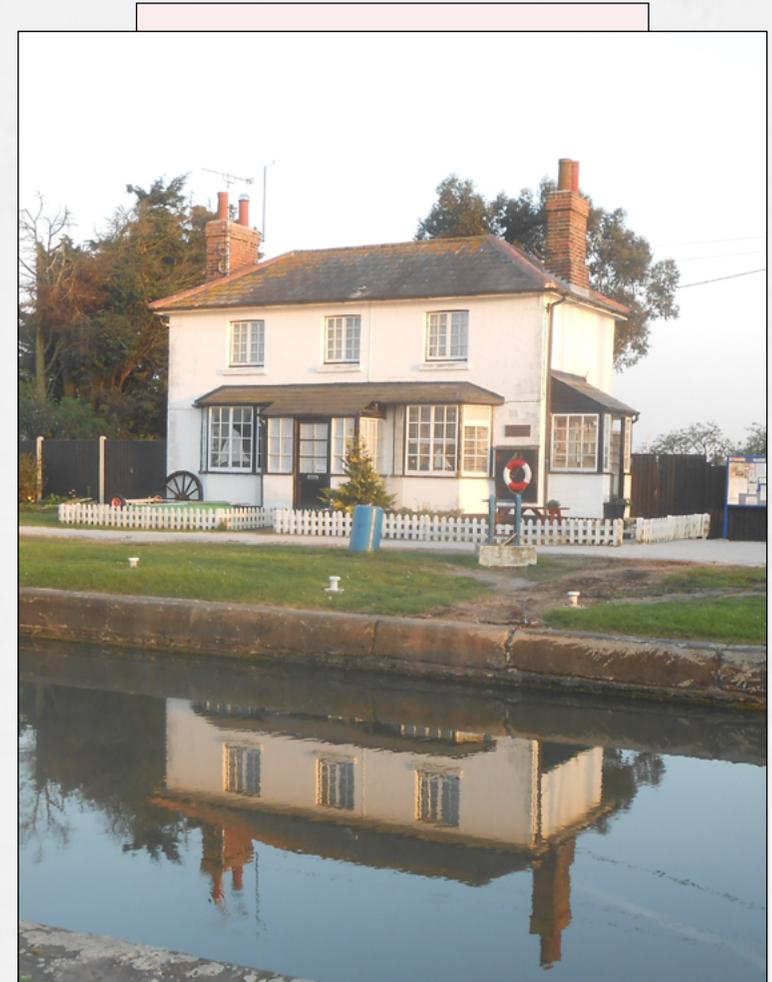
**FIG. 7:**  
**Lock House in Heybridge Basin.**

The adjacent canal is a vital element to this grade II listed building's setting and significance

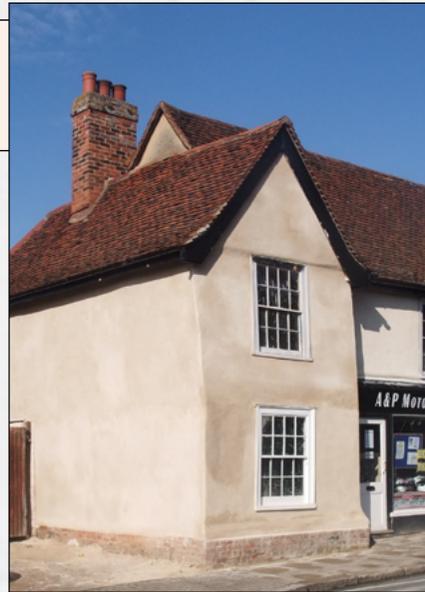
**8a:** This is a late 15th-century crosswing. Although the render and Georgian sash windows are much later, they are nonetheless important components of the building's history and significance.

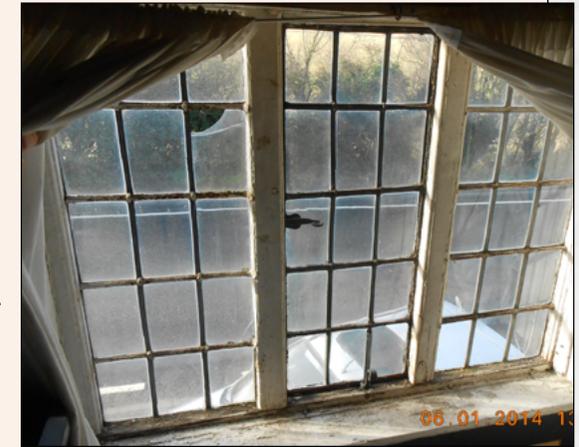
**8b:** These lead-glazed casement windows are original to this cottage, which was built in 1799. Lead-glazed windows were common in Georgian cottages, but they rarely survive. Because of their rarity, these windows are of considerable significance.

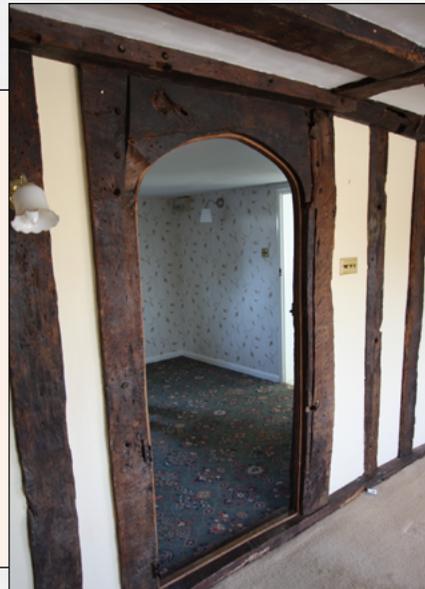
**8c:** An original doorway in a 15th-century crosswing. It has a gothic, 4-centre arched head. The door itself has been lost, but a rebate and hinge pintles show how it was fixed.

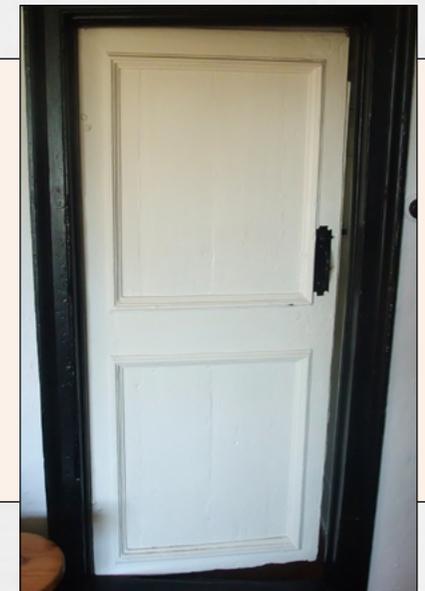
**8d:** An 18th-century internal door. Most old doors were always intended to be painted, and it may therefore not be appropriate to strip the paint off to the bare wood.

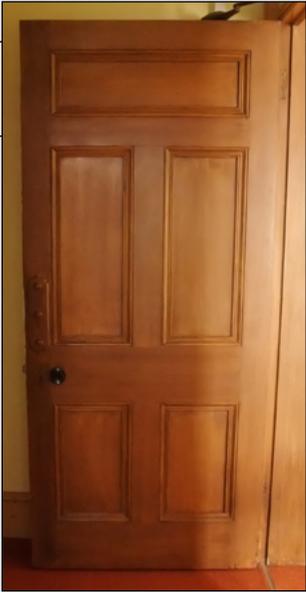
**8e:** An original panelled door in a high-status house dated 1880. It has been painted to appear like exposed wood.

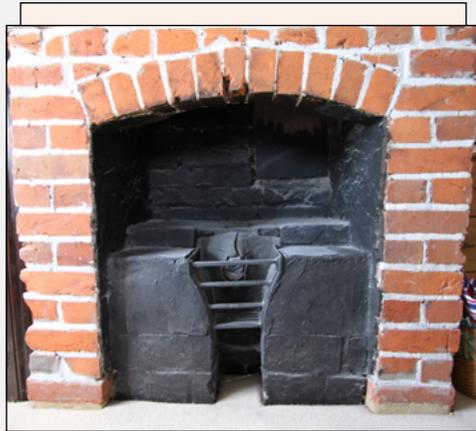
**8g:** An original bedroom fireplace incorporating hobgrate in a Georgian cottage of c.1760.

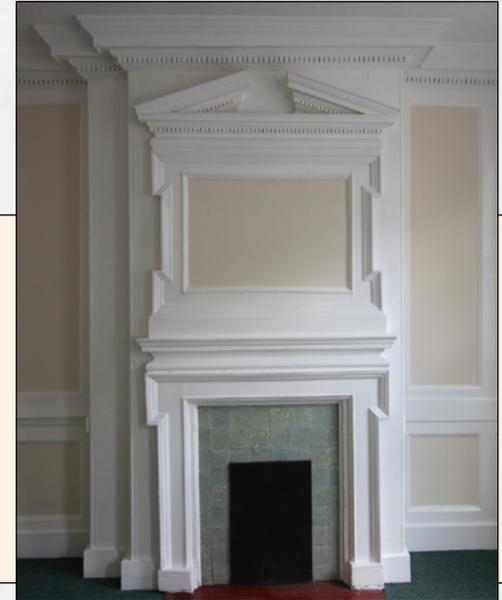
**8f:** A fine 'eared' fire surround and overmantle with a broken pediment. This is the centrepiece of a panelled room in a townhouse of c.1740. It is the best example of its type in the Maldon District. Great care must be taken not to disturb this joinery through work such as re-wiring.

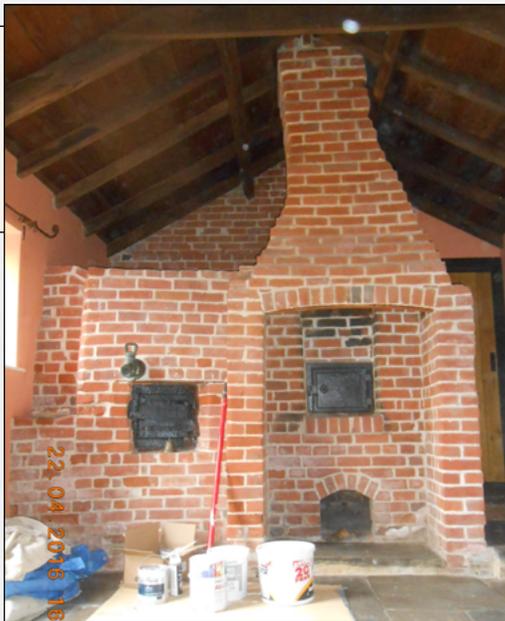
**8h:** The interior of a Brewhouse attached to a listed farmhouse. In the back of the fireplace can be seen the doors to a bread oven. To the left-hand side is a warming copper. Such features provide a valuable record of the routine activities which structured life in vernacular houses.

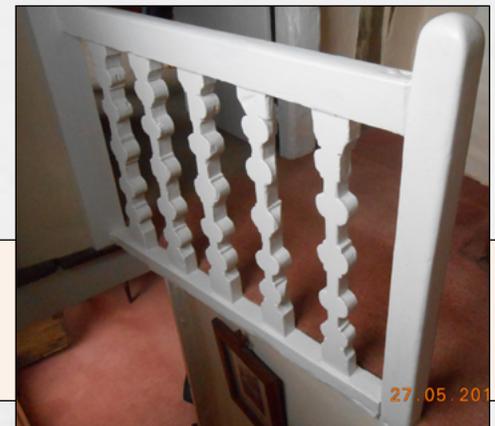
**8i:** Stair bannisters in a grade II listed cottage dating from the late-17th or early-18th century. The splat balusters are of an unusual ovolo-moulded design, and may be recycled. The rustic character of this feature reflects the humble status of the cottage.

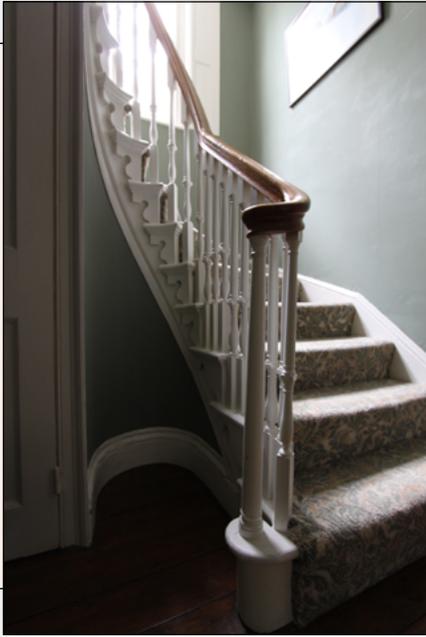
**8j:** Staircase in 63 High Street, Maldon, a town house built c.1770 for Edward Bright, a grocer. Shaped tread ends, turned balusters and a sinuously curved handrail are characteristic features of staircases of this period, of which this is a handsome example.

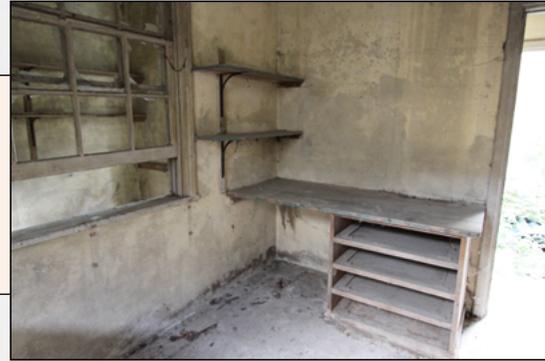
**8k:** The interior of a room in the Officers' Mess at Stow Maries Great War Aerodrome, which is listed grade II\*. Abandoned after the war, the original plan chest, shelves, window and paint finishes are highly evocative features.

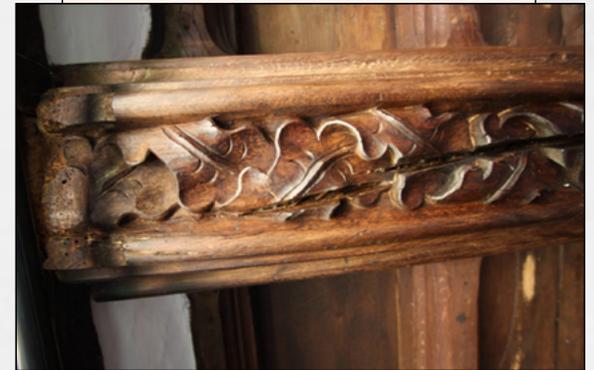
**8n:** This ceiling joist has flat chamfers with lambs-tongue stops. It is in the former workhouse on Market Hill, Maldon, which was erected in 1719, and is now listed grade II. Lambs-tongue stops first appear in the second half of the 16th century and are commonly encountered in buildings of the 17th and 18th centuries.

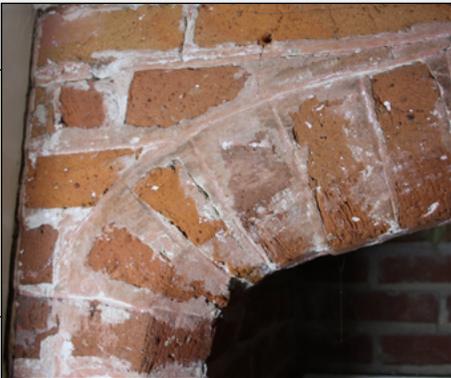
**9d:** Detail of an early-17th century fireplace with the remains of an original 'ruddled' finish. Ruddling involved coating the bricks with a mixture of red ochre and size and then painting thin white lines to convey the impression of much finer brickwork. It was very common on medieval, Tudor and 17th-century brickwork but has often been removed by people in ignorance of its significance.

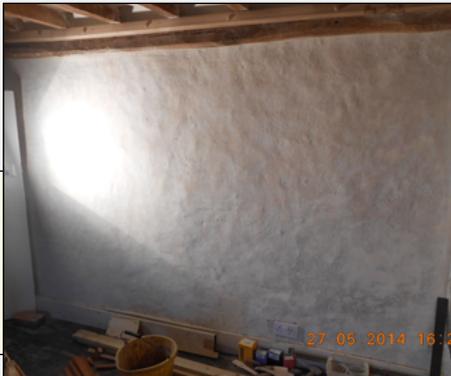
**9f:** A lath and lime-hair plaster wall in a late 17th-century cottage. The undulations of the plaster's surface make a very important contribution to the historic character of the interior. The wall was patch-repaired using lime-putty.

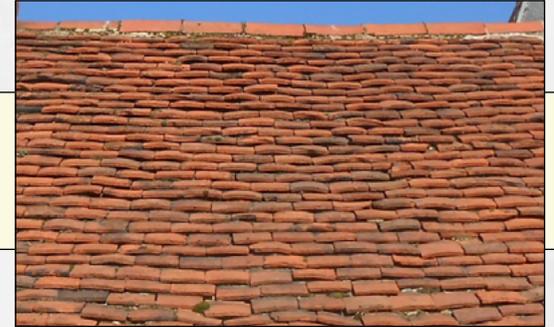
**9a:** Double-cambered clay plain tiles. The varied hues and irregularities of the tiles impart warmth and texture to the appearance of the building. The use of locally sourced materials reflects the building's vernacular character.

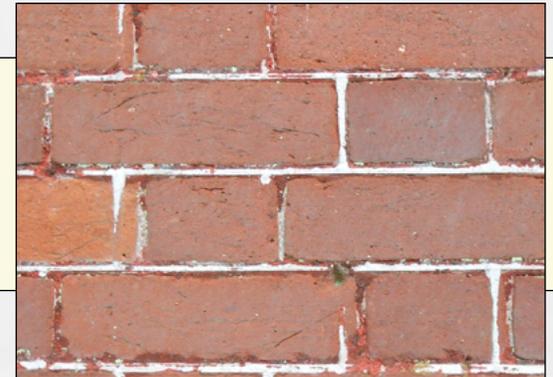
**9c:** Tuck-pointed brickwork on a house dated 1798. This is a particularly sophisticated treatment found on Georgian and early Victorian brickwork, intended to emulate the appearance of fine rubbed and gauged brickwork whilst using cheaper bricks. The stopping mortar matches the red colour of the bricks. Thin strips of white lime mortar were applied to create the impression of much finer mortar joints.

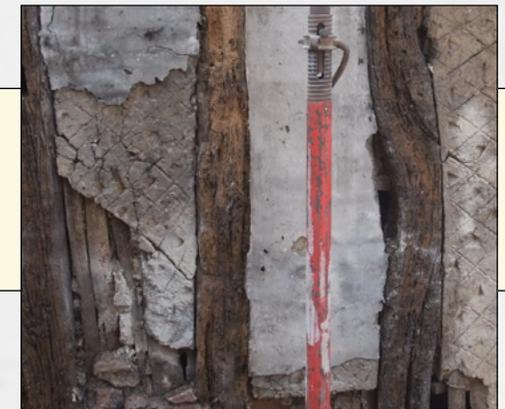
**9e:** Late-medieval studwork exposed during re-rendering. The infill in between the studs is original wattle and daub with a thin, lime plaster finish. These infill panels are almost as important as the timber structure itself. In this instance appropriate care was taken to retain and repair the infill.

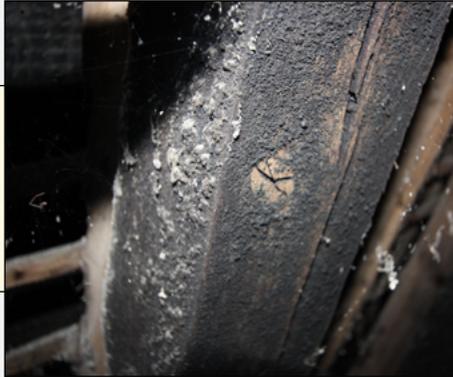
**9h:** Detail of an original rafter in the 13th-century roof at Bradwell Hall. The surface is thickly encrusted with soot from the fire which burned for two or three centuries on the floor of the open hall below. This soot blackening is important evidence of the building's age and function.

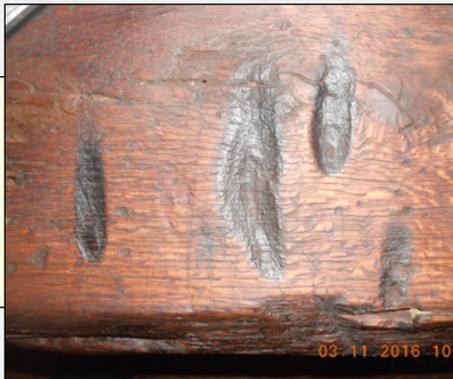
**9j:** It is a peculiar phenomenon that flame-shaped burn marks can be found in most timber-framed houses predating c1650. Traditionally interpreted as accidental, it has more recently been argued that such marks were made deliberately by superstitious builders. These examples are on a fireplace bressumer, which is a common location for such marks.

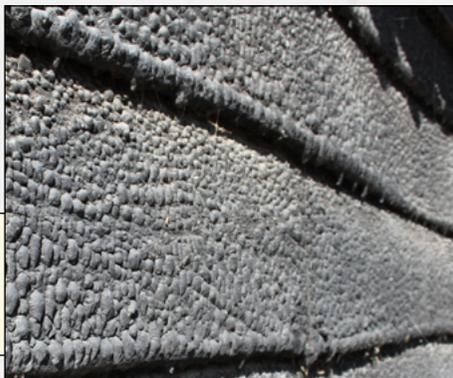
**9j:** Tarred weatherboarding on a grade II listed barn. This surface finish and the boards' irregular profile contribute to the building's patina of age.

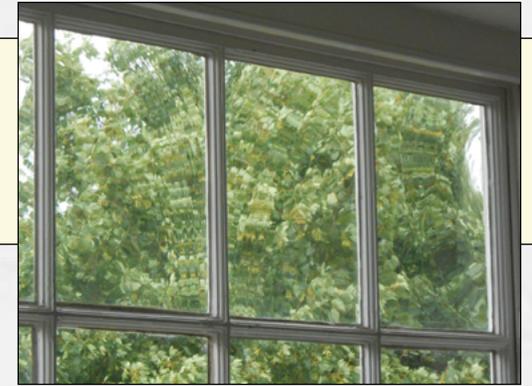
**9g:** Panes of original crown glass in a late 18th-century sash window. The subtle irregularities of handmade glass contribute much to the character and appearance of old houses. The skill required to manufacture crown glass was lost in the 20th century, which makes surviving examples all the more precious.

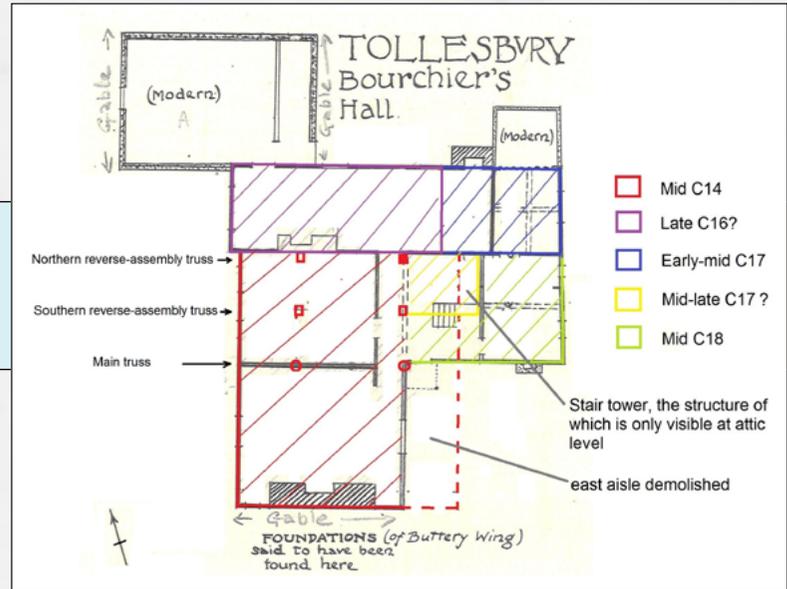
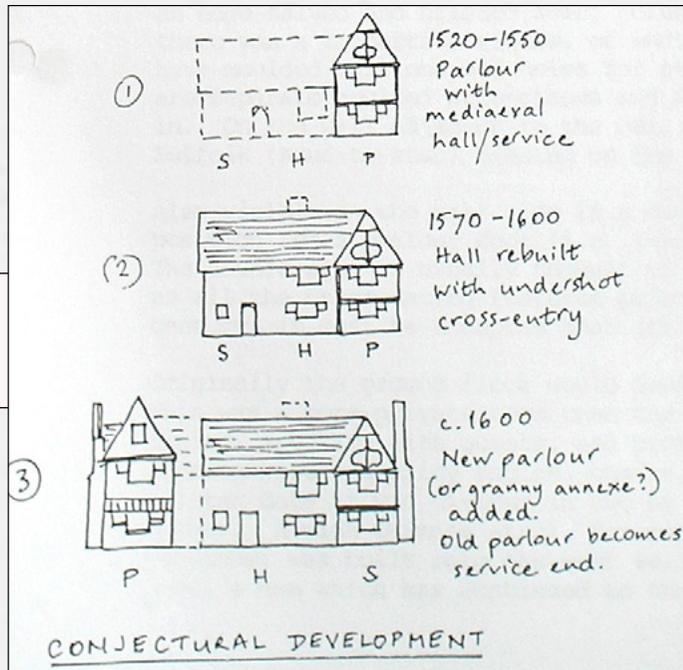
**FIG. 11:** Simplified sketches illustrating the evolution of a multi-phased farmhouse. By Anne Padfield.

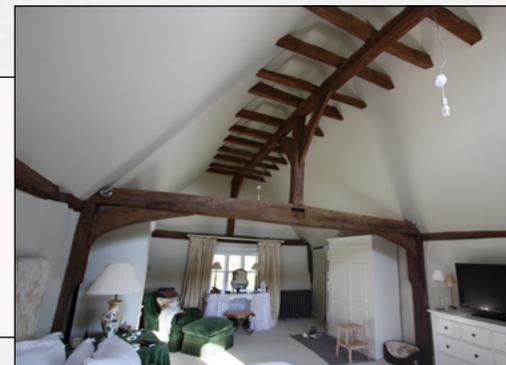
**12a:** This is a late example of a crown-post roof. The crown post is the vertical timber standing on top of the tie beam. The top of the crown post and its two braces are connected to a central 'collar purlin'. Most houses dating from c.1300-c1550 had this type of roof.

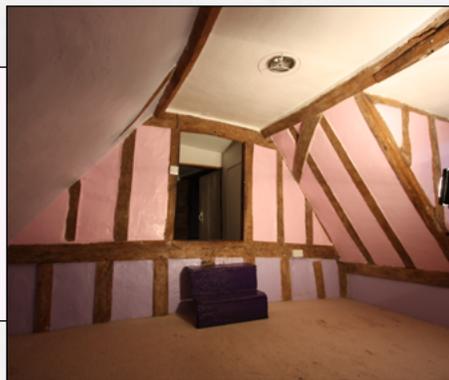
**12b:** Crown-post roofs fell out of use during the second half to the 16th century, and were superseded by side-purlin roofs. This is an example of a 'clasped' side-purlin roof in a house dating from the late-16th century. Note the arched wind braces which were common before the 18th century.

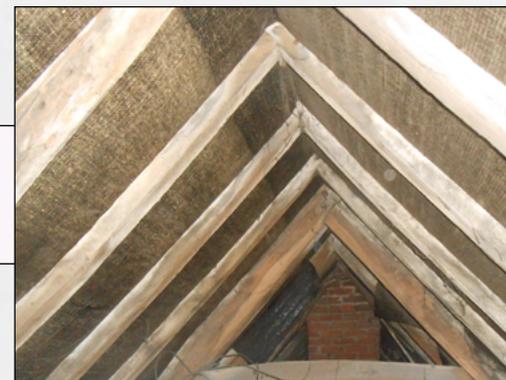
**12c:** When each pair of rafters is separately jointed and pegged at the ridge, this is normally an indication the roof pre-dates c1800.

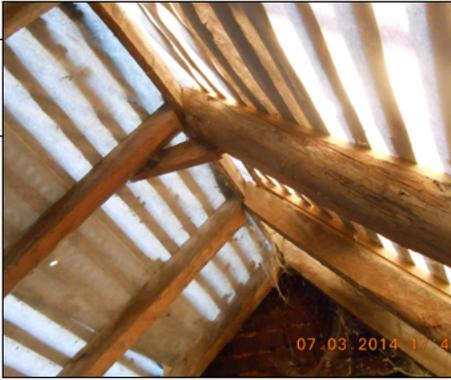
**12d:** From around the mid-18th century the tops of rafters are often nailed to a ridge plank.

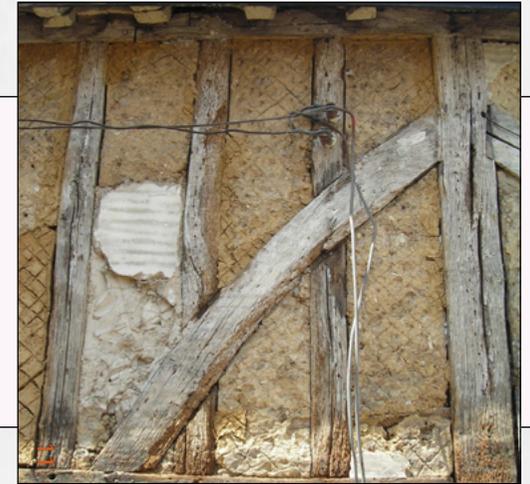
**12e:** Before the early-17th century it is common to find wall braces which are trenched into the face of the studs. This is known as secondary bracing. Before c1550 it is most common to find such braces on the external face of outside walls. In the late-16th and early-17th century secondary braces are commonly found on the internal face of external walls. In timber frames predating the mid-17th century, the ends of most structural timbers are morticed, tennoned and pegged in place, whereas nailing becomes increasingly common in later structures.

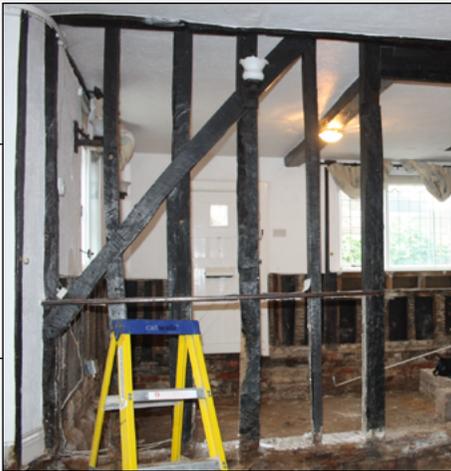
**12f:** In later timber framing, wall braces are 'primary' in that they are as thick as the studs. In this example, in a cottage of c.1760, the top and bottom of the brace are jointed and pegged into the frame, with the studs above and below it nailed into place in separate sections. Most examples of primary bracing are 17th century and later although early examples occur in the late-16th century.

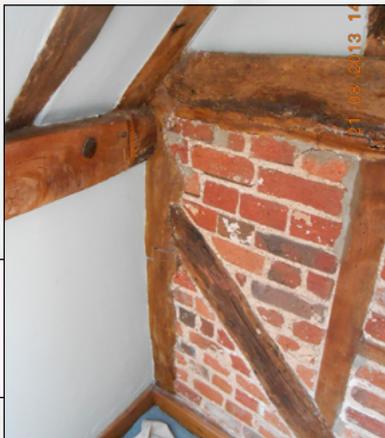
**12g:** Jowled posts are those which swell in size at the top to enable a connection with the tie beam as well as the wall plate. They normally point to a date before the early-18th century.

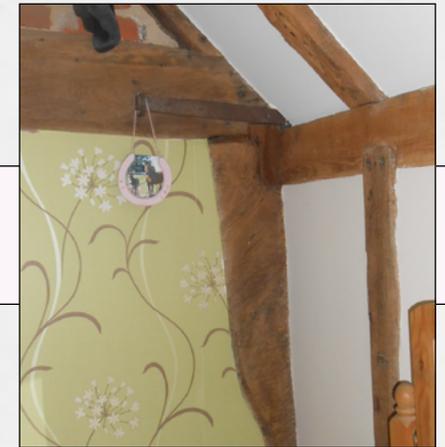
**12h:** Posts without jowled tops are occasionally found in medieval buildings, but they are a feature of all timber-framed buildings post-dating the early-18th century.

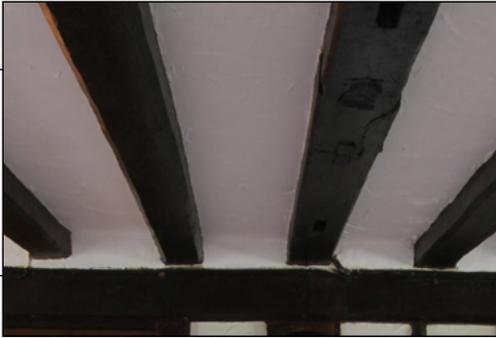
**12i:** Floor joists which are wider than they are tall (flat section) tend to date from before c.1620. The floor joists in this photograph are in a building tree-ring dated to c.1615. In the same building, the original attic storey joists are of vertical section but were intended to be hidden by plaster.

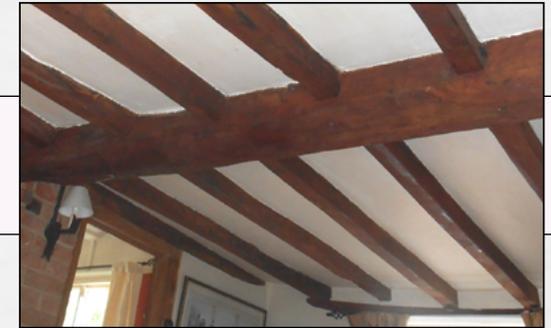
**12j:** Floor joists which are narrower than they are tall (vertical section) are first thought to appear in the late-16th century but they are normally a feature of 17th-century and later buildings.

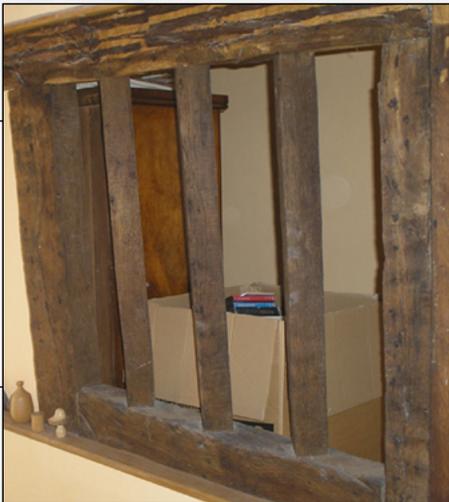
**12k:** Most houses pre-dating the mid-16th century had unglazed windows with diamond-section mullions. These windows were originally served by internal shutters (sometimes hinged but more occasionally sliding) which never survive but are evidenced by rebates, grooves and hinge pintles. Such windows rarely remain intact but can be detected by diamond-section mortices for the mullions.

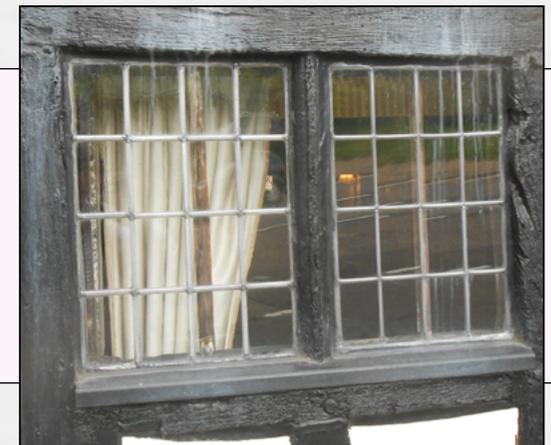
**12l:** Only houses which were particularly high status had glazing before the mid-16th century. The drop in the price of glass during the second half of the 16th century caused glazed windows to be used in common houses. This ovolo-moulded mullion window is in The Bell in Woodham Walter, which dates from the early 17th century. Ovolo-moulded mullion windows first appear around the third quarter of the 16th century and are common throughout the 17th century.

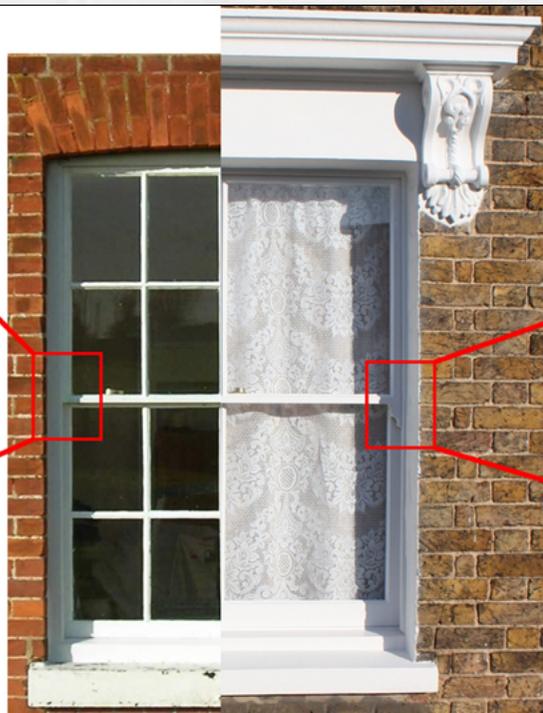
**12m:** A sash window of c1829. In the upper sash, the junction between the bottom rail and the stile has no 'horn'.

**12n:** A sash window of c1860. In the upper sash, the stile extends below its junction with the bottom rail to form a horn. The presence of horns on sash windows indicates a date after c.1850.

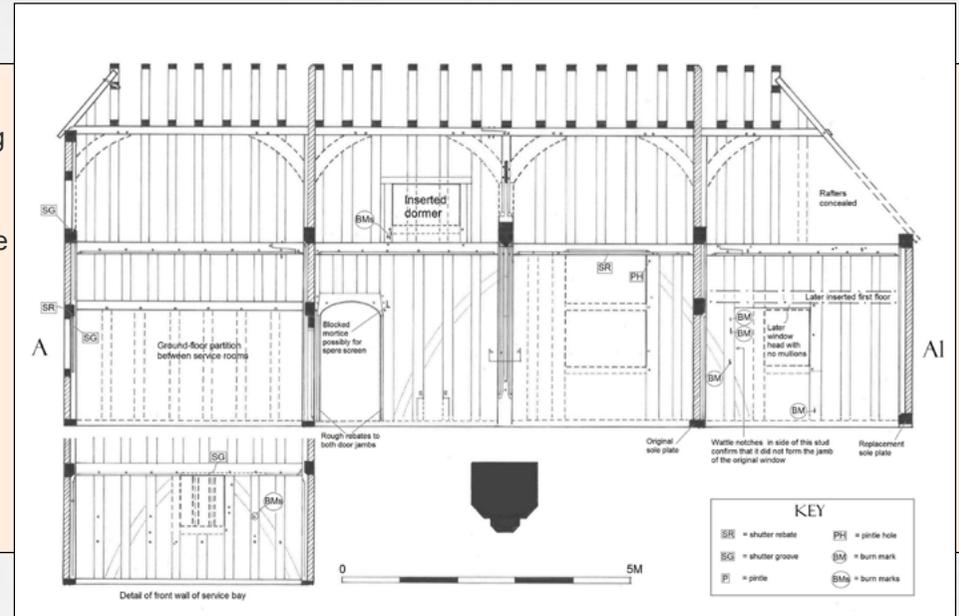
**FIG. 13:** A detailed survey drawing of a 15th century timber-framed house. It is a section through the house looking at its front wall from the inside. Missing original features are indicated by broken lines. For clarity most later alterations are omitted from the drawing. By Tim Howson.

Building recording is not the same as a heritage statement, being much more detailed (FIG. 13). It is typically required where works have a major impact on the listed building, where fabric will be lost (thus ensuring preservation by record) or opened up revealing new information about it. It will generally be required where a building such as a barn or industrial building is being converted to a new use, establishing a baseline for our knowledge about it. Ideally it should accompany and inform the application, and not be prepared afterwards. Building recording drawings can prove useful in planning the extent of necessary repairs (FIG. 14).

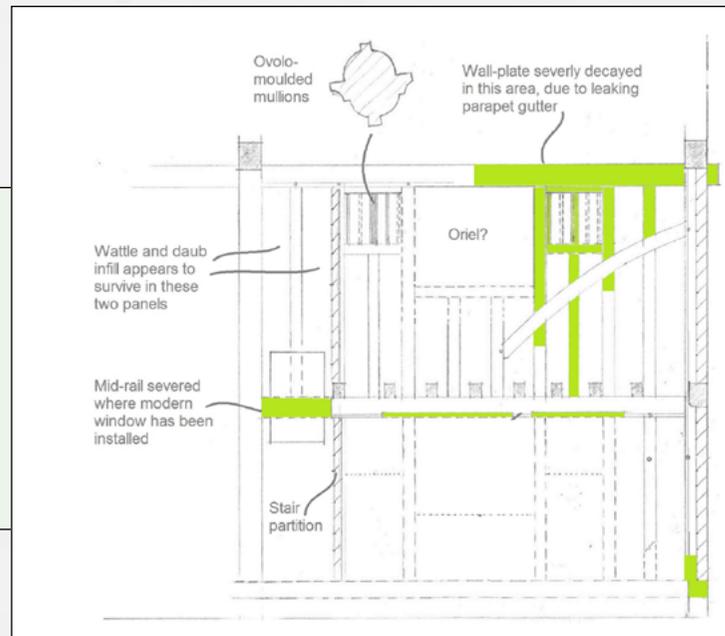
**FIG. 14:** A detail of a draft survey drawing of part of an early 17th-century crosswing. The timber-framed structure was found during the course of work to be severely decayed. The survey drawing was used to agree the extent of replacement timber required. Sections highlighted in green required replacement. By Tim Howson
