PURLEIGH

Conservation Area Review and Character Appraisal

MALDON DISTRICT
COUNCIL

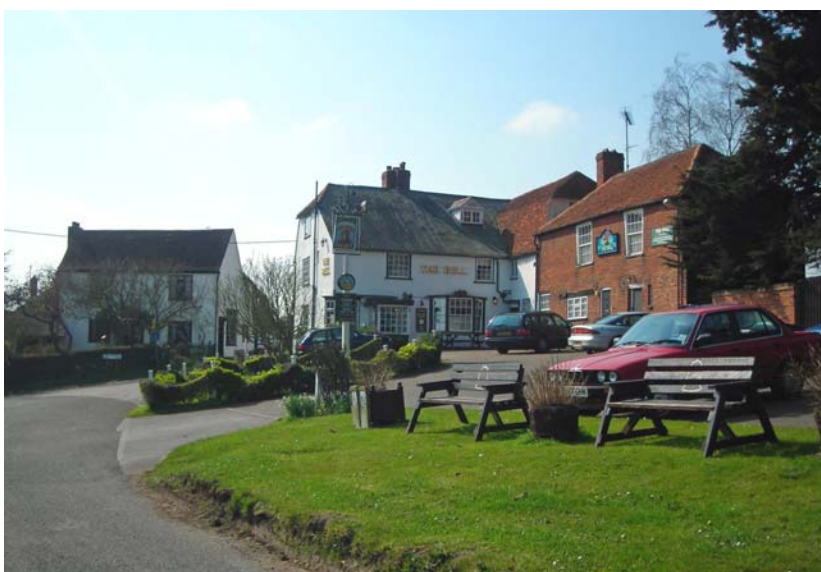
Fig. 11 The Bell and The Old Gate House, formerly village stores.

The open area in front of the Bell pub is an important element in the spatial character of the conservation area. The Street broadens here, creating attractive views to the Bell, and the area now provides car parking space for the pub (*Fig. 11*). This has been landscaped with grassed areas, planting and benches so that it is not visually intrusive. This open area is a historic townscape feature which provided a commercial focus for the settlement in the past, and should be preserved. Historically The Bell together with various associated buildings, some of which have now been lost, enclosed the south and west side of this space, with the village stores on the south-east corner (now The Old Gate House). The informal arrangement of historic buildings around this space creates a delightful street scene and represents a well-preserved historic core of this small settlement.

The Bell provides a focus for the conservation area and is an attraction for the local community and for visitors (*Figs 11, 34*). Originally two separate 15th century houses, including a medieval open hall house with a cross wing, the property has a long history of additions and alterations and now has a complex plan and irregular form (see the list description in Appendix 1 for an explanation of the different elements of the building). A brick stable block was added in the 18th century, and the premises included a slaughter house and butcher's in the 19th century. Attached ancillary buildings originally extended further north than they do now. It is grade II listed.

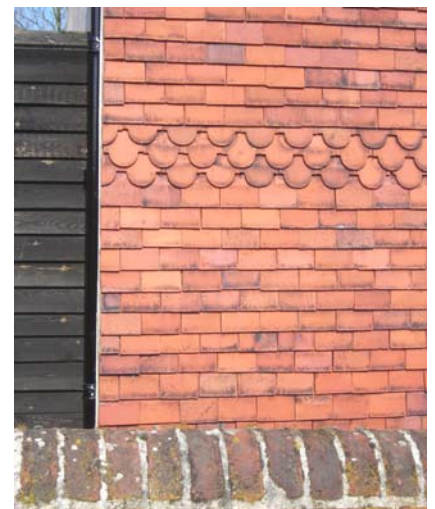
Fig. 21 Decorative tile hanging on The Old Bakery.

Decorative clay hanging tiles are a Victorian intervention used to good effect on both The Old Bakery and The Old Rectory, creating attractive and interesting frontages (*Fig. 21*).

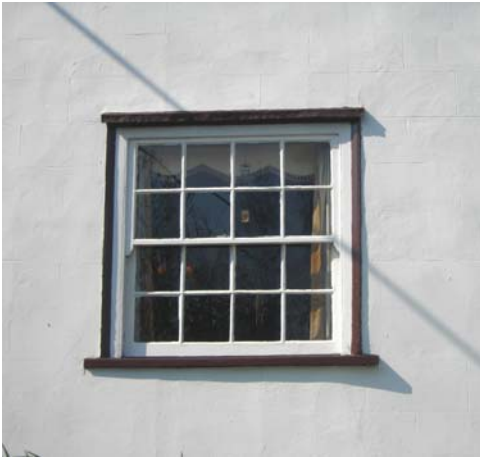
Fig. 22 Traditional timber small paned sash window, The Bell.

Traditional windows are of painted timber, usually white, and small paned vertically sliding sashes are the dominant window form (*Fig. 22*). Windows tend to be flush to the front in timber-framed and weatherboarded buildings, or slightly recessed in brick buildings. Elevations are given interest with a variety of projecting windows and bays, most noticeably along the eastern stretch of The Street, making the best of the splendid views.

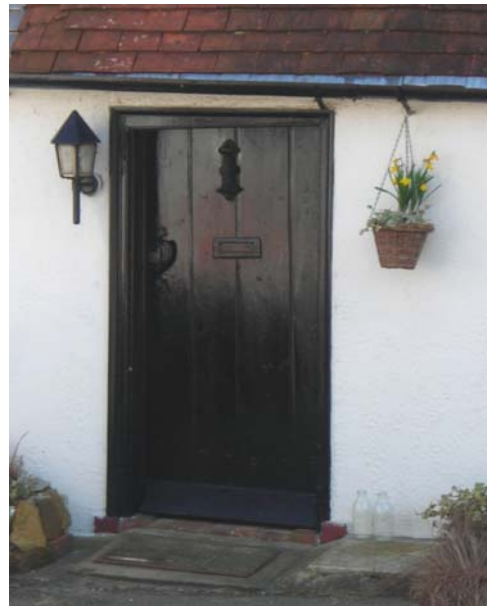
Fig. 23 Traditional timber boarded door, the Old Gate

Traditional doors are painted timber, and include panelled and boarded doors (*Fig. 23*). Doorway treatments include small canopies and pitched or hipped roof porches that add variety and interest to frontages.

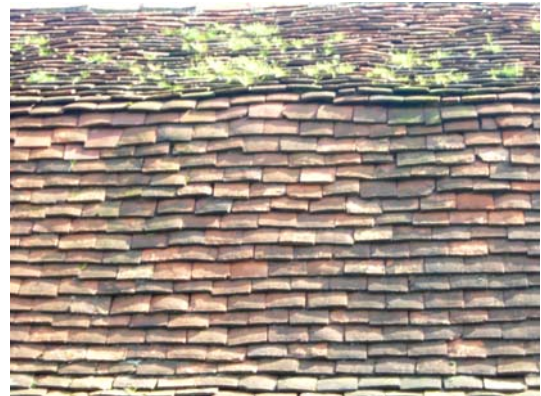
Fig. 24 Handmade double cambered clay tiles on the roof of

Roofs are typically pitched and positioned flank to the street. Hipped roofs are also seen. Roof materials are most commonly double cambered handmade red clay plain tiles laid between 47 and 50° (Fig. 24). Modern dwellings have made good use of this vernacular material. Natural blue-grey slate is occasionally used at a lower pitch (35 to 40°). Orange clay interlocking tiles are used on agricultural buildings at Purleigh Hall Farm (Fig. 25). Brick chimney stacks, often with corbelled courses, enliven the roofscape. Dormer windows are not typical in the roofscape of the settlement. Restrained use of dormers in later properties (Roundsmans Cottages and Aylesbury Barn does not overly disrupt the traditional character, but dominant dormers would not be appropriate.

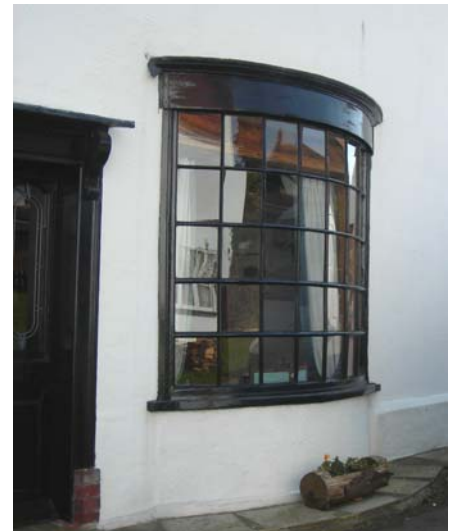
Fig. 26 Original 18th century shop window, The Old Gate House.

Properties in the conservation area today are principally residential. Purleigh Hall farm retains some of its agricultural use, with traditional farm buildings at the southern end of the farmstead. The historic barns were converted for residential use in 1984. The settlement's former shop at The Old Gate House has retained its shop window although it is now purely residential, the shop having closed in the 1970s (*Fig. 26*). The Bell has been in use as a pub since the 17th century. The old schoolroom and schoolmaster's house still survives opposite the church, retaining evidence of its former use in its appearance. The only surviving building representing past industrial activity in the settlement is The Old Bakery, which retains ancillary buildings set back from the road and now converted for residential use. The original early 19th century oven survived *in situ* until recently when a new house (Aylesbury Barn) was built on the site of one of the buildings. However the remains of the oven have been incorporated into the new building, which is generally of a good modern design that has been influenced by the building it replaced.

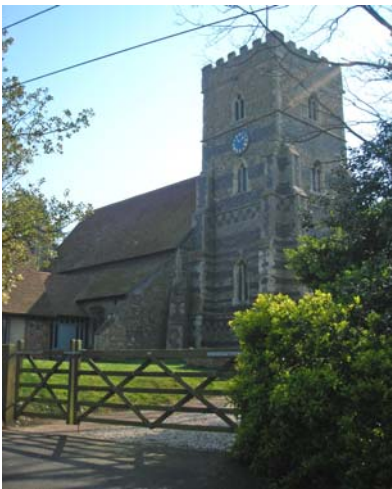
Fig. 30 All Saints Church.

All Saints Church is mainly 14th century but significantly restored by Chancellor 1886-1892 (*Fig. 30*). It is constructed of Kentish Ragstone, septaria, dressed flint and yellow brick, with dressing of limestone and clunch. The fabric includes very early brickwork from the 14th century. The roof is of handmade clay tiles. A well designed single storey extension by Inkpen Downie was added on the north side in 2002-3, and this was the winner of Maldon District Council's Design Award in 2003 (*Fig. 31*). The church is grade I listed. The churchyard is well cared for, and attractively planted, particularly with evergreens. It has a variety of monuments and gravestones which are informally arranged beneath the shade of the churchyard trees, including Victorian body tombs and some quite grand memorials. At least one of these is worthy of listing (a box tomb for John Strange, 1688). There are some tall conifer trees which are important features in the conservation area and prominent in distant views towards Purleigh Hill.

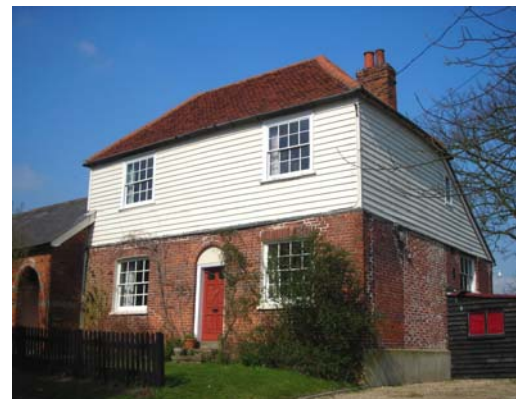
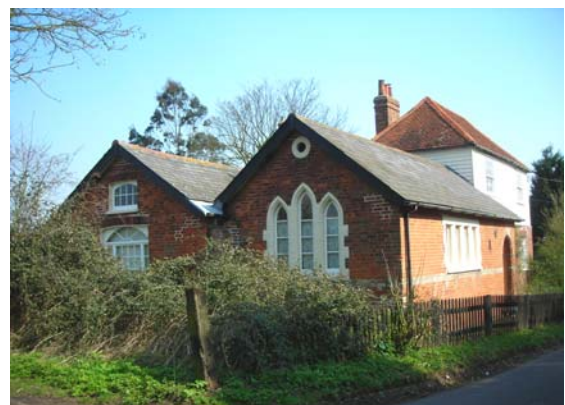
Figs. 32, 33 Eveleigh House, with the brick classrooms (bottom).

Opposite the church is **Eveleigh House**, which is grade II listed. It is named after the rector of Purleigh, John Eveleigh, who had it built as a schoolmaster's house with schoolroom to the rear in 1807 (*Fig. 32*). Other classrooms were added in 1817 and 1872. When a new school opened in the village in 1915 the school closed and it is now a private residence. The main house is two storeys with Flemish bond red brick ground floor and timber framed and weatherboarded first floor. The house retains original small paned sash windows with crown glass. The schoolrooms are built in a Gothic Revival style, and comprise two single storey brick ranges to the west with gables facing the cemetery (*Fig. 33*). A little bell tower has been lost over the past 25 years or so. As well as its local significance, this is a picturesque building, prominent in views along The Street and from the cemetery. It also represents a good survival of an early 19th century rural village school.

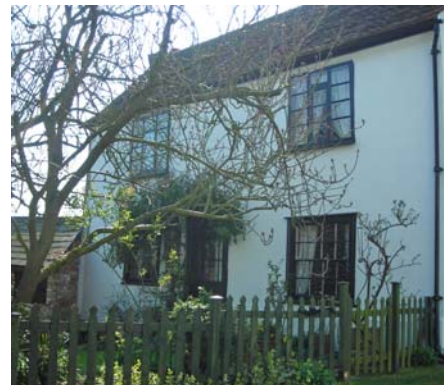
Fig. 35 The north elevation of The Old Gate House.

Opposite the pub **The Old Gate House** was built in 1759 as a grocer's and draper's shop, and subsequently also became a post office and telegraph office (*Fig. 35*). The building occupies an important corner position where The Street narrows before approaching the farm. It retains a good 18th century bow shop window with some original glass as evidence of its former use. There are also two original doors. A single storey rear gambrel roof range was originally a bake house. There is also a late 19th century single storey ancillary building extending east. It is grade II listed.

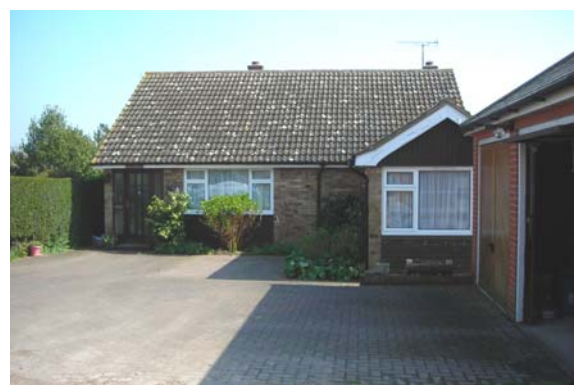
Fig. 36 Michelette.

Michelette is a modest single storey detached 1960s house with a detached garage (*Fig. 36*). Constructed of modern materials that are unsympathetic to the traditional character of the conservation area, it is nonetheless not intrusive by virtue of being set back in its plot and of low profile, although the double garage is prominent to the front of the plot. It would benefit from some soft landscaping to the front to soften the appearance, and from a more sympathetic surface treatment.

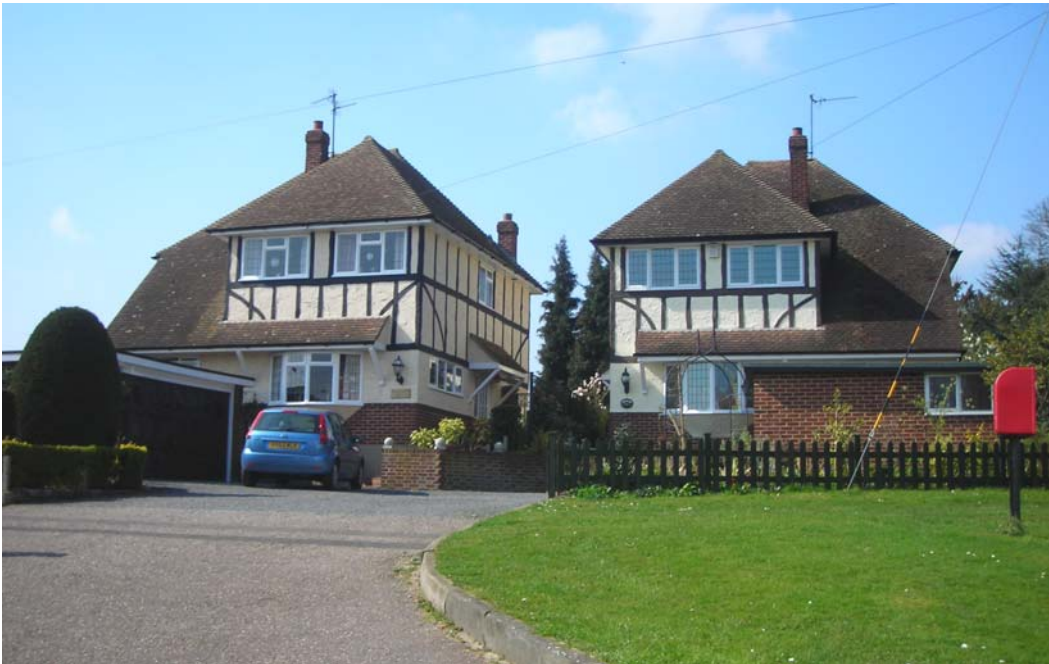
Fig. 37 Creran and Tudor House.

Creran and Tudor House are a pair of large 1960s detached houses of a neo-Tudor design (*Fig. 37*). They are constructed of modern materials, both with large flat roof garages to the front of the plots. They are overly suburban in style for this small rural settlement, but are nevertheless good quality architecture of their time, and distinctive elements in the street scene. They are built on the site of a former smithy.

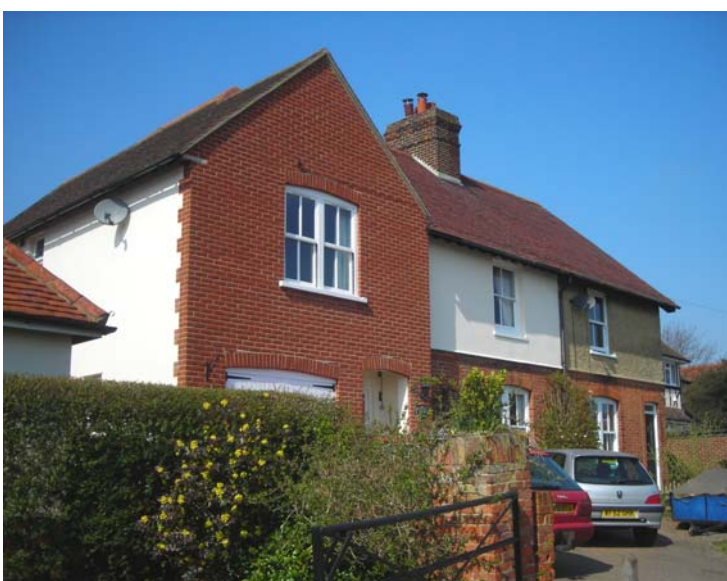
*Fig. 38 Hall Cottages.
The gable to the left is a new extension.*

On the approach to the farm **Hall Cottages** are semi-detached cottages that stand just outside the farm gates (*Fig. 38*). They were built in 1901, and have to some extent lost their integrity as a pair through alterations. One has recently been restored with UPVC windows which, although of good quality and design, undermine the traditional character of the buildings. The other cottage has been extended with a two storey gabled extension and integral garage. The extension has been constructed in stretcher bond brickwork, where the original cottage is of Flemish bond.

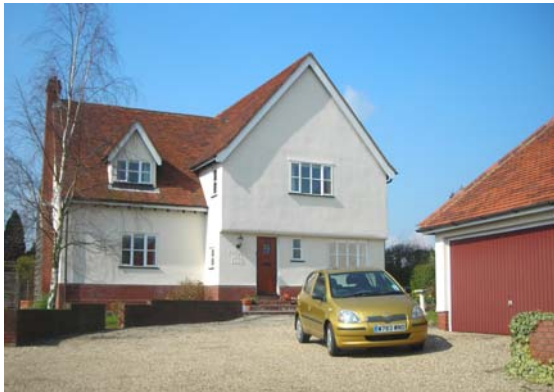
Fig. 39 Hall Lodge.

Hall Lodge (Fig. 39) and **The Red House** (Fig. 40) were built within the area of the farmstead in the 1980s. They are large detached houses built in a traditional style, but with stretcher bond brickwork. The handmade clay tile roofs contribute to an attractive roofscape. **The Old Barn** and **Purleigh Hall Barn** are two dwellings converted from a historic barn with two porches of c.1800 around 1982 (Fig. 41). The barn was originally thatched but now has a clay tile roof. The barn is listed grade II, and has a grade II listed crinkle-crankle wall running east-west from the southern end, presumed to have been built to separate the barn from the gardens of the adjacent Purleigh Hall. To the front of this group of buildings are a pair of long single storey 19th century buildings of yellow stock brick which create a sense of enclosure.

Hall Lodge	1980s N	Handmade clay tiles	Painted render and stretcher bond brick	Casements	Stained timber	Metal	Stretcher bond brick wall and gravel drive	
The Red House	1980s N	Handmade clay tiles	Stretcher bond red brick	Painted timber sashes	Painted timber with doorcase	Metal	Stretcher bond brick wall and gravel drive	
The Old Barn	c.1800 Grade II	Handmade clay tiles	Black weatherboard	Timber casements	Timber boarded	Metal	Stretcher bond wall and gravel drive	Converted to residential in 1980s
Purleigh Hall Barn	c.1800 Grade II	Handmade clay tiles	Black weatherboard, English bond brick to left side elevation	Timber casements	Timber boarded	Metal	Stretcher bond wall and gravel drive Adjoining crinkle crackle wall, c.1800, is Grade II listed	Converted to residential use in 1980s
Purleigh Hall	Late 19th century with later alterations N	Machine made tiles	Rough painted render and false timbers	UPVC casements	Not visible	Metal	Yellow and red brick stretcher bond wall and garden planting

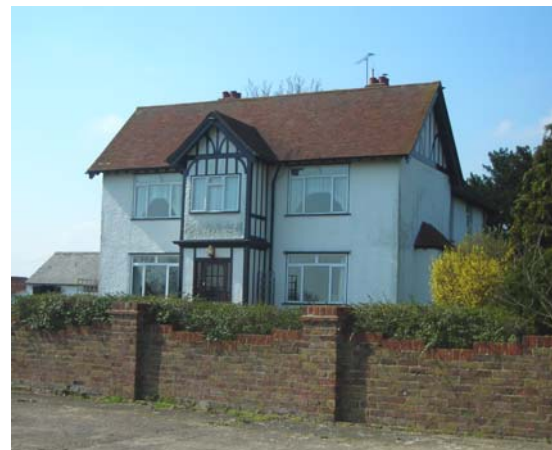
Fig. 42 Purleigh Hall.

Purleigh Hall is a large detached house of 19th and 20th century date, occupying a historically important site where the manorial hall has been located for centuries previously (Fig. 42). This house has some poor replacement UPVC windows which detract from its appearance. To the south is a group of largely 19th century farm buildings, of traditional construction, mainly of black weatherboard, with roofs of clay pantiles, slate or corrugated sheeting. These buildings remain in use as agricultural buildings.

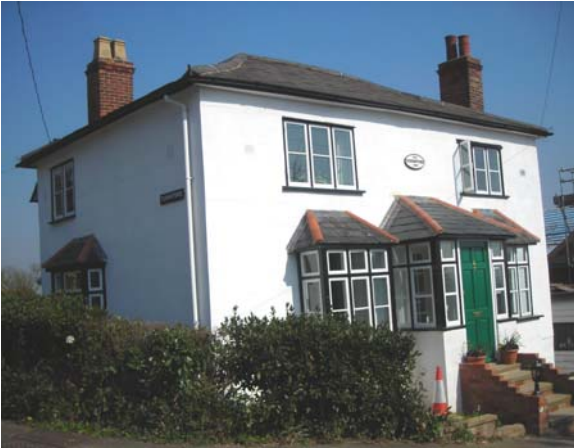
Fig. 43 Turnstone.

As The Street heads east down the hill opposite The Bell, **Turnstone** occupies an important position on a large plot (*Fig. 43*). Previously there was a smithy on the site. The house is early 19th century in date, with a good hedge around the garden across from The Bell. On the east side there is a poor flat roof. Adjacent to Turnstone a new house is under construction which, although the plot is rather cramped, is of a suitable scale for the street and for neighbouring properties, and is being constructed of sympathetic materials including Flemish bond red brick, slate roof and timber windows.

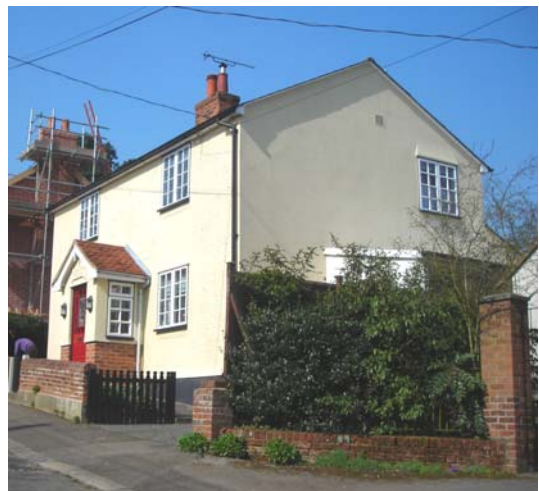
Fig. 44 Mountville.

Mountville is a detached late 19th century cottage (*Fig. 44*), and adjacent to this are two detached houses of the 1960s/1970s, **Kenbury** and **Taprobane** (*Figs. 45, 46*). These are unassuming houses of their time, and although they have some unsympathetic features (stretcher bond brick, stained timber casement windows), overall they sit comfortably in the street scene and do not detract from the special character of the area.

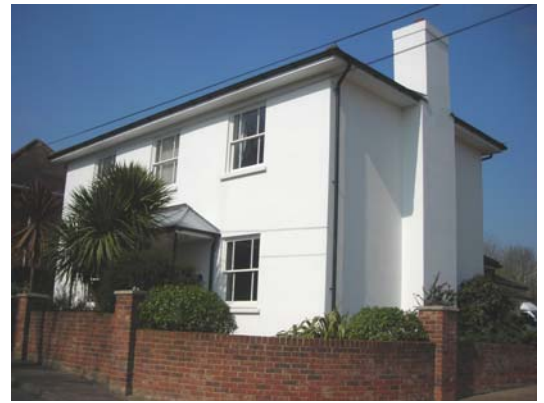
Fig. 47 Old Orchard Cottage.

Old Orchard House and the adjacent **Chestnut Cottage** are both attractive late 20th century properties. Old Orchard House is built in the style of a white Victorian villa with a red brick front wall (which could have been improved with a more traditional brick bond) (*Fig. 47*). Chestnut Cottage is built in a vernacular brick and weatherboard style and set back gable end to the road with a good weatherboard and pantile garage to the front of the plot (*Fig. 48*). The expanse of paved driveway to these two properties is rather hard and bland for the informal rural context.

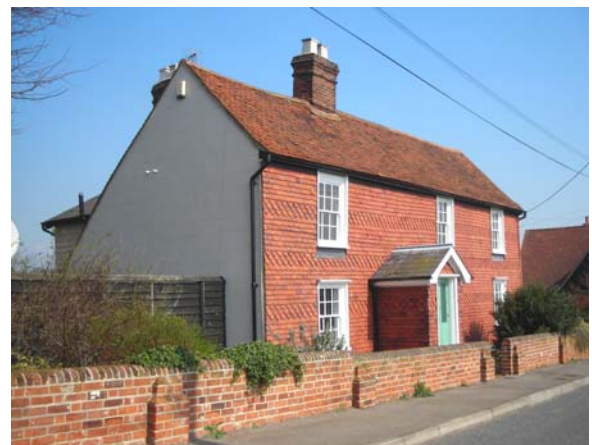
Fig. 49 Old Bakery, main house.

The Old Bakery comprises a house and former ancillary buildings, and is grade II listed (*Figs 49, 50*). This is an attractive group of buildings that have been sympathetically restored for residential use. The house is late 18th century in date. Later tenements built on the site were converted for use as a bakery in the 1830s. The building housing the original oven was demolished in the late 1990s to make way for **Ayelsbury Barn** (*Fig. 51*). This is a good example of a modern design that integrates into the historic context whilst avoiding aping a historical style.

The Old Bakery	18th century with later additions Grade II	Handmade clay tiles, slate	Flemish bond brick, weatherboard, hanging tiles	Painted timber sashes and casements	Painted timber	Metal	Stretcher bond brick wall and gravel, some tarmac surfacing	
Aylesbury Barn	Late 20th century N	Handmade clay tiles	Weatherboard and stretcher bond brick	Painted timber casements	Stained timber	Metal	Stretcher bond brick wall	Weatherboard and clay pantile garage to side
Roundsmans Cottage	Late 20th century N	Handmade clay tiles	Weatherboard, painted render	Painted timber sashes	Painted timber	Metal	Painted timber picket fence, stretcher bond wall, gravel drive

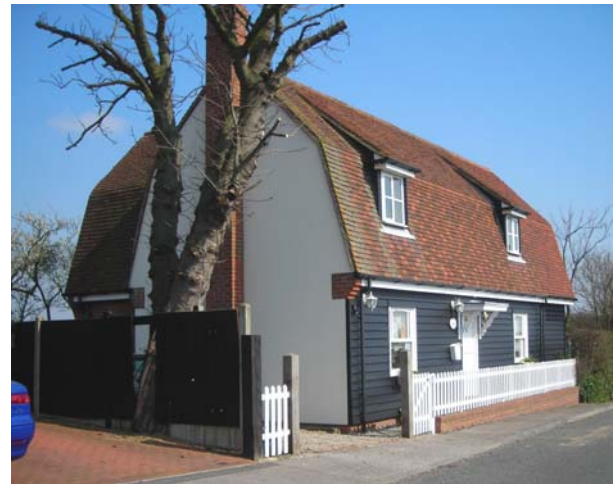
Fig. 52 Roundsmans Cottage.

Roundsman's Cottage is a good quality late 20th century house in a vernacular style with a gambrel roof constructed using traditional materials and details (*Fig. 52*).

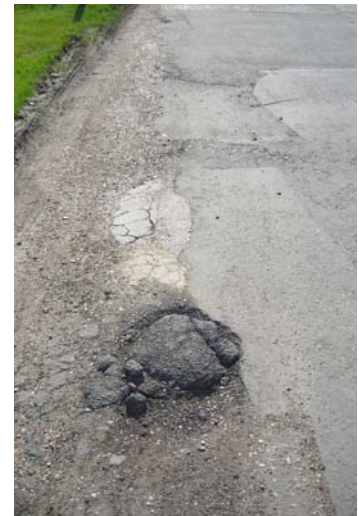
Fig. 53 Degraded road surface on the approach to the farm.

1. Pavement and road surfaces currently comprise mainly tarmac and concrete kerbstones where they exist. Traditionally the roads in Purleigh were surfaced with gravel. The use of bound gravel rather than tarmac, with stone kerbs or cobbles where required, would soften the appearance of the streets and relate better to the historic character and rural setting of the village. The surface to the south of The Bell on the approach to the farm is worn and pot-holed (*Fig. 53*). Patch repair should be avoided, and consideration should be given to a more sympathetic surface treatment for the rural context rather than tarmac.

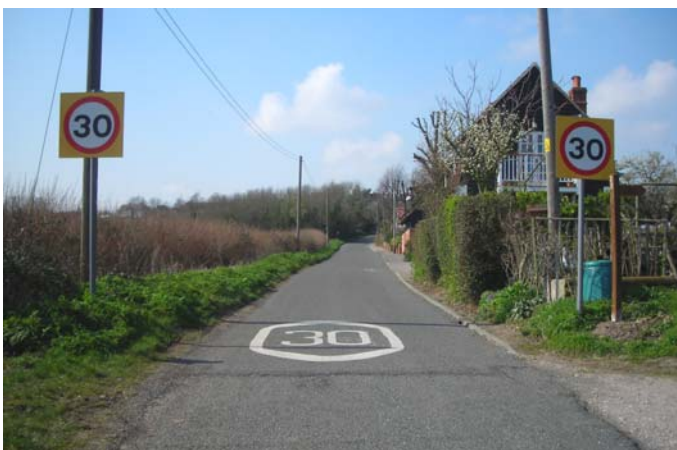
Fig. 54 Overbearing road signs in The Street.

2. There are some large speed limit signs and road markings on the approach from the west up The Street (*Fig. 54*). Although the need for speed limitation along this straight, quiet stretch of road is understandable, alternatives that would be more sympathetic in this historic, rural context should be sought. Deviation from standard road markings and signs is allowed in environmentally sensitive areas, and this should be born in mind for highway works. Broadly, highway works should respect the small-scale, informal and rural character of the conservation area.

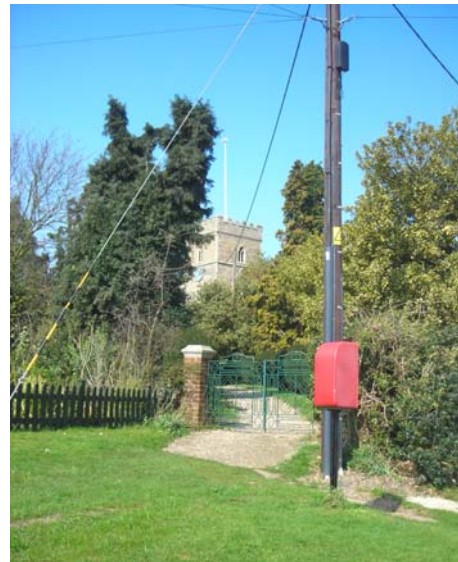
Fig. 55 Electricity pole and cables detract from the setting of the church

3. Some services have been relocated below ground but there is an electricity pole with cables occupying a prominent position south of The Bell adjacent to the public footpath leading into the churchyard (*Fig. 55*). The cables run through the churchyard to the church. These would be better located underground and run into the new extension to the church. This would not only allow removal of the pole and unsightly cables, but would also allow removal of untidy electrical paraphernalia from within the church tower. It is generally preferable to lay cables underground in conservation areas wherever possible.
