# LANGFORD

## CONSERVATION AREA APPRAISAL AND MANAGEMENT PLAN

MALDON DISTRICT  
COUNCIL

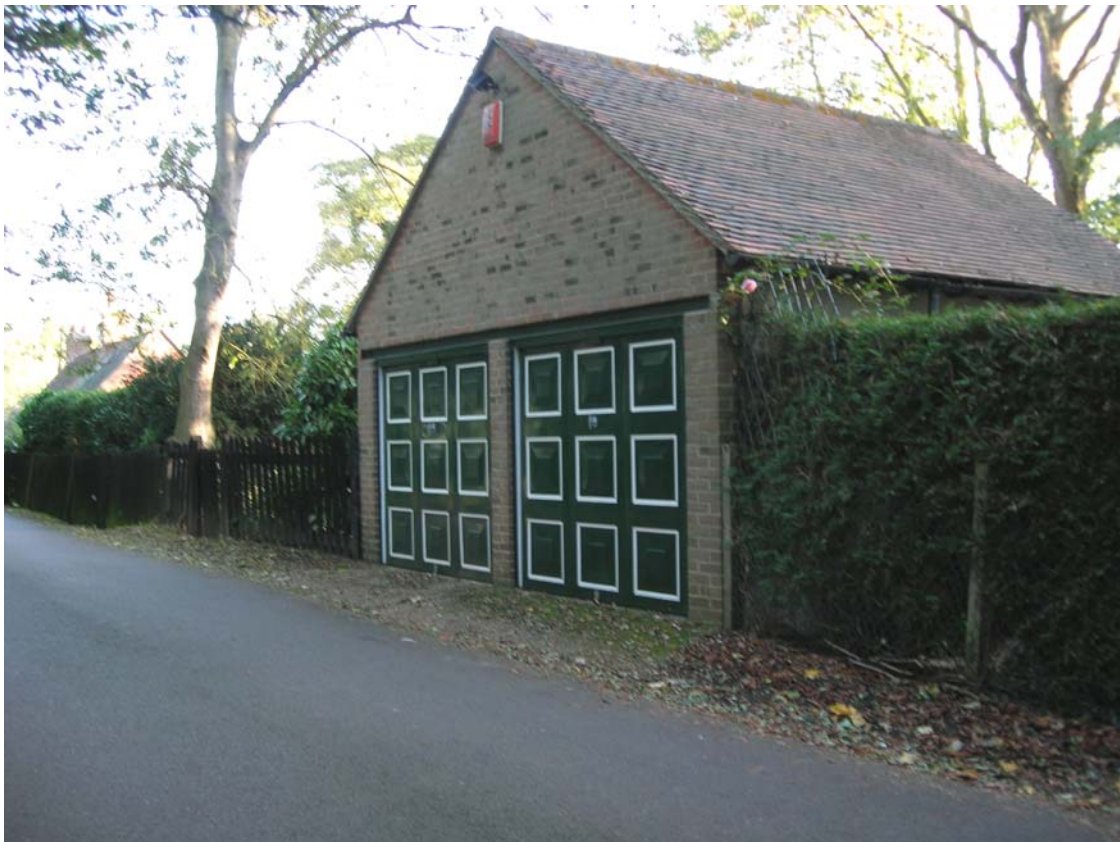
**Fig. 24 Garage at mill cottage**

To the west boundary of the cottage is a single track lane leading to the golf club and Beeleigh Weir. A security fence provides a somewhat harsh boundary to the pumping station. A modern garage with up and over opening panelled doors gives little regard for the traditional character of the setting of Mill Cottage.

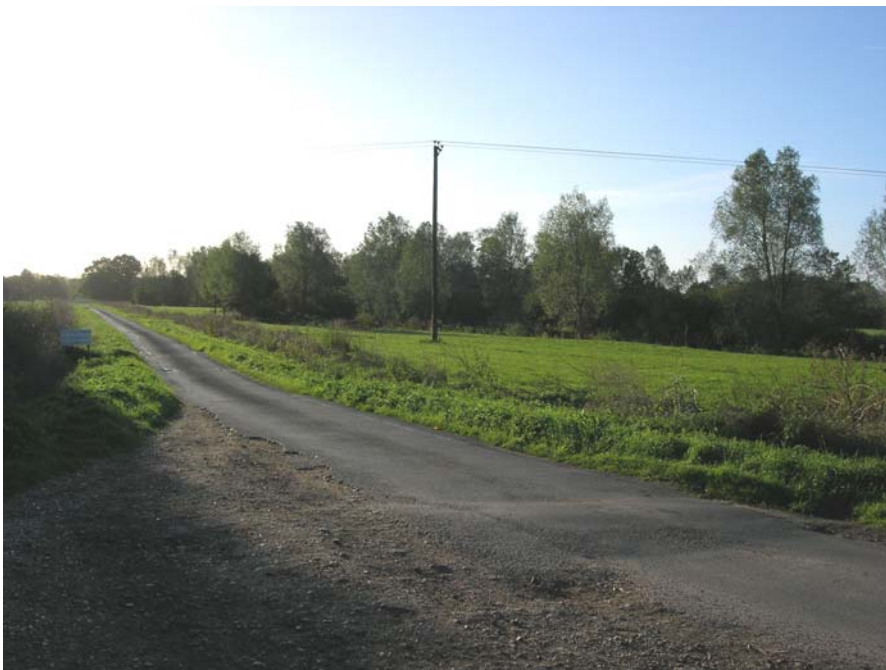
**Fig. 26 View along lane towards Beeleigh Weir**

The lane running between the museum and Mill Cottage is well used by golfers, and dog walkers, but not well maintained. It has an open green space to both sides of the lane lined with willow trees, but this is inaccessible due to large ditches that have been dug to stop travellers from parking. This may be necessary, but along with the problem of fly tipping along the lane, it ruins the appearance of the green open space that could be more appealing to walkers and tourists visiting the museum. At the entrance to this lane there is a set of gates to the museum. This is not an entrance for the public to use but does have numerous board signs advertising events and opening times of the museum. These are not sympathetic and create visual clutter to the Conservation Area.

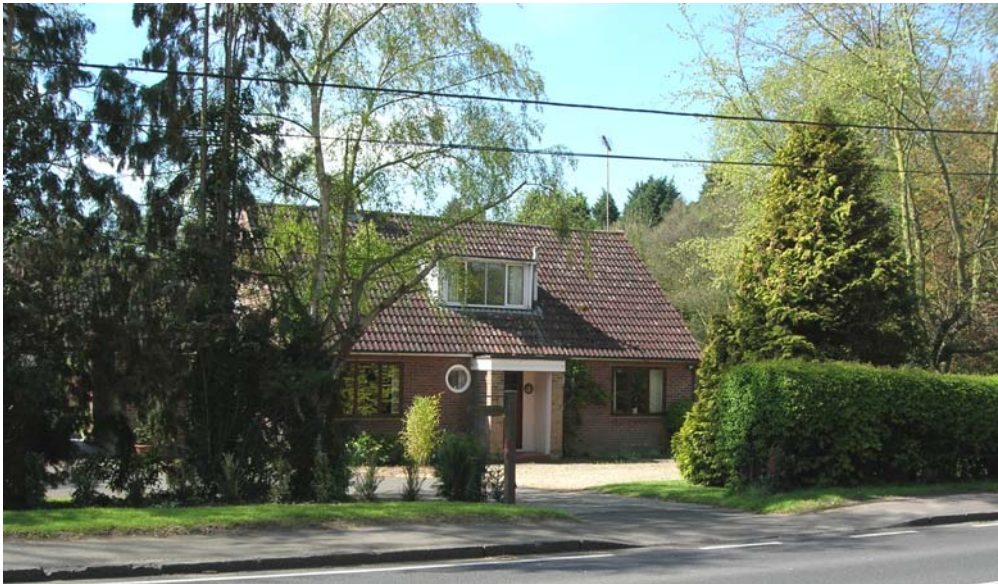
**Fig. 28 Langmere**

**Langmere** (south side) is a 20<sup>th</sup> century, one and a half storey house, built of modern brick in stretcher bond with a concrete pantile roof. It is set back from the road behind well established trees and hedging. It has a tarmac drive to the side and gravel to the front of the house. An overlarge flat roof dormer dominates the roof space. Despite the non traditional materials and details, the impact it has on the Conservation Area is reduced by the set back location of the house. The established rear garden runs alongside Langford Cut which runs to Beeleigh Weir.

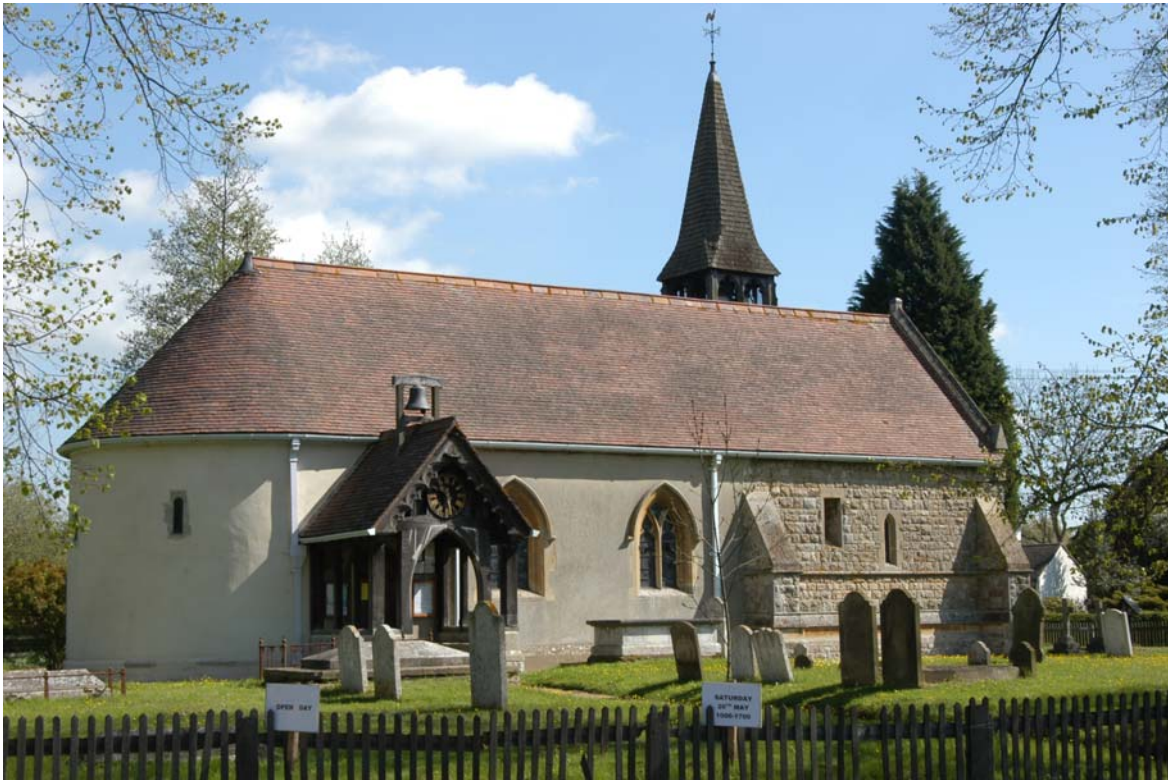
**Fig. 31 Church of St Giles**

The road is then flanked with churchyards to north and south. To the north is the **Church of St Giles**, at the centre of the village and the Conservation Area. The front boundary to the church is a picket fence with care taken on the detailing. The rear boundary is post and rail fence with sycamores planted to the front. There are good views across to Langford Hall from this point, and historic visual link between the church and the manor. Sadly some poor repairs have been made to the church that spoil its aesthetics, machined red plain tiles have been used on the roof which gives a much too uniform and untraditional look. Also some unsympathetic stone repairs have been made to the walls of the church. The graveyard immediately surrounding the church is closed to new burials but across the road on the south side the graveyard is still in use. The line of established yew trees in the graveyard are very traditional and a pleasing feature that gives a strong green character to the centre of the Conservation Area. There could be more care taken with the upkeep and maintenance of both graveyards.

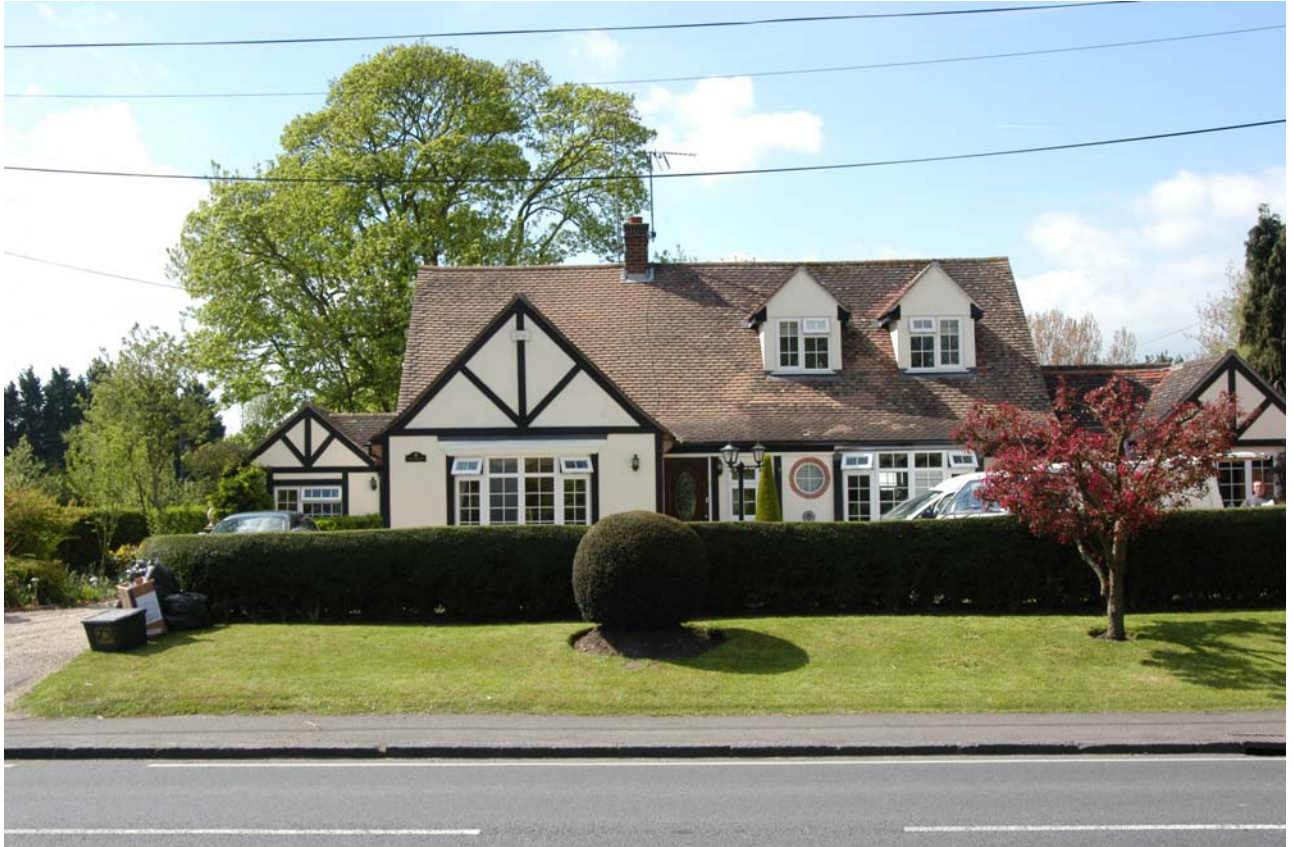
**Fig. 33 The Croft**

On the south side in a prominent position opposite the junction with Witham Road is **The Croft**. This is a 20<sup>th</sup> century one and a half storey house that has had extensions to both sides. It presents three gables to the road. This building form is rather overbearing in such a sensitive position, at this main road junction at the centre of the village, the Conservation Area and directly opposite the church. The house is rendered with exposed mock timbers, a large double garage of similar design and an overpowering amount of windows. The only softening effect is that there is an established hedge to the front roadside boundary with quite a wide grass verge which slightly softens the impact the house has on the Conservation Area. The house and garden are well maintained.

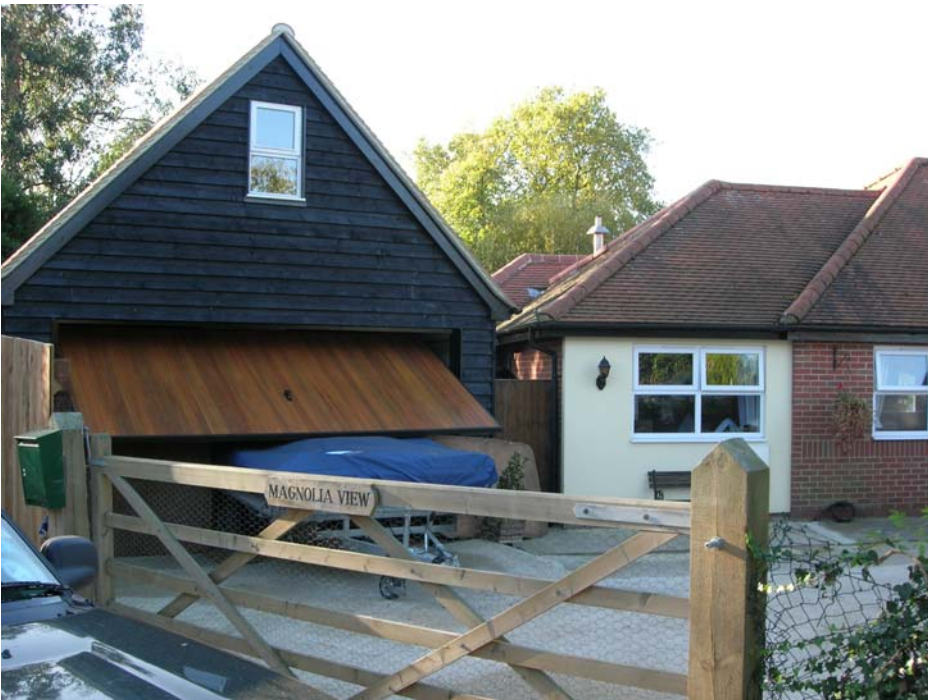
**Fig. 35 Magnolia View**

**Magnolia View** (south side) makes no positive contribution to the special character and appearance of the Conservation Area. It is a 20<sup>th</sup> century brick and rendered bungalow and set back from the road by way of a tarmac hard standing behind a timber farm gate. The recently erected traditional style weather boarded double garage gives a traditional element to a very modern designed bungalow. The boundary to Magnolia View has hedge to the front and close boarded fence to the side.

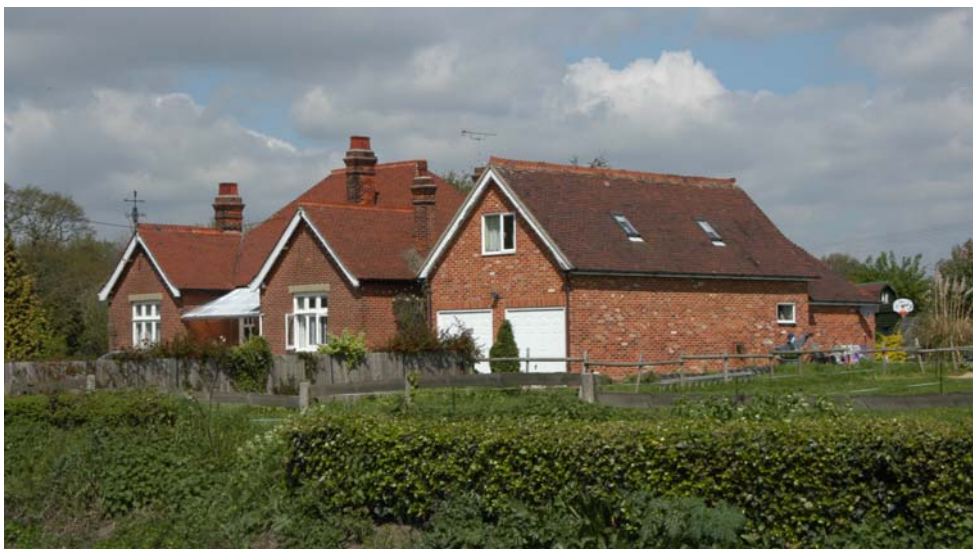
**Fig. 37 Langford Lee**

On the approach into Langford Conservation Area from the east along Maldon Road (north side) is a paddock with field shelter that separates Station Bridge Cottage and Langford Lee. An established hedge with a traditional post and rail fence is the boundary treatment for the paddock. A mixture of post and rail and close boarded fence separates the paddock from the garden at Langford Lee. **Langford Lee** is a 20<sup>th</sup> century one and a half storey house that has a recent double garage extension with accommodation above to the east of the house. The brickwork has not been matched well to the house and the difference is very noticeable. This does not give a pleasing look on entering the Conservation Area from the east. The front garden is open to the road with established trees dotted about. The house would benefit from a front boundary hedge to help soften the three gabled building form that faces the road and the spreading footprint of the building caused in part by a large timber decking area that has also been erected to the west of the house.

Langford Lee, Maldon Road, north side has at present no boundary treatment to the road. **It is proposed that a hedge is planted to the roadside that would soften the impact that this building has on the Conservation Area by its spreading footprint and over dominant garage.**

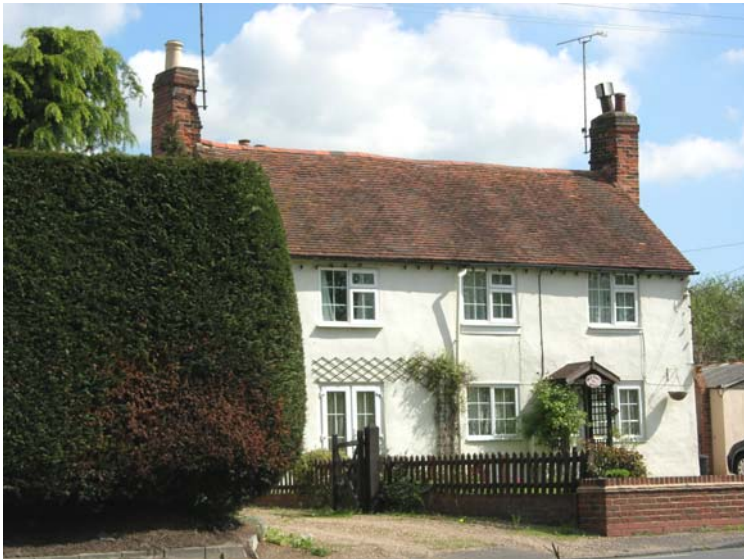
**Fig. 38 The Old Post Office**

**The Old Post Office** (north side) is a 19<sup>th</sup> century house, unlisted but with many traditional features, such as the rendered exterior, the hand made plain clay tiles on the steeply pitched roof, the red brick chimney and the picket fence to one boundary. Unfortunately these traditional features are mixed with numerous negative features. These comprise of the modern block paving to the driveway, the low brick wall to the front boundary constructed in stretcher bond, the poorly designed single garage to the side with its slack roof and metal up and over door, and the replacement UPVC windows and doors.

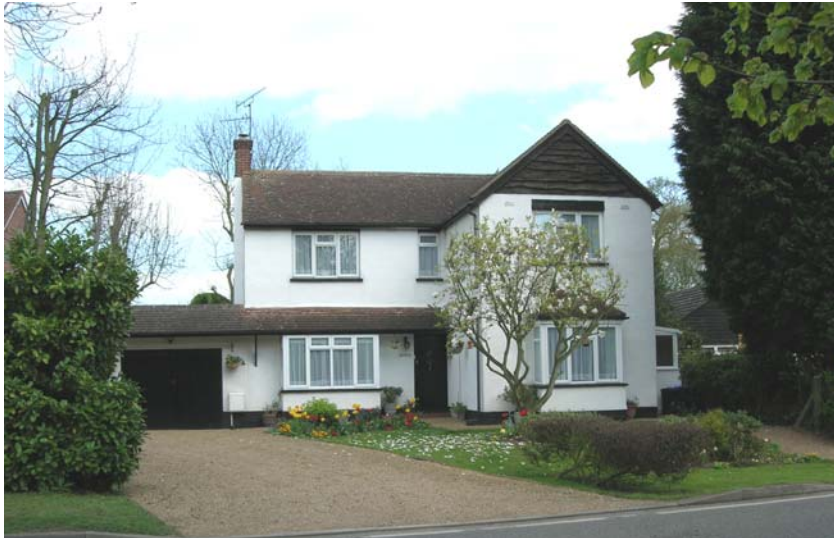
**Fig. 43 Brierley**

**Brierley** (east side) is a 20<sup>th</sup> century traditional style two storey house. The exterior is rough cast render, with red plain tiles on the roof. The house is set back from the road with an open lawn to the road with low hedging to the front boundary. The windows are UPVC but the front door and the garage door remain timber. Aside from the windows this modern but traditional style house sits comfortably within the Conservation Area.

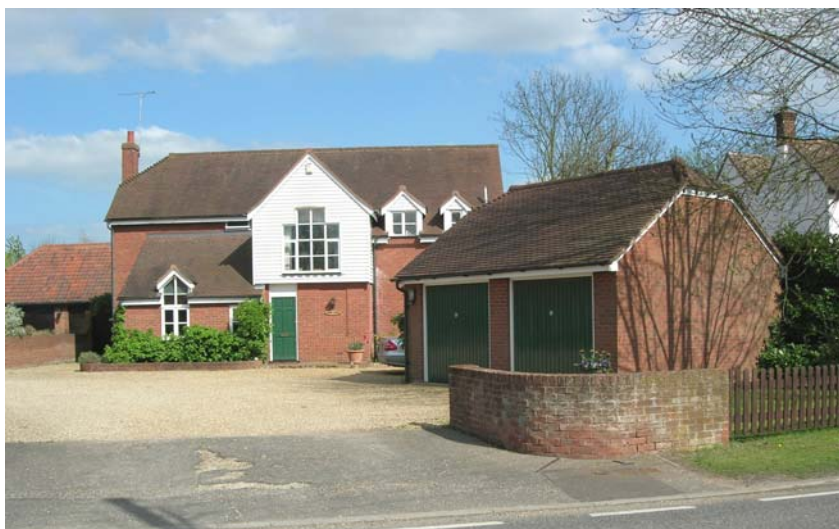
**Fig. 44 White Gables**

**White Gables** sits next door to Brierley. This is a large 20<sup>th</sup> century two storey house based on traditional forms with timber windows and a weather boarded gable feature to the front. A detached double garage sits between the house and the road, its half hips unfortunately too small to be truly traditional. Both house and garage are roofed in machined red plain tiles. Unfortunately the design of the two dormer windows at the front of the house gives a very cramped appearance to the front elevation.

It is unfortunate that more care was not taken with the materials and details used to build these two modern houses within the setting of a 16<sup>th</sup>/17<sup>th</sup> century grade II listed barn.

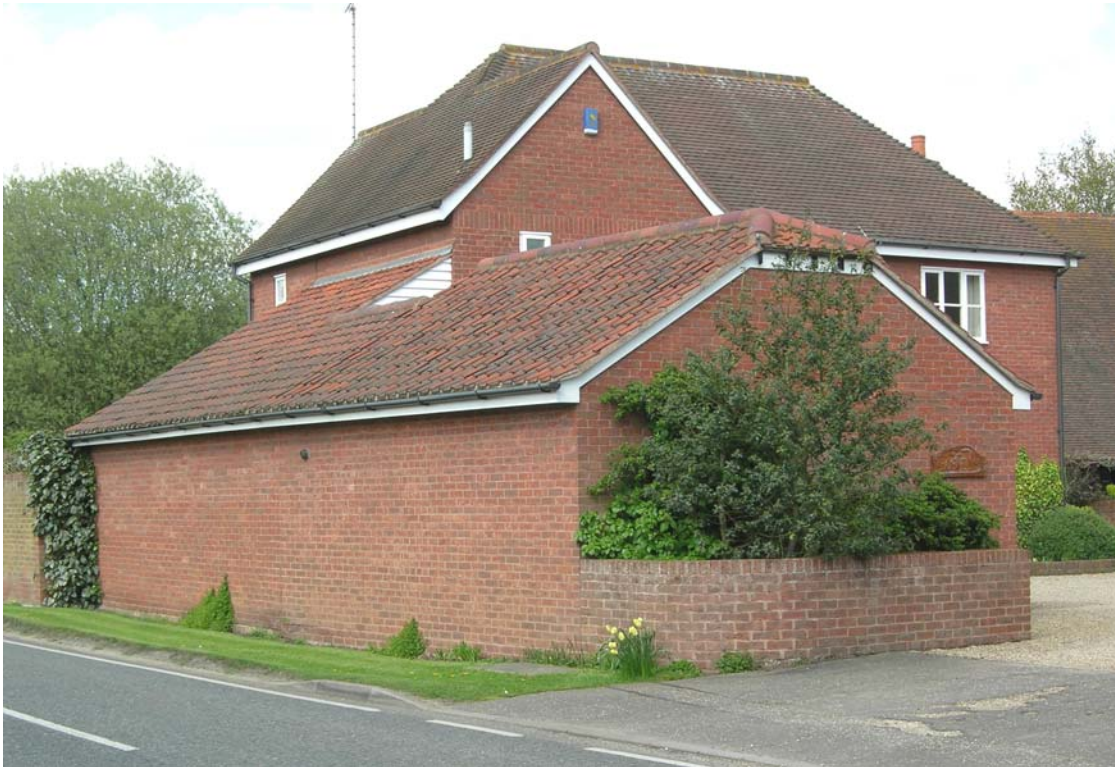
**Fig. 45 Boswells**

**Boswells** is another modern large red brick building built at the same time as White Gables when Willows barn and the farmyard were developed. Like White Gables the double garage for Boswells is to the roadside making a brick boundary wall to the road. The garage has pantiles on the roof but the house has machined red plain tiles giving an appropriate hierarchy in appearance. Boswells has a design feature of a weather boarded dormer window to the front. The courtyard has a low boundary stretcher bond brick wall and a picket fence that link the three buildings together.

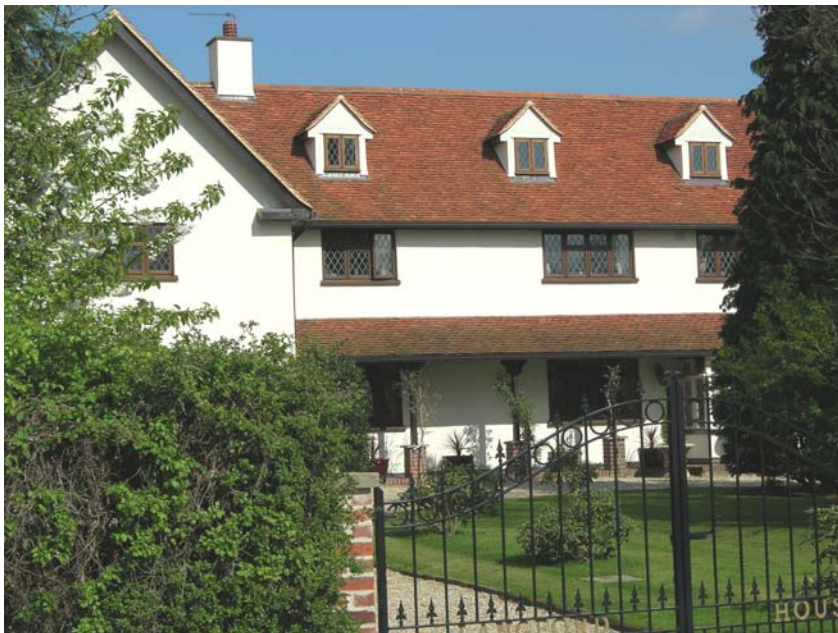
**Fig. 47 Langford House**

**Langford House** is a large detached 20<sup>th</sup> century house built in the traditional form. It has a plain red tile roof with well proportioned dormer windows inserted, a rendered exterior and a gravel driveway. The only negative design feature of this building is the asymmetric stained timber windows with faux leaded lights. The house is set back from the road in its own well established garden with hedge for the front boundary and brick piers and metal gates to the road.

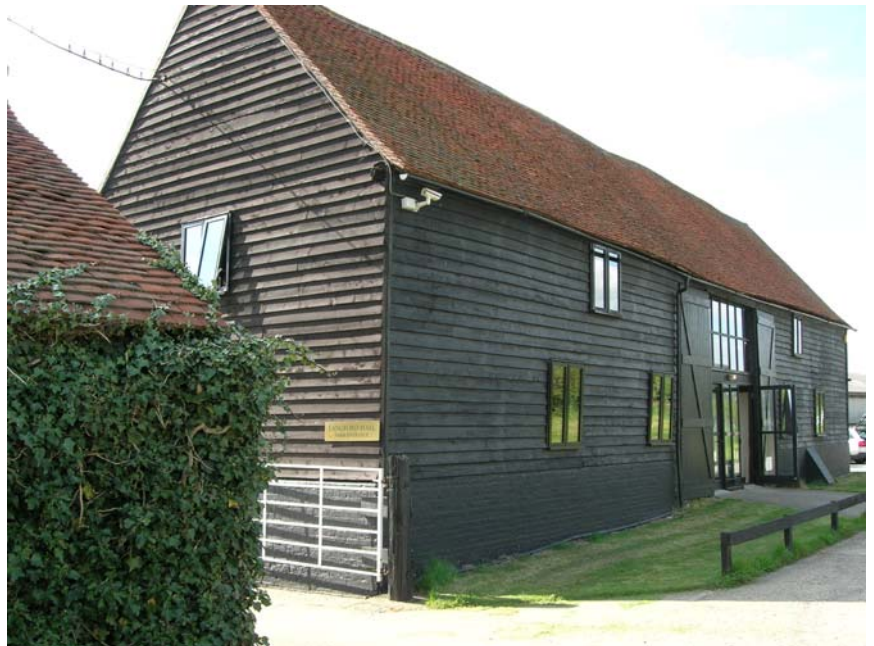
*Fig. 50 Barn converted to office use*

The grade II listed 17<sup>th</sup> century **barn** follows fronting the roadside. This five bay barn is timber framed and weather boarded and is now converted to office use. This is the only building to depart from the historic traditional character of the group, in the number of new windows to the roadside elevation.
