# BRADWELL-ON-SEA

## Conservation Area Review and Character Appraisal

MALDON DISTRICT  
COUNCIL

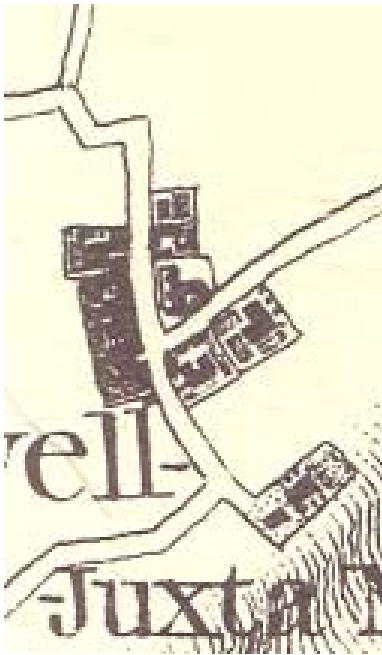
Fig. 4 1777

The earliest surviving cartographic evidence for the settlement of any clarity is the Chapman and André map of 1777 (*fig. 4*). This shows the building forms, but in an over exaggerated plan, but gives a good indication of the extent and pattern of development.

The maps show that there has been little increase in the development in and around the conservation area since 1777. 20th century expansion has only occurred to the east of the village.

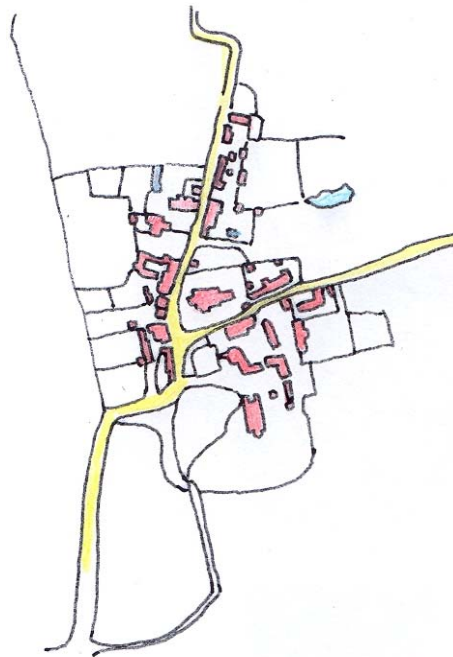
Fig. 5 1839

The first relatively accurate maps are of the 19th century, the tithe map of 1839 and second edition ordnance survey map of 1897. These can be compared in *figs 5 and 6*.

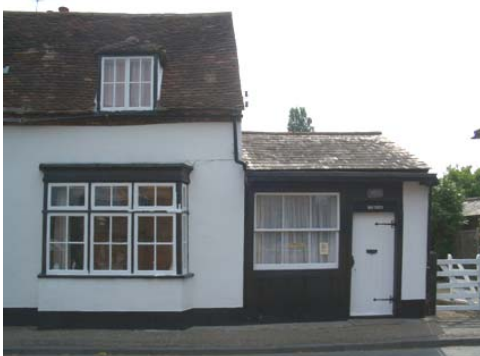
Windows are traditional, in painted timber with either symmetrical flush casements or vertically or horizontally sliding sashes; some modern replacements harm the appearance of the area due to their crude detailing and the uPVC replacements are particularly out of keeping. There are a variety of interesting historic shop windows, including multipaned windows in projecting bays, larger paned windows in formal surrounds and workshop windows of overlapping glass panes (*figs. 12, 13 & 28*).

*Fig. 13 Different traditional window types*

Roof materials are most commonly double cambered handmade red clay plain tiles laid steeply (47 to 50°). There are some natural blue-grey slate at a lower pitch (35 to 40°) (*figs. 13 & 14*), but orange clay pantiles only occur on the odd outbuilding (*fig. 30*). Gambrel roofs are common in Bradwell (*figs. 10 & 15*). Traditionally, tiled verges are cropped, i.e. without barge boards, and eaves have open rafter feet.

Roofscape interest is derived through the use of substantial brick chimney stacks and dormer windows on 1½ storey cottages; dormer windows are traditionally narrow and minor incidents within the roof (*figs. 13 & 15*).

The **Baytree range** has a low single-storey black weatherboarded end structure with a shallow slate roof (*fig. 13*). The wide 3/3 sash indicates that this had a commercial use. There is a change in the side elevation material, to render. This simple single storey element is significant for the variety of built form and history of the village. Baytree is a 1½ storey building, double pile in plan, with a gambrel roof to the front and cat slide roof to the rear range. It has hipped dormers and early 20th century side hung casements, with top vents, but a balanced appearance. The elevation is enlivened by two bay windows. The original appearance of Bay Cottage has been superficially damaged by a twee doorcase and shutters in varnished wood, incongruous features. Baytree House has traditional vertical sliding sashes with large dormers containing sliding sashes that appear overlarge compared to the side hung casements traditionally seen. At the end Baytree Cottage, drops down in height and has a simpler gabled roof form, with a simple and appropriate slate roofed dormer. The recessed windows and doors indicate that the range had a brick front added which was then rendered in the 20th century.

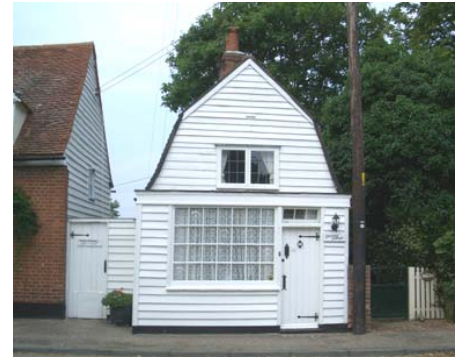
Feather-edged weather board is prevalent (*figs. 10 & 15*). It is usually painted white, but black is also seen on side and rear elevations and on outbuildings. Bricks are predominantly handmade reds, with good detailing, including cambered or gauged arches to openings (*fig. 11*) and sometimes dentils under the eaves. Occasionally, yellow London stock bricks have been used. Brick bonding is most commonly in Flemish bond, but always historically in a solid wall traditional bond, rather than stretcher bond which is monotonous by comparison. There are some rendered elevations, but many appear to be 20th century alterations to 19th century brick facades.

*Fig. 10 Weatherboarding*

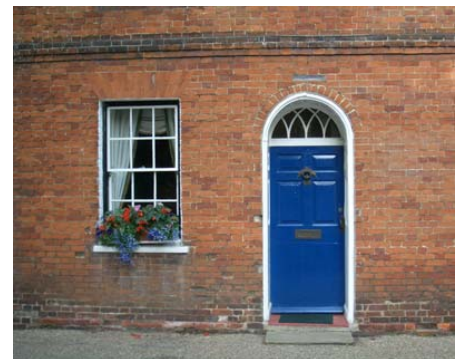
*Fig. 11 Brick details*

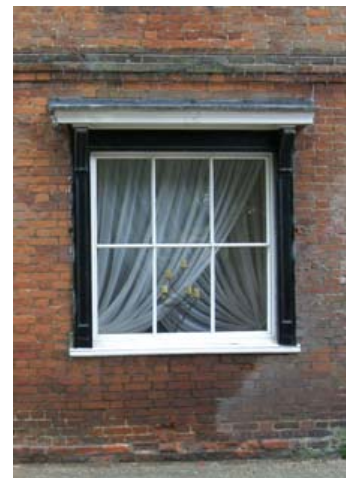
*Fig. 12. Shop window*

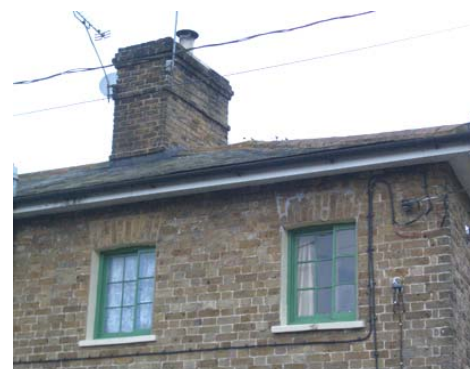
*Fig. 14 Chimneys, brick details and original horizontally sliding sash*

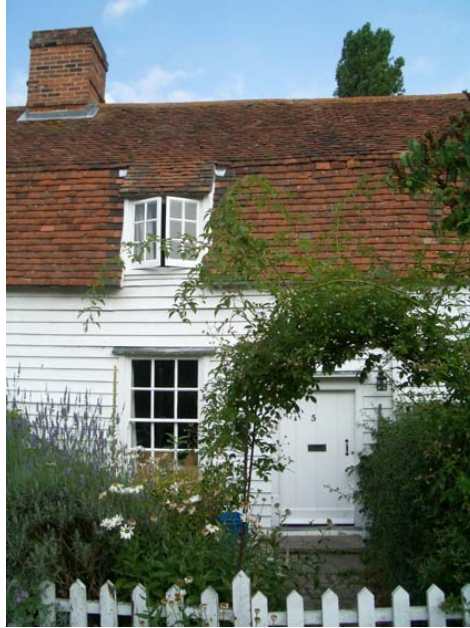
*Fig. 15. Typical details: weather-board, tiled gambrel roof, a narrow dormer and picket fence.*

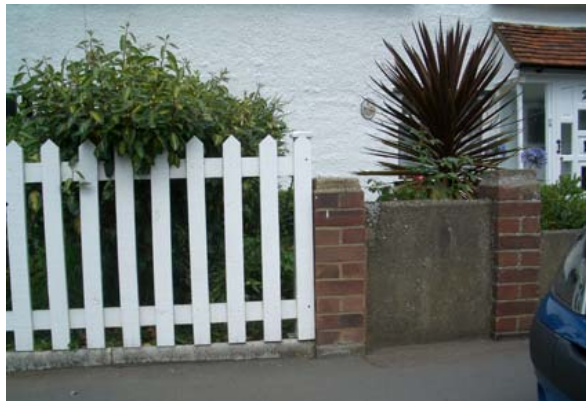
Boundary treatments are an important form of townscape enclosure and make a significant impact on the area. Boundary walls and fences are typically low to front and side elevations on public through-fares. Brick boundaries are used on prominent corner sites where enclosure by built form is otherwise lacking and typically occur with buildings of high status and large plots (e.g. New Hall). White painted timber picket fences are more common for cottages. Hedged boundaries are also frequent. Iron railings are not a feature of the village. There are also a range of poor quality timber, concrete and brick boundaries which harm the appearance of the area (*fig. 16*).

*Fig. 16 Good and poor quality boundary treatments*

2. **Boundary treatments**  
Boundary treatments play an important role in the enclosure of the street edge within the conservation area. Painted timber fences and brick walls are particularly prevalent in Bradwell. Some of the brick walls require repair; the church wall in particular would benefit from a brick capping to replace the cement capping. Replacing some of the boundary treatments with a traditional painted picket fence, e.g. at 2 Caidge Row, would also have a beneficial affect.

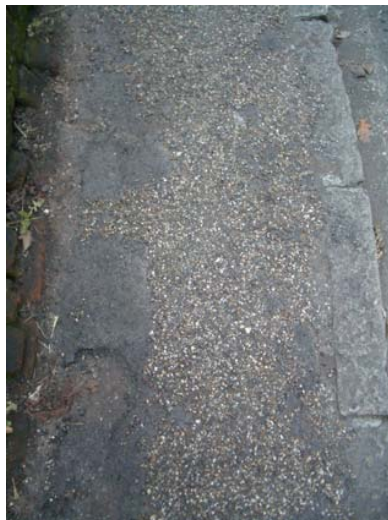
The main roads are predominantly tarmac with large rolled aggregate. The pavements along South Street and the High Street have been covered in bonded shingle, which is more appropriate for this rural village than the tarmac along East End Road, but they are now in a state of decay (*fig. 17*). Similarly, the natural granite kerb stones complement the character of the village, while the concrete replacements are bland and inappropriate by comparison.

*Fig. 17 Bonded shingle pavement surface, in poor condition*

1. **The pavements and roads**  
Pavement surfaces currently comprise a mixture of bonded shingle and tarmac, all in poor condition. Bonded shingle with stone kerbs throughout the Conservation Area would provide a softer appearance than tarmac and concrete, and relates better to the character of the historic buildings and the rural setting of the village. Similarly, deviation from standard road markings is allowed in environmentally sensitive areas; the use of narrow yellow lines within the conservation area would be a significant enhancement.

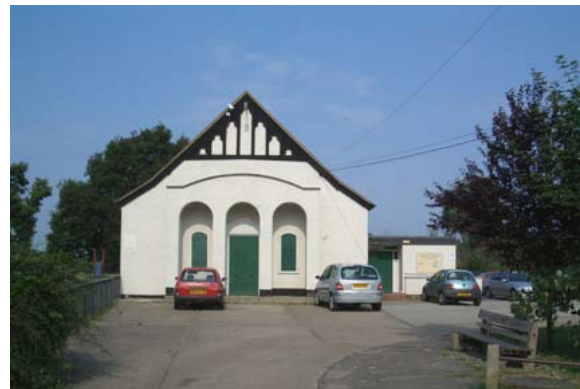
**The Village Hall** is offset to the left (*fig. 19*). It feels divorced from the main settlement, relating little to the grain of the village. It was constructed on the site of allotment gardens in the 1930s, with a rendered finish and neo-vernacular timber detailing in the gable. This large building appears heavy and solid in a poor setting, a sea of concrete and tarmac for car parking. It has also suffered from unsympathetic alterations: the uPVC windows, flat roof side extensions and machine tile repairs all suggest a lack of concern for its appearance. There is scope for much improvement to this area. The trees and hedge marking the boundary to the site, to both the recreation ground and the backlands of South Street, are a positive feature.

Fig.19 Village Hall

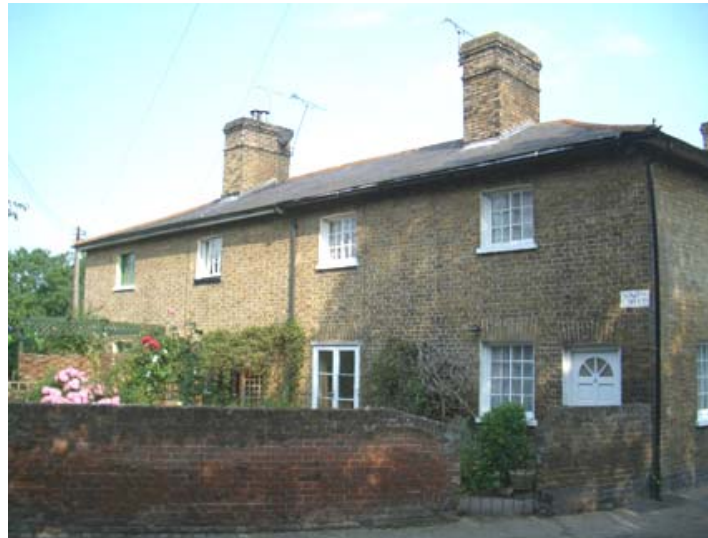
The first building to directly front onto the main road comprises **nos.1-4 South Street** (*fig.21*) This is a hipped slate roof terrace of yellow London stock bricks in Flemish bond, probably of mid 19th century date. It retains much of its original detailing, with arched brick heads to openings and charming horizontal sliding sash windows. These are significant for indicating a lower status of building than if they were vertical sliding sashes and the use of smaller windows at first floor reflects traditional hierarchy of design. The insertion of French doors at no.3 has a minor impact overall, but any further alteration to openings would damage the quality and appearance of the building. This is an attractive range that turns the corner into the village, but its front garden setting is equally significant. The red brick boundary wall is in need of repair, but provides a good strong edge to the road. It is echoed by the wall opposite marking the boundary to **Bradwell Lodge**.

*Fig.21 1-4 South Street*

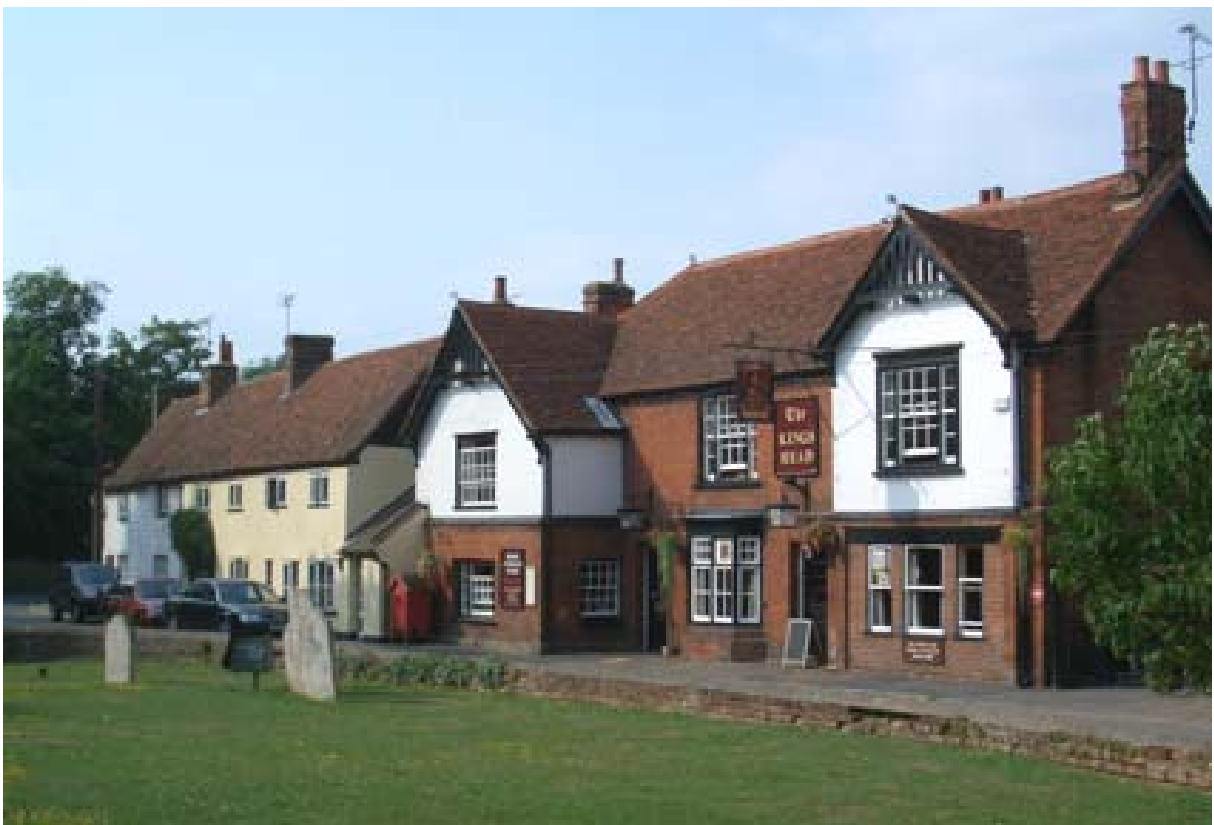
The gables on the front of the **Kings Head** provide visual stops in the line of the street (*fig. 23*). This building has a 1900s appearance, with good quality Flemish bond brickwork, arched brick heads, dentils at the string course, rendering at first floor and applied timber framing in the gables in the neo-vernacular manner. There is a combination of painted timber side hung casements and vertical sliding sashes with horns. Signage does not dominate the building - it is neat and well-mannered, traditional in material and appearance. There is a pleasing arrangement of form and detail at the Kings Head and it provides a good landmark in views from East End Road. To the rear, it retains a well-preserved group of outbuildings, including the charming white weatherboarded stable or brewhouse. Access to the rear of the building lies adjacent to an access for no.14. A brick boundary wall and planting subdivide the access, which helps to prevent an overlarge gap in the street scene.

*Fig.23 The King's Head PH*

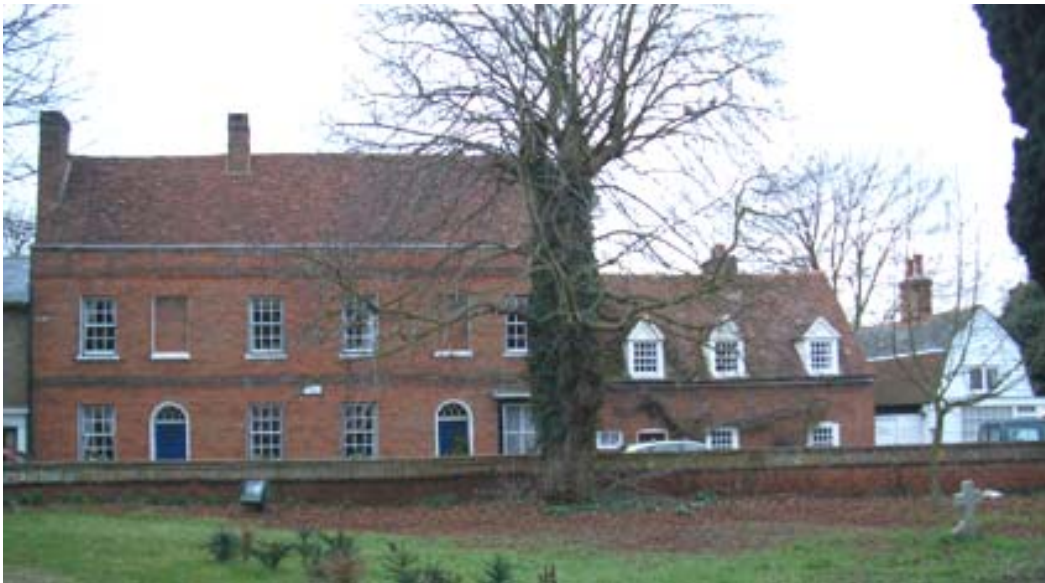
*Fig.24 White Lyons, White Lyons Cottage and Orchard Cottage.*

**White Lyons Cottage** drops down to 1½ storeys and provides a pleasingly strong contrast in scale. It also has a red brick façade and retains historic features in the 8/8 pane sashes, vertical boarded door and three gabled dormers, but it has unfortunately been heavily repointed in cementitious mortar.

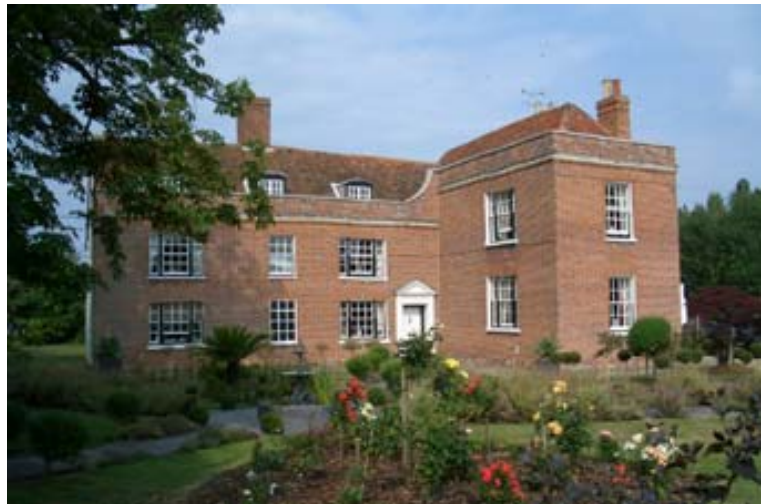
**New Hall** has a classical brick grandeur, the tudor house hidden by an 18th century façade with Flemish bond brickwork and parapets with lead roofed dormers. The forward projecting wing gives interest and individuality to the building, as well as a clue to its earlier origins. The outbuilding is very significant to the setting of New Hall and appropriate for a building of this character and status. It has overlapping panes of glass, black weatherboard, white details and both pantile and plain tile roofs. Its traditional character is well-preserved and it adds to the variety of traditional buildings to be found in the conservation area.

Fig.25. *New Hall*

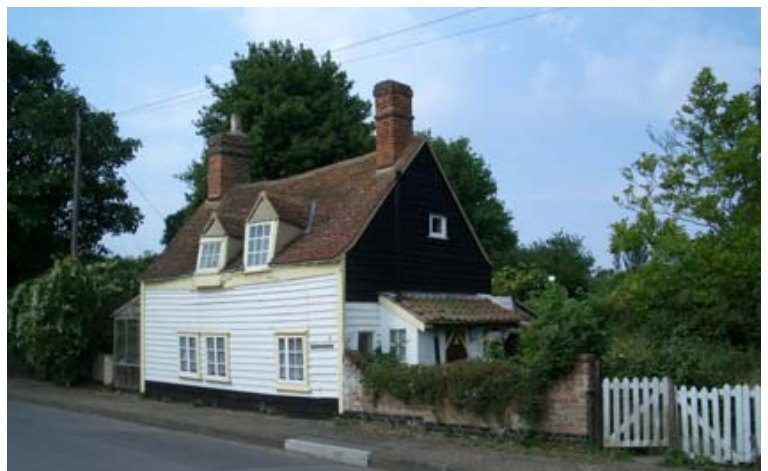
Adjacent to the outbuildings lies **Tudor Cottage** (fig. 26). This is a white weather-boarded cottage, built along the road edge. At 1½ storeys with an asymmetric arrangement of windows of side hung casements of horizontal panes, it creates a very picturesque and rural image. It has a distinct stand-alone character which is significant for marking the transition to the countryside. A strong hedge along the roadside then leads out of the village.

Fig.26. *Tudor Cottage*

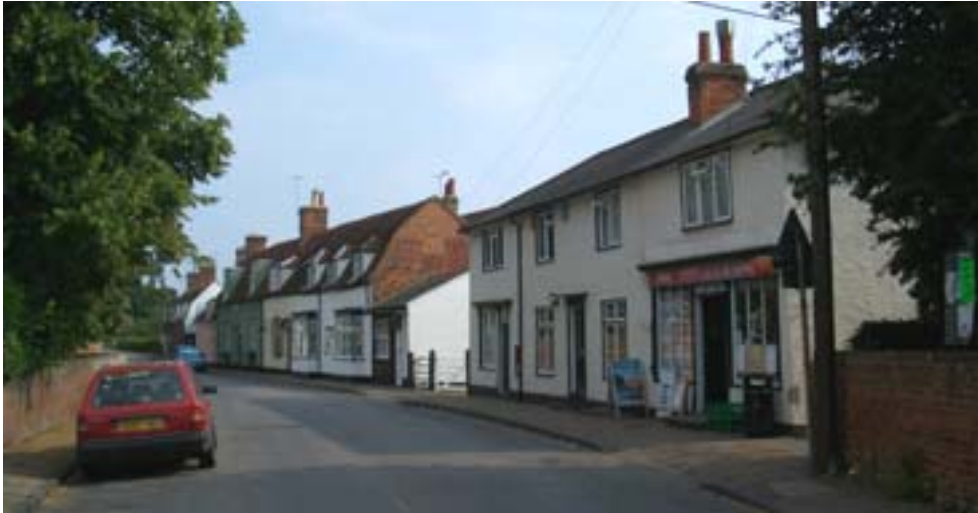
*Fig.27 East side of High Street*

Development on the east side comprises linear groups of buildings running up to the edge of the conservation area and the village itself (*fig. 27*). It is again a counterpoint to a landmark building, New Hall, in a spacious green setting. **Post Office Cottages** are slate roofed and date from the 19th century but their original traditional character is eroded by poor asymmetric windows. The north end retains more of the original classical character of the terrace, but still appears to have lost a chimney, damaging the symmetry of the terrace.

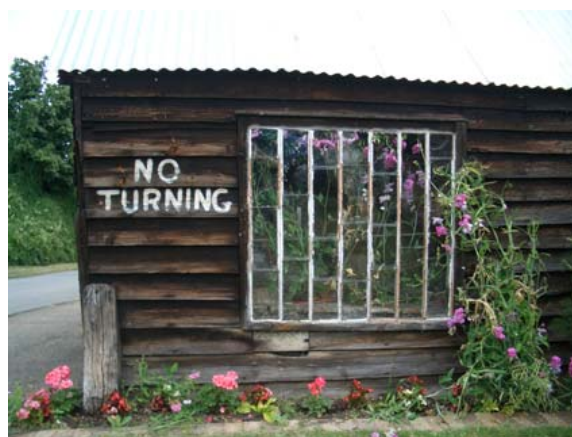
*Fig.28 Former smithy*

An open parking area provides a good view of the weatherboarded building formerly occupied by **the smithy**, but it would improve the townscape to break up the gap with a picket fence or planting along the boundary between the properties. The single storey height of the smithy, the window of long panels of overlapping glass and the corrugated roof reflect the utilitarian nature of use and are essential elements of its character (*fig.28*). Plaques indicating association with the Bentalls and

Maldon ironworks add greatly to its interest. This building is very significant for reflecting the history of the village and contributing to the hierarchy of forms and building types of Bradwell.

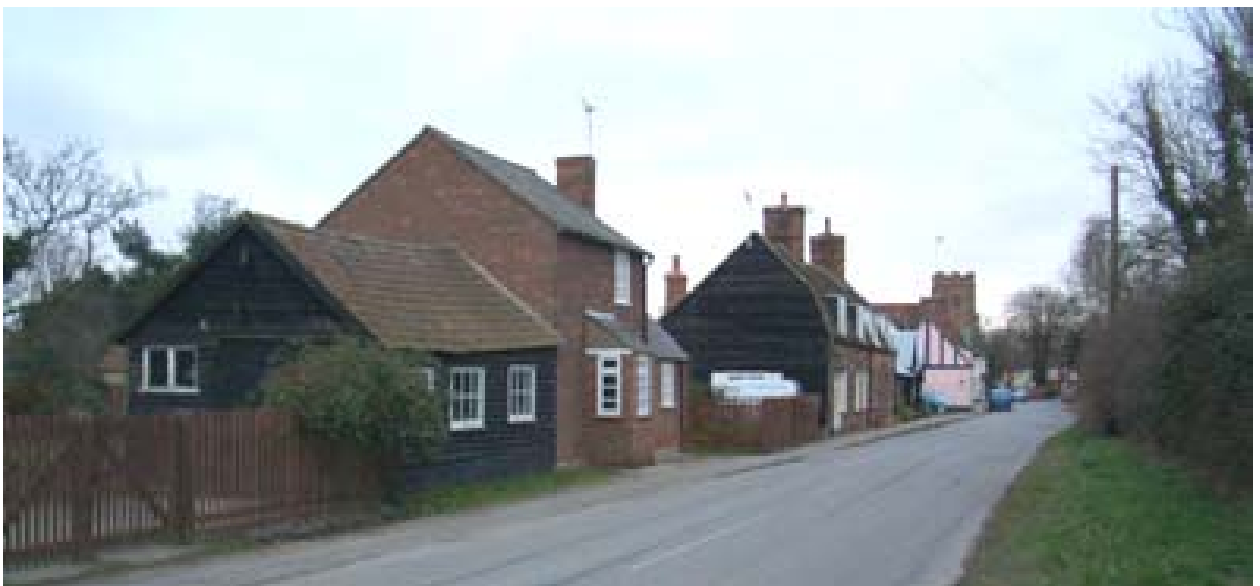
*Fig.29* View from north into Conservation Area

Views from the north of Bradwell show an attractive group of buildings marked by a variety of gable ends and materials, set against the church tower at the end (*fig.29*).

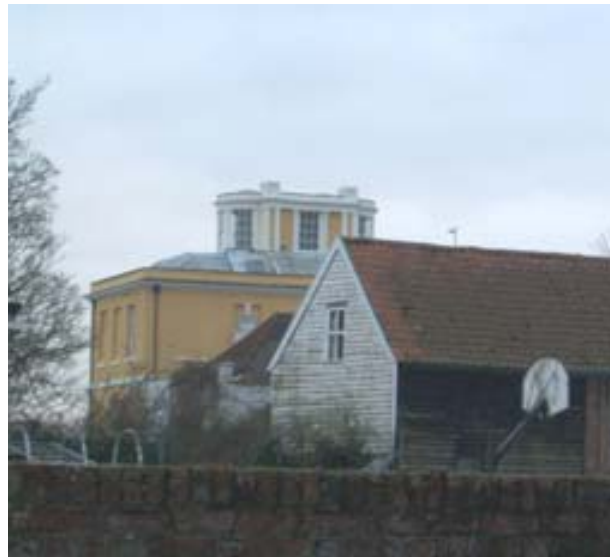
*Fig.30. Bradwell Lodge*

At the road junction, East End Road is characterised by the churchyard on its north side and on its south, the long brick boundary wall which continues from **Bradwell Lodge** to the School. At first, heavy planting screens views to the Lodge, though the pond may be glimpsed. The open tennis courts and playgrounds, however, provide views to the Lodge and, in particular, its belvedere (*fig.30*); this is a significant, if sometimes discreet, landmark in the village. The green, undeveloped character of this land between the Lodge and the road is again very significant for the character of the area. The churchyard and the lodge land provide a break in development between East End Road and the High Street, so the school and Caidge Row feel slightly removed from the main street.

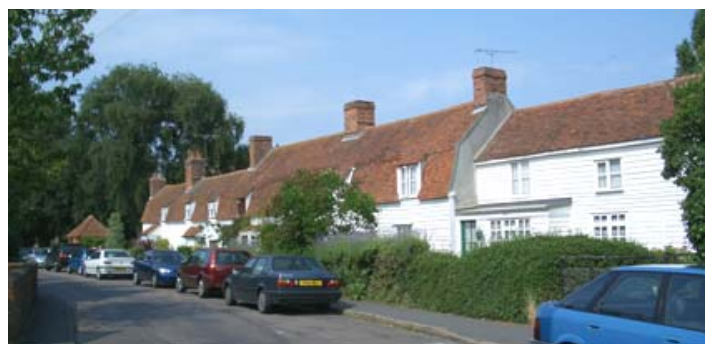
*Fig.31. Caidge Row and lock-up*

Two interesting historic structures enliven the run of the churchyard wall along East End Road: mounting steps of worn stone by the entrance dated to the 18th century and the square brick lock-up built in 1817. The lock-up provides a strong corner feature. This has a pleasing contrast with the softer vernacular character of the Caidge Row.

The line of cottages, **Caidge Row**, provide a very picturesque streetscape (*fig.31*), containing a successful balance of variety (such as in the roofline) and unity (such as in the 1½ storey height, size and shape of dormers and the white colour throughout). This is a simple linear range, with an undulating roofline broken by large chimney stacks. Nos.1-2 have a low gambrel roof with a catslide to the rear, nos.3-5 one slightly higher, and then No.6 returns to a simple gable. Nos.1-3 have suffered more from alterations, with modern asymmetric windows at 1 and 2, brown stained windows at 3, and porches of varying size and detail. Nos.4 and 5 contain more sympathetic details with symmetrical side hung casements in dormers, and no.5 retains the vertical sliding sash at ground floor (*fig.15*). Nos.1-3 are rendered, while nos.4-6 have weatherboard that retains the pleasing irregularity of historic weatherboard. The contrast between render and weatherboard adds to their picturesque affect.

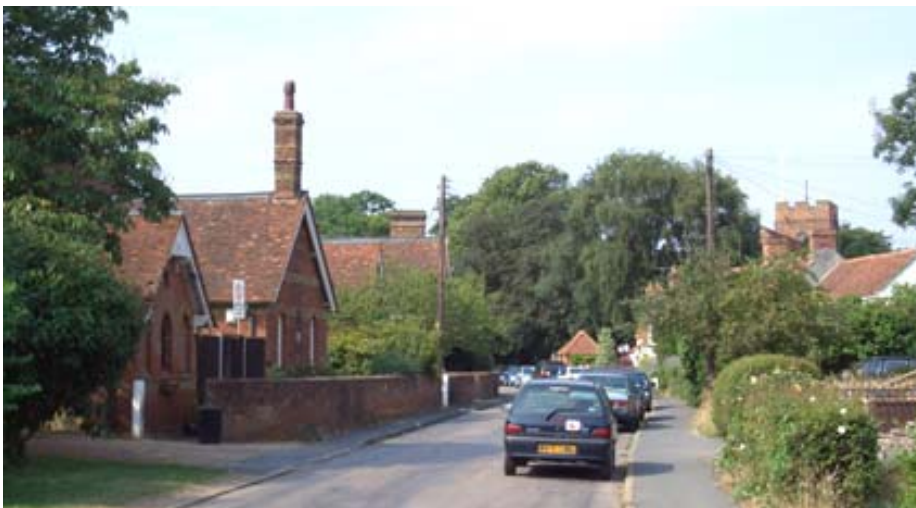
*Fig.32 View from East into Conservation Area*

The view from the east into the Conservation Area is characterised by the pleasing juxtaposition of the brick school with the white cottages opposite, framing the heavily tree covered aspect of the churchyard with the church tower visible over the rooftops. Further in, the view becomes terminated by Nos.9-11 High Street and then the King's Head.

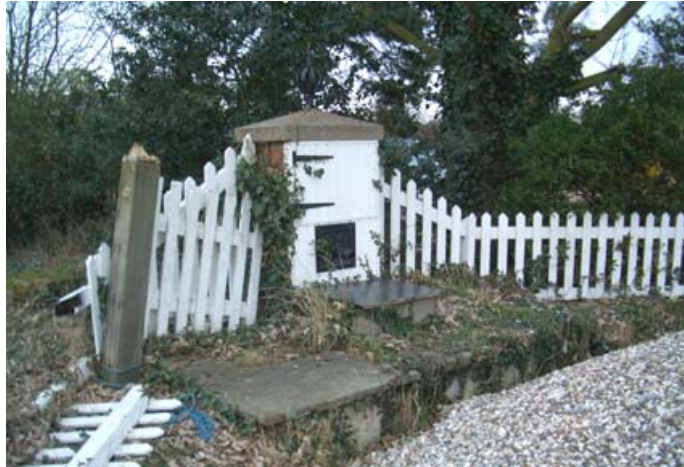
*Fig.33 Water pump*

1. To extend the conservation area to include the water pump (*fig.33*). This is not a listed structure and it is vulnerable to neglect, yet it is a locally significant historic feature. To include it within the conservation area would recognise its historic relationship with the village. The boundary would more logically follow the boundary to the rear of Wheelwrights Cottage and include the roadside hedges and green space behind, which are significant to the setting of the conservation area.
