Maldon District Council Level 1 Strategic Flood Risk Assessment

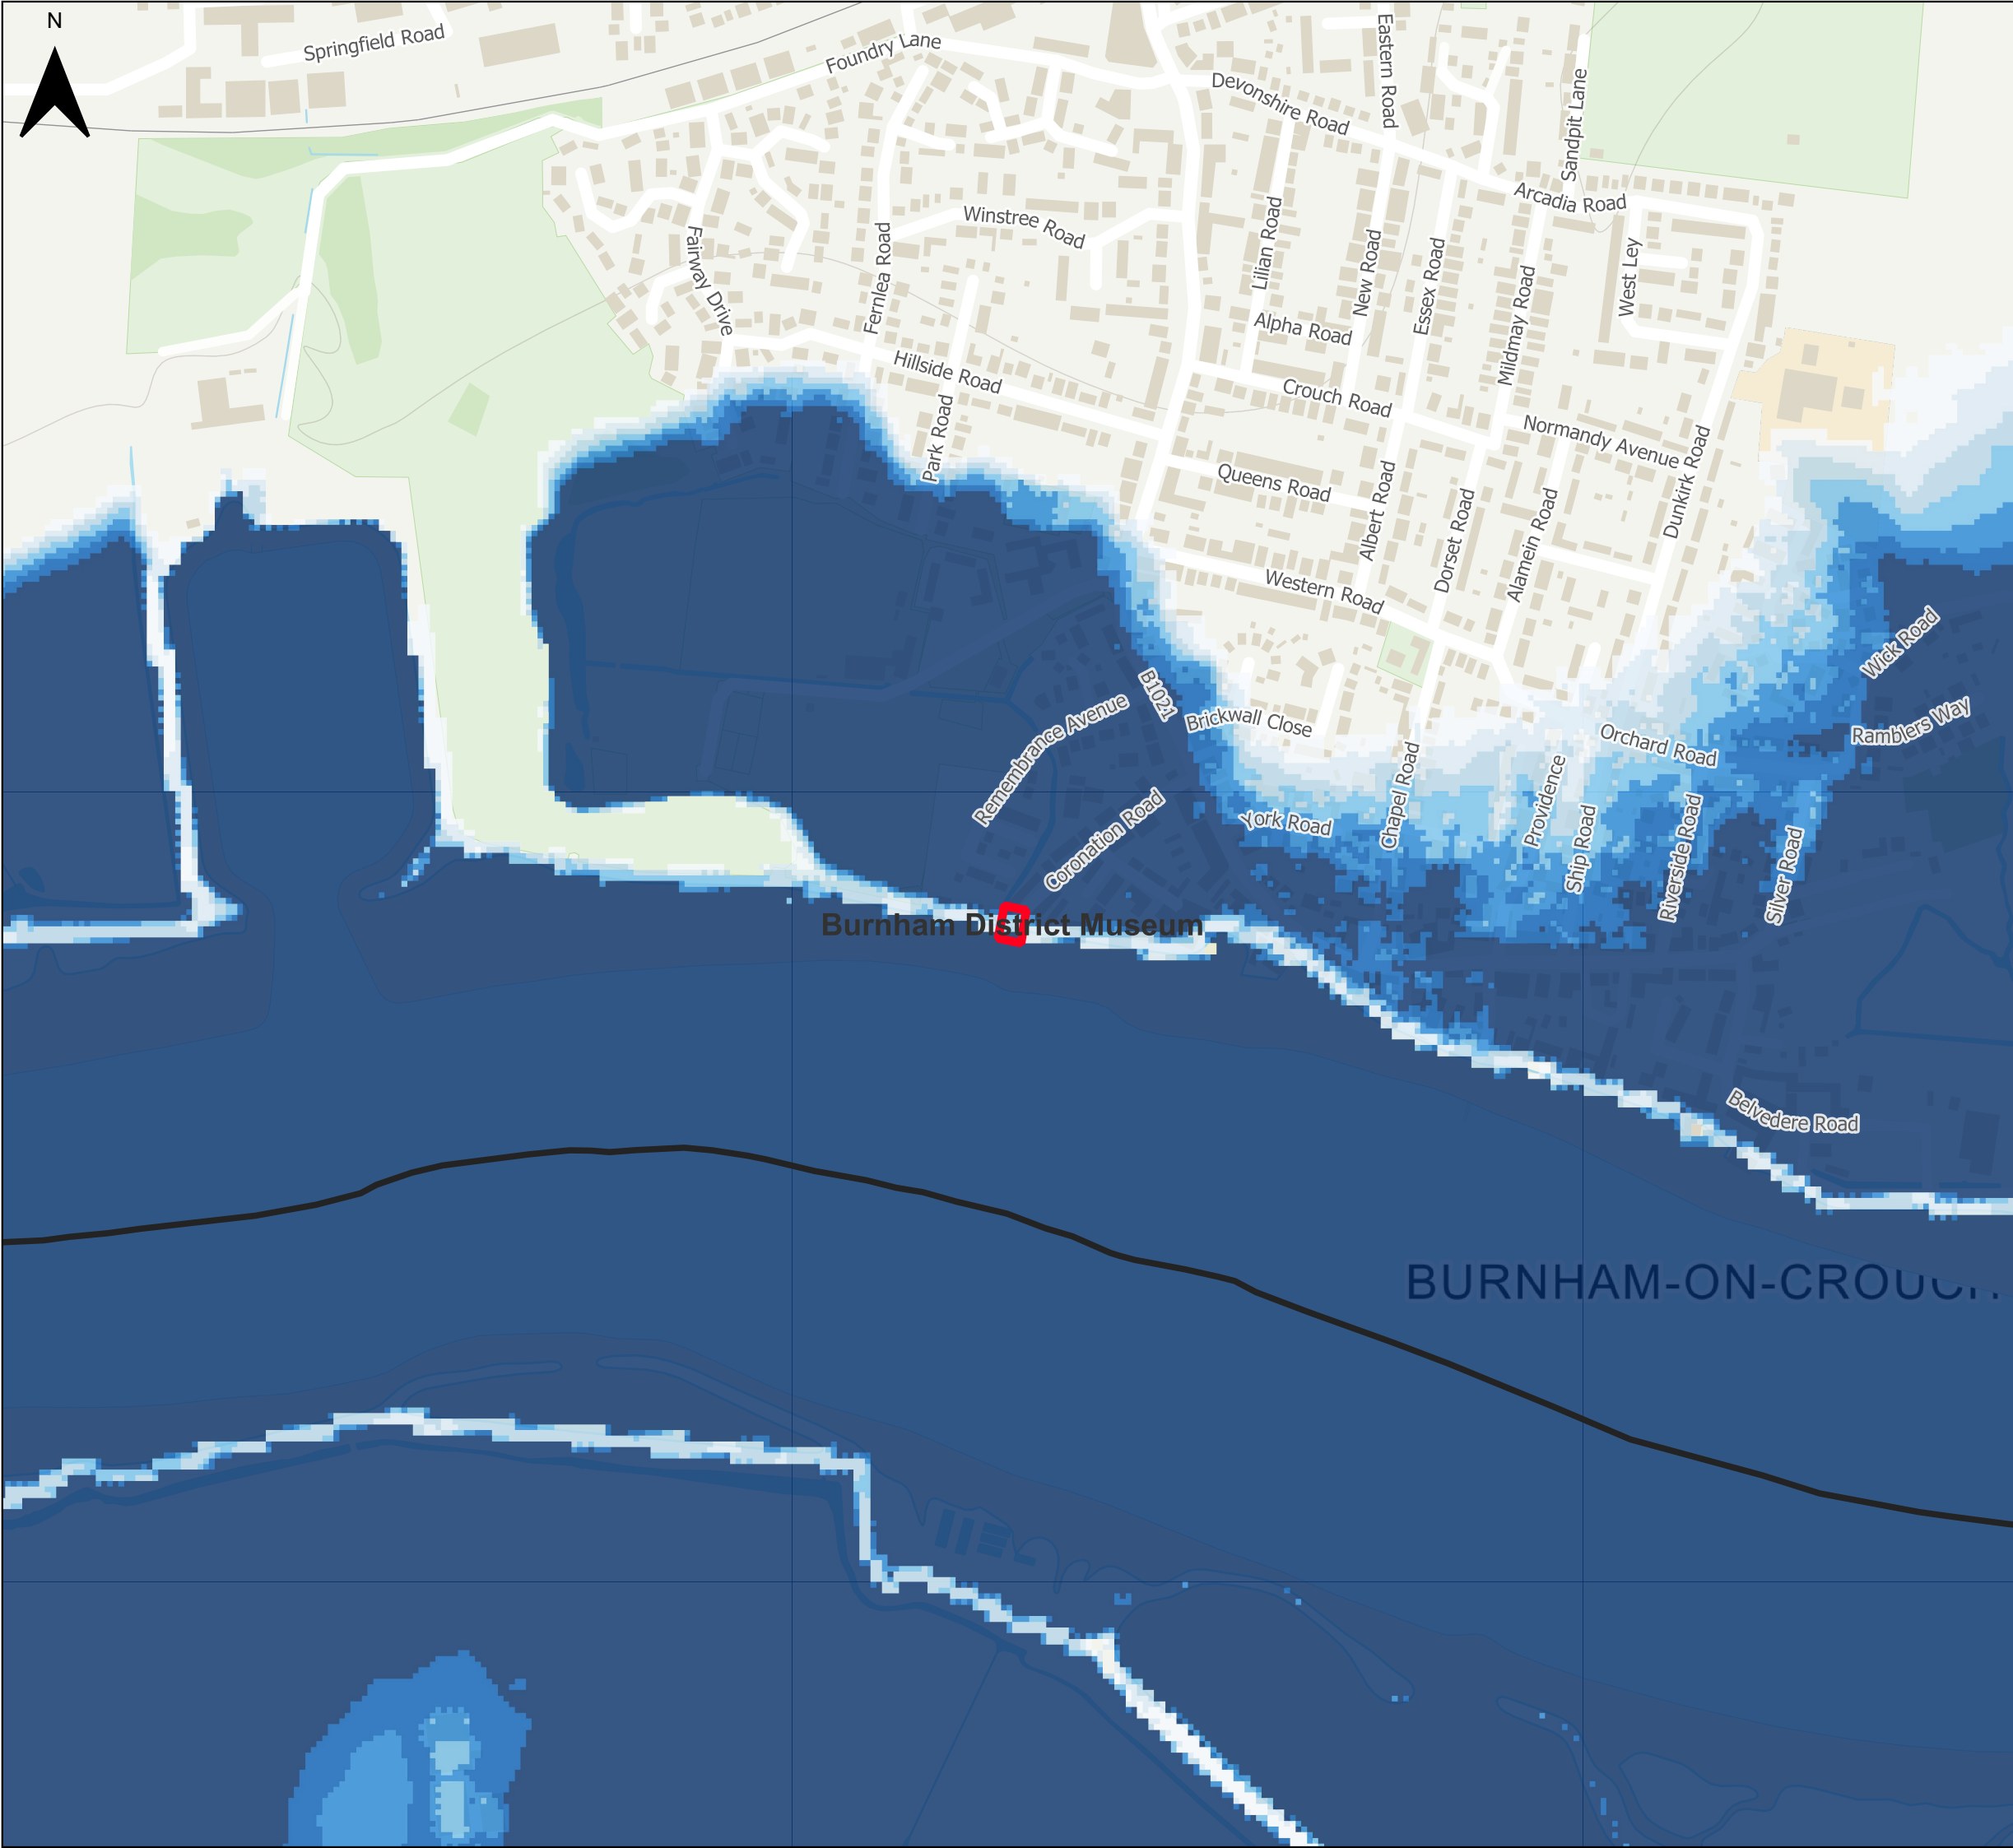
Burnham District Museum

- Breach Depth (m) 0.5% AEP Plus Climate Change (2121-year event)**
- <= 0.3

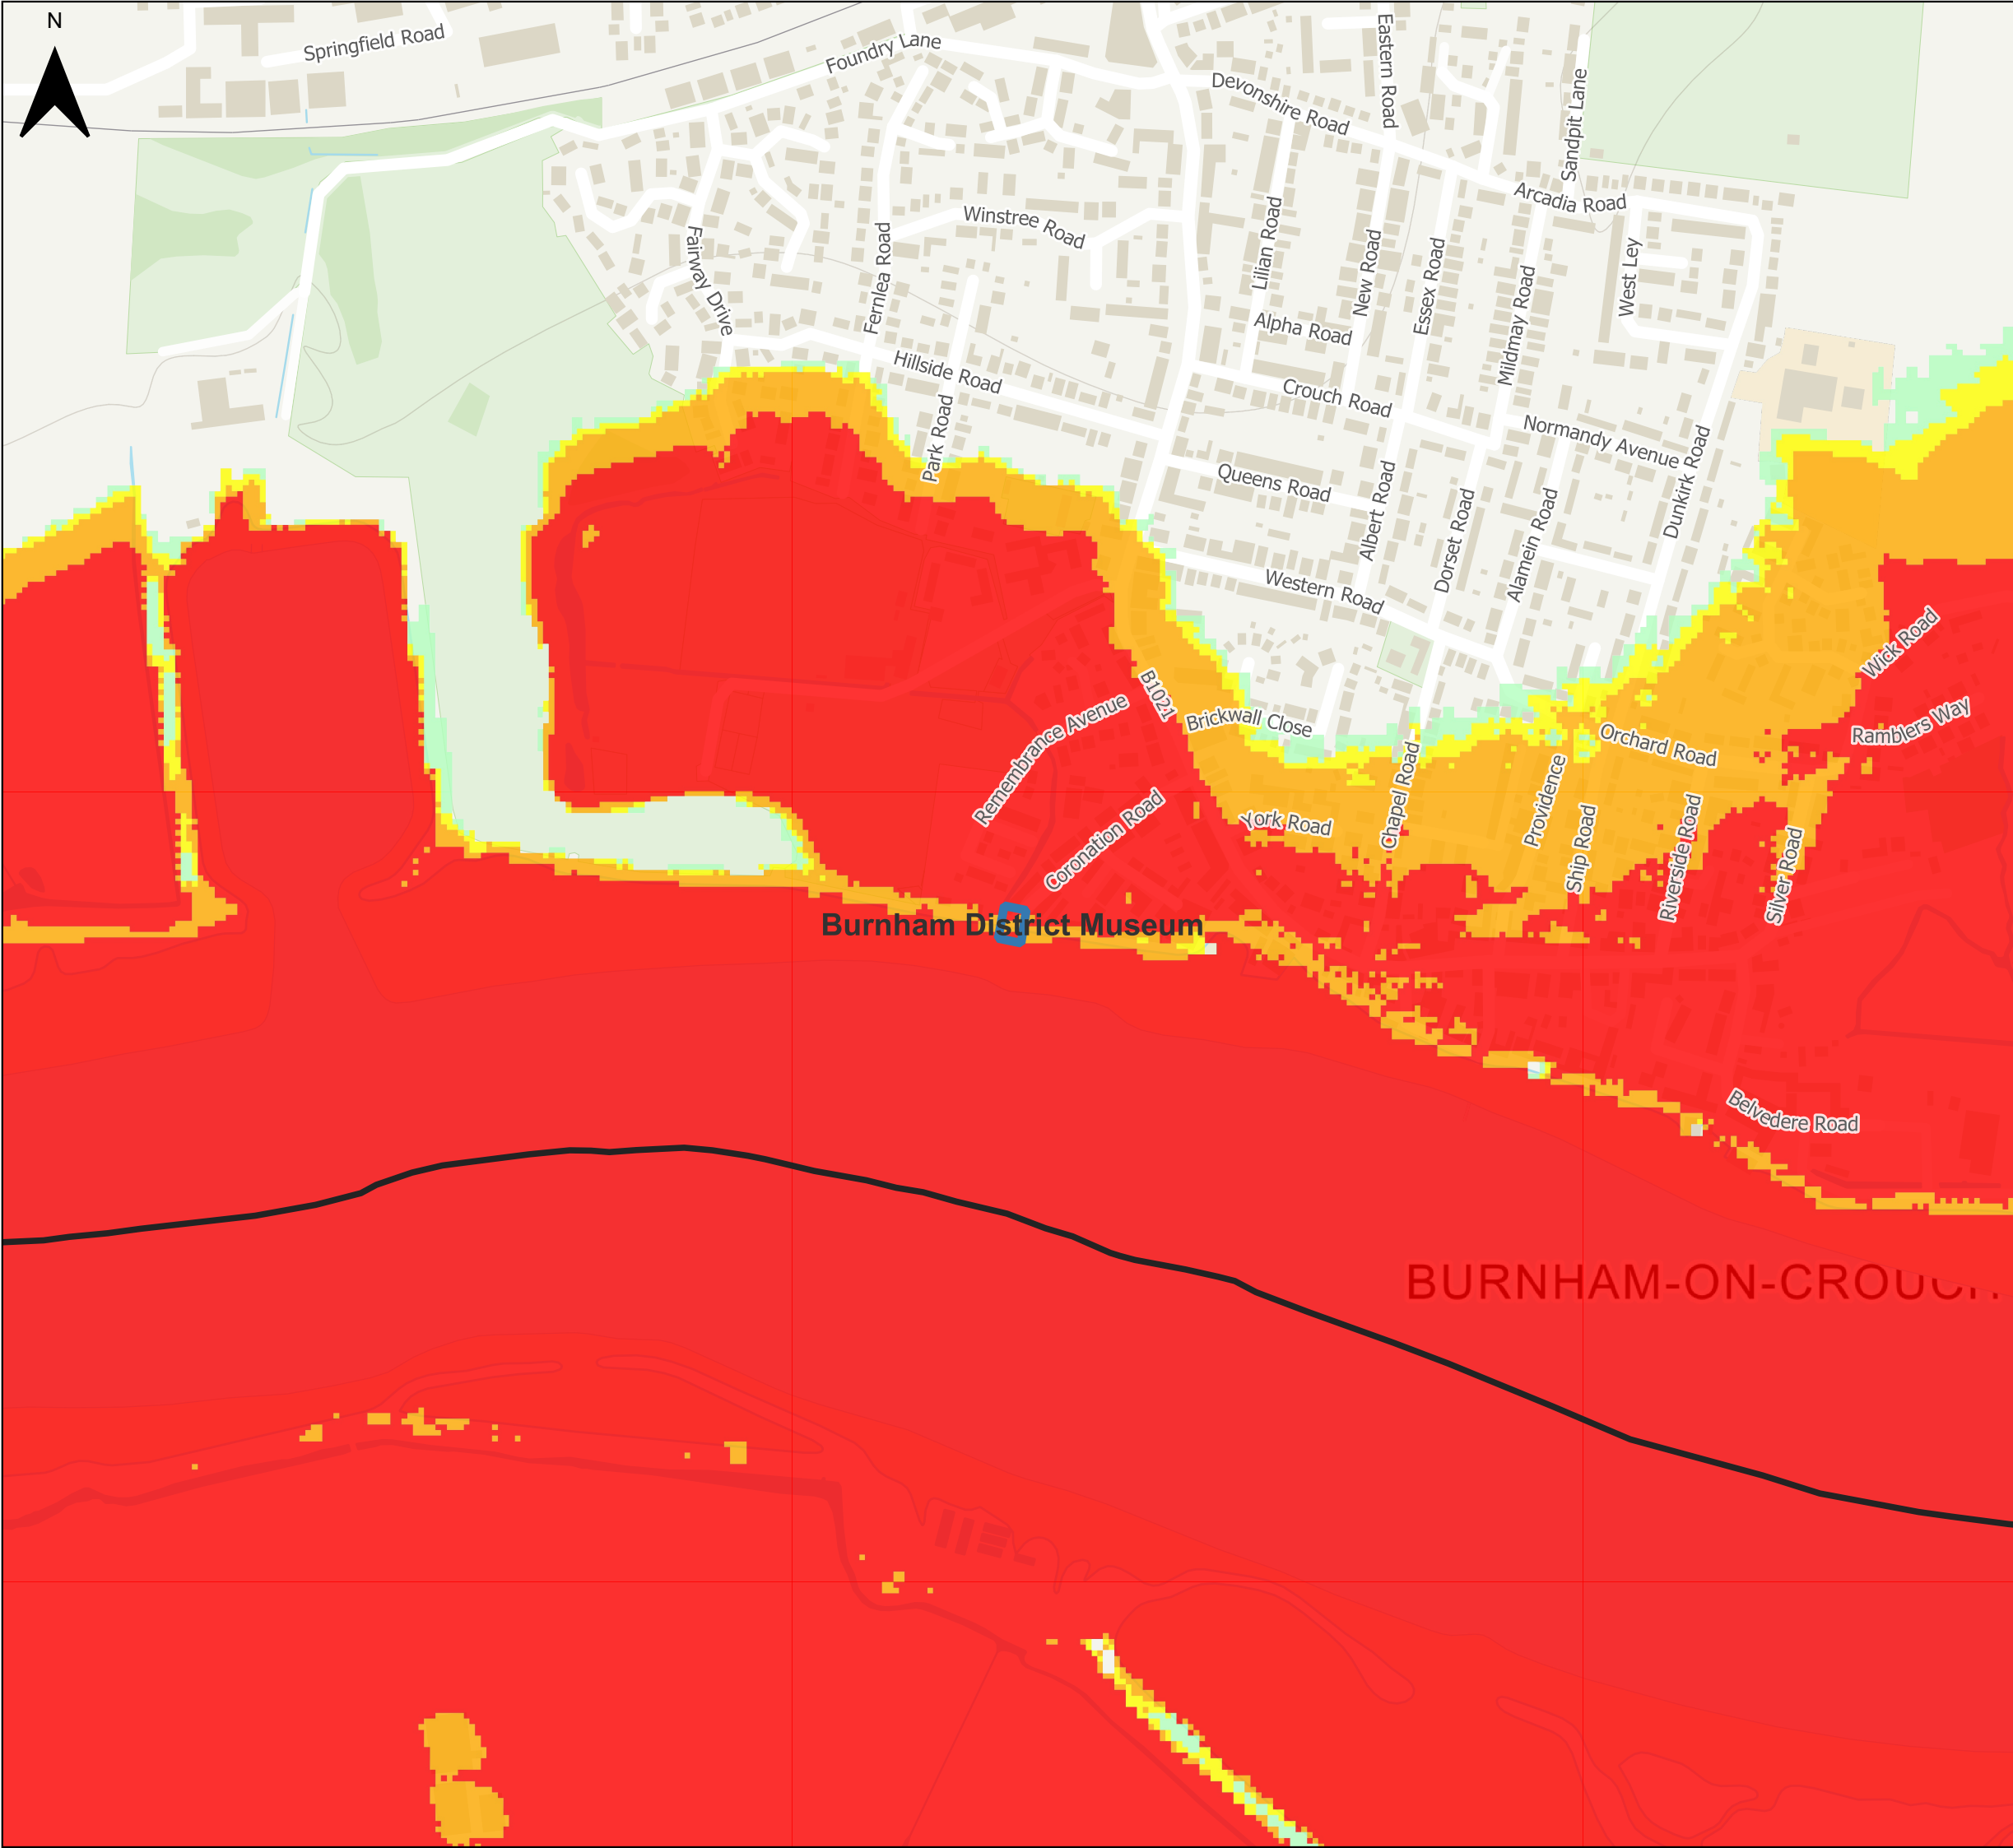
Burnham District Museum

- Breach Hazard 0.5% AEP Plus Climate Change (2121-year event)**
- No hazard

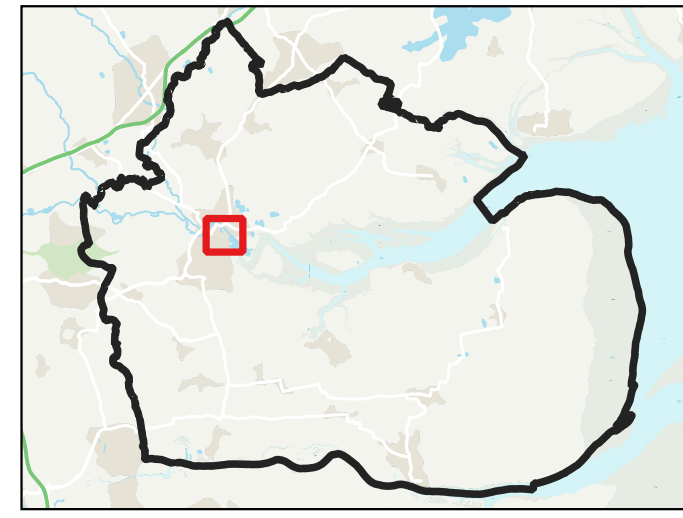
Heybridge Creek Embankment

- Breach Depth (m) 0.5% AEP Plus Climate Change (2121-year event)**
- <= 0.3

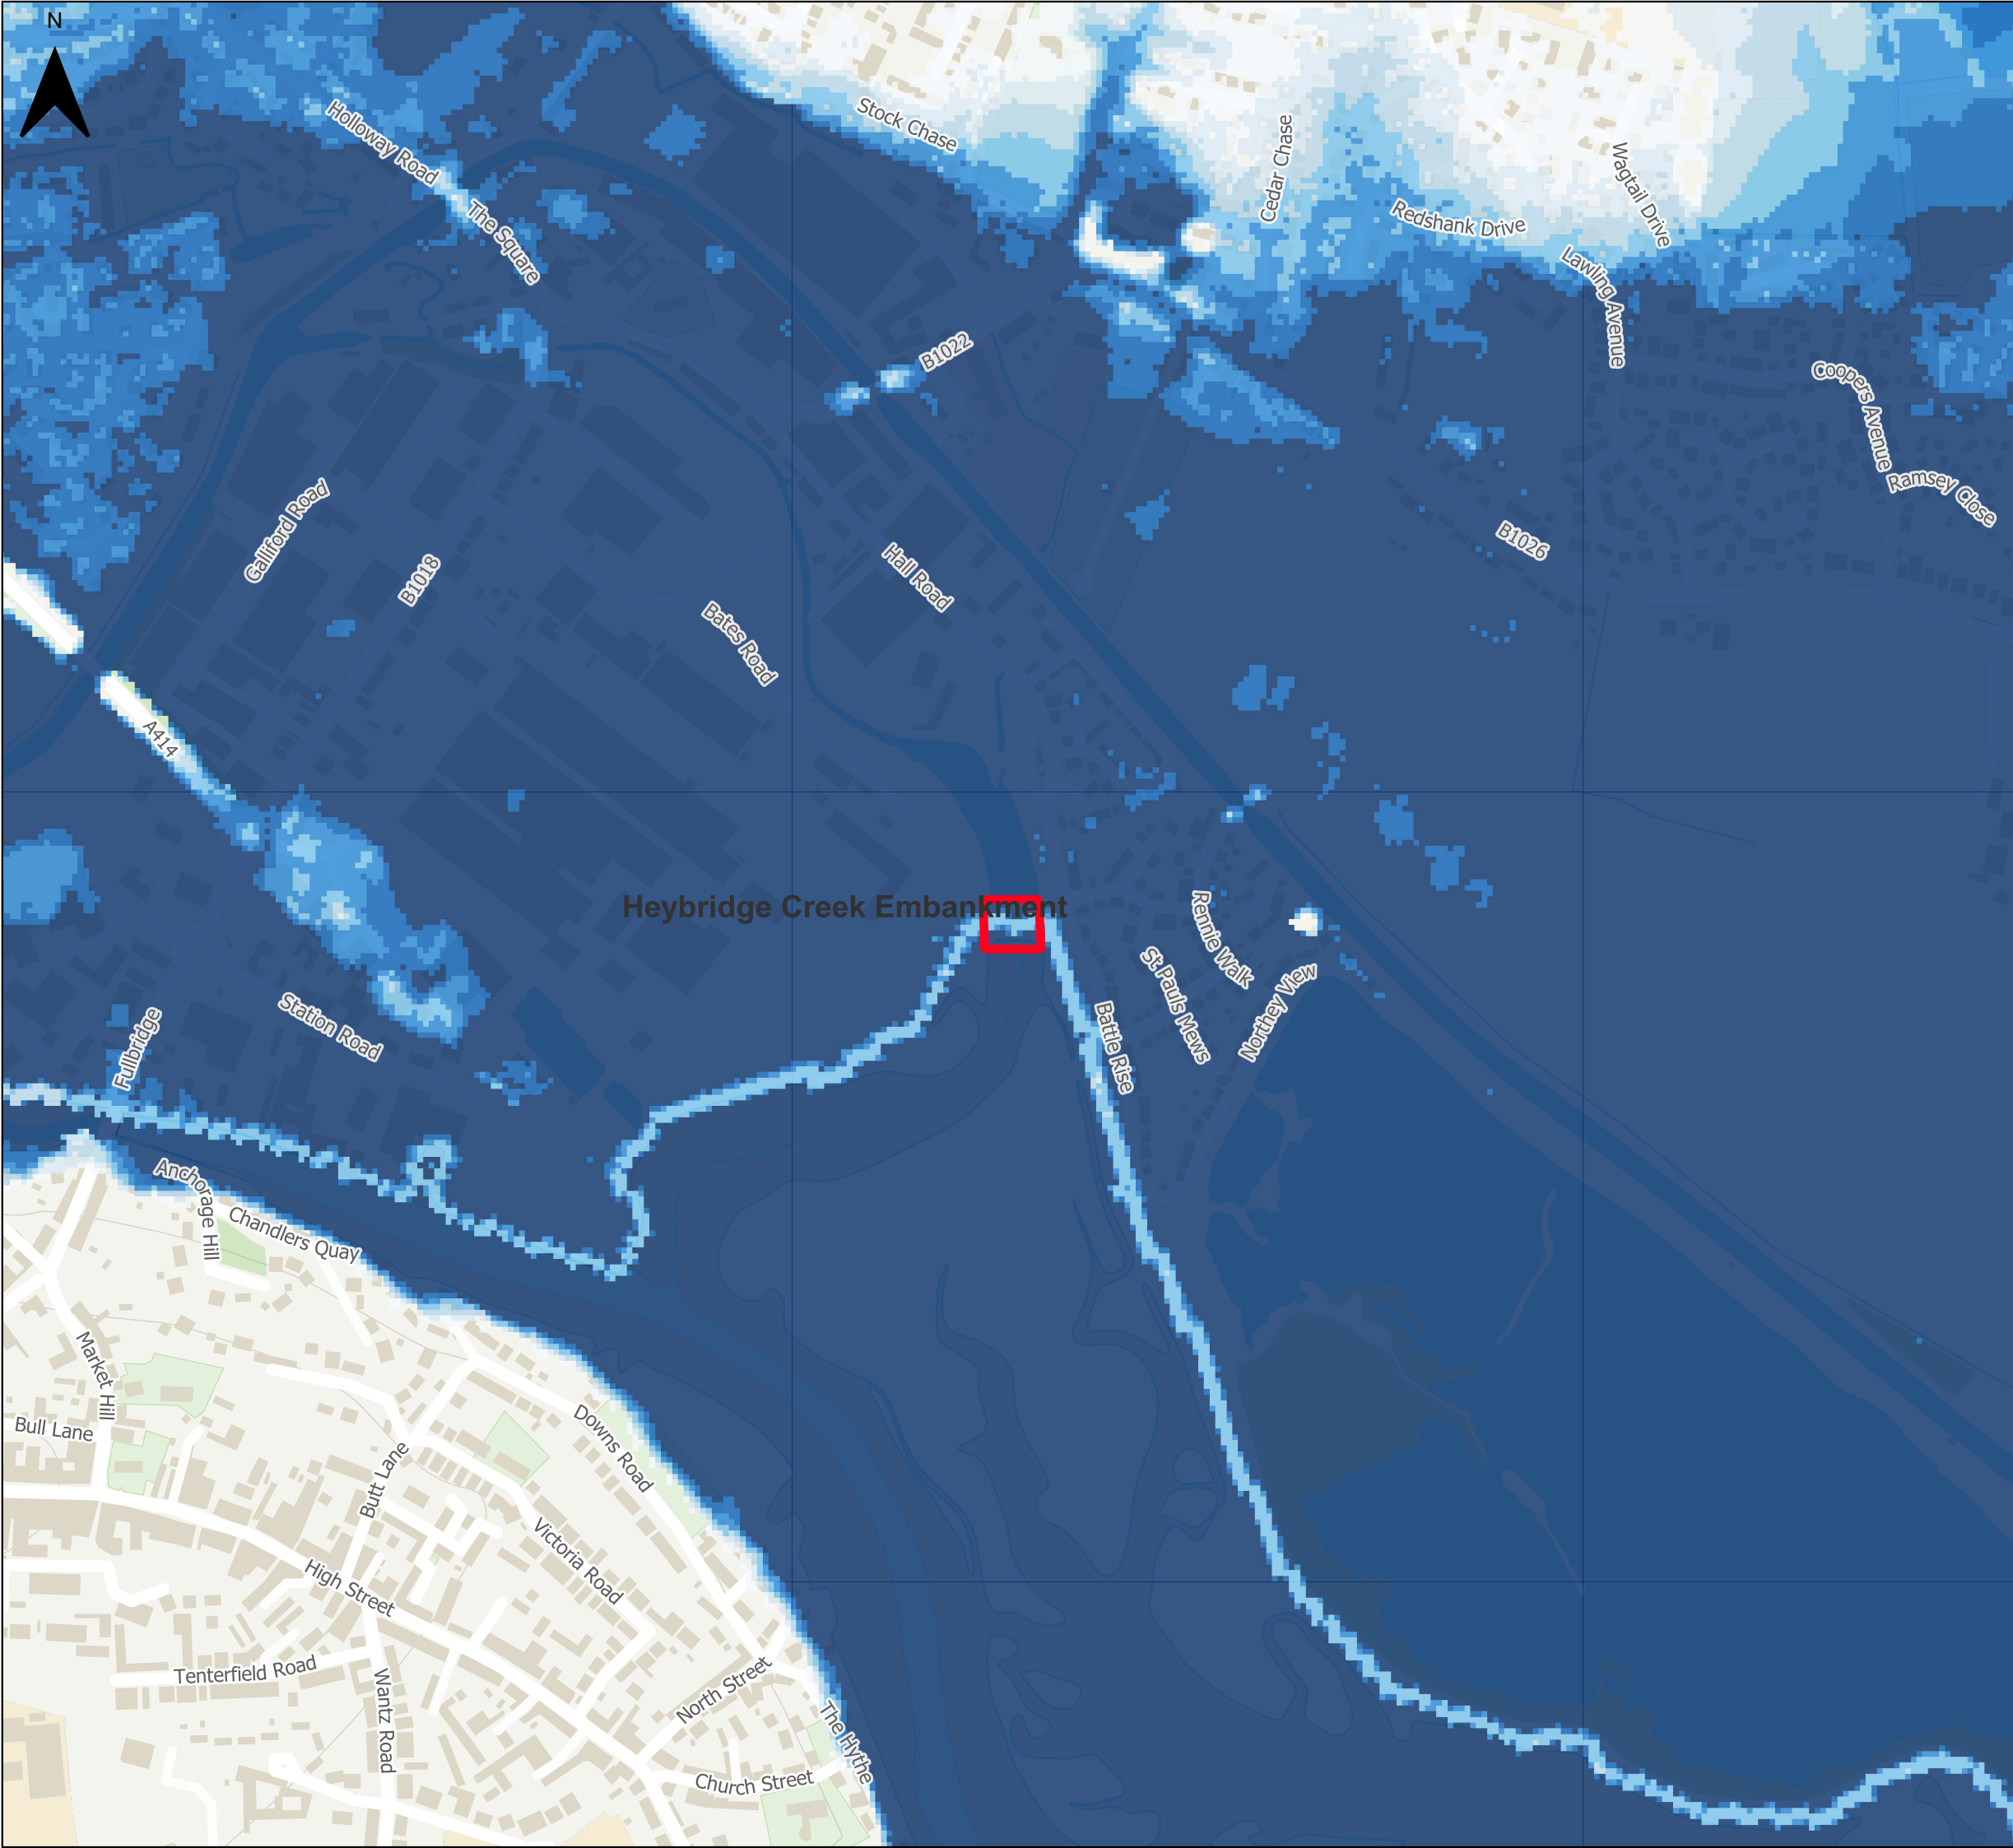
Heybridge Creek Embankment

- Breach Hazard 0.5% AEP Plus
Climate Change (2121-year event)**
- No hazard

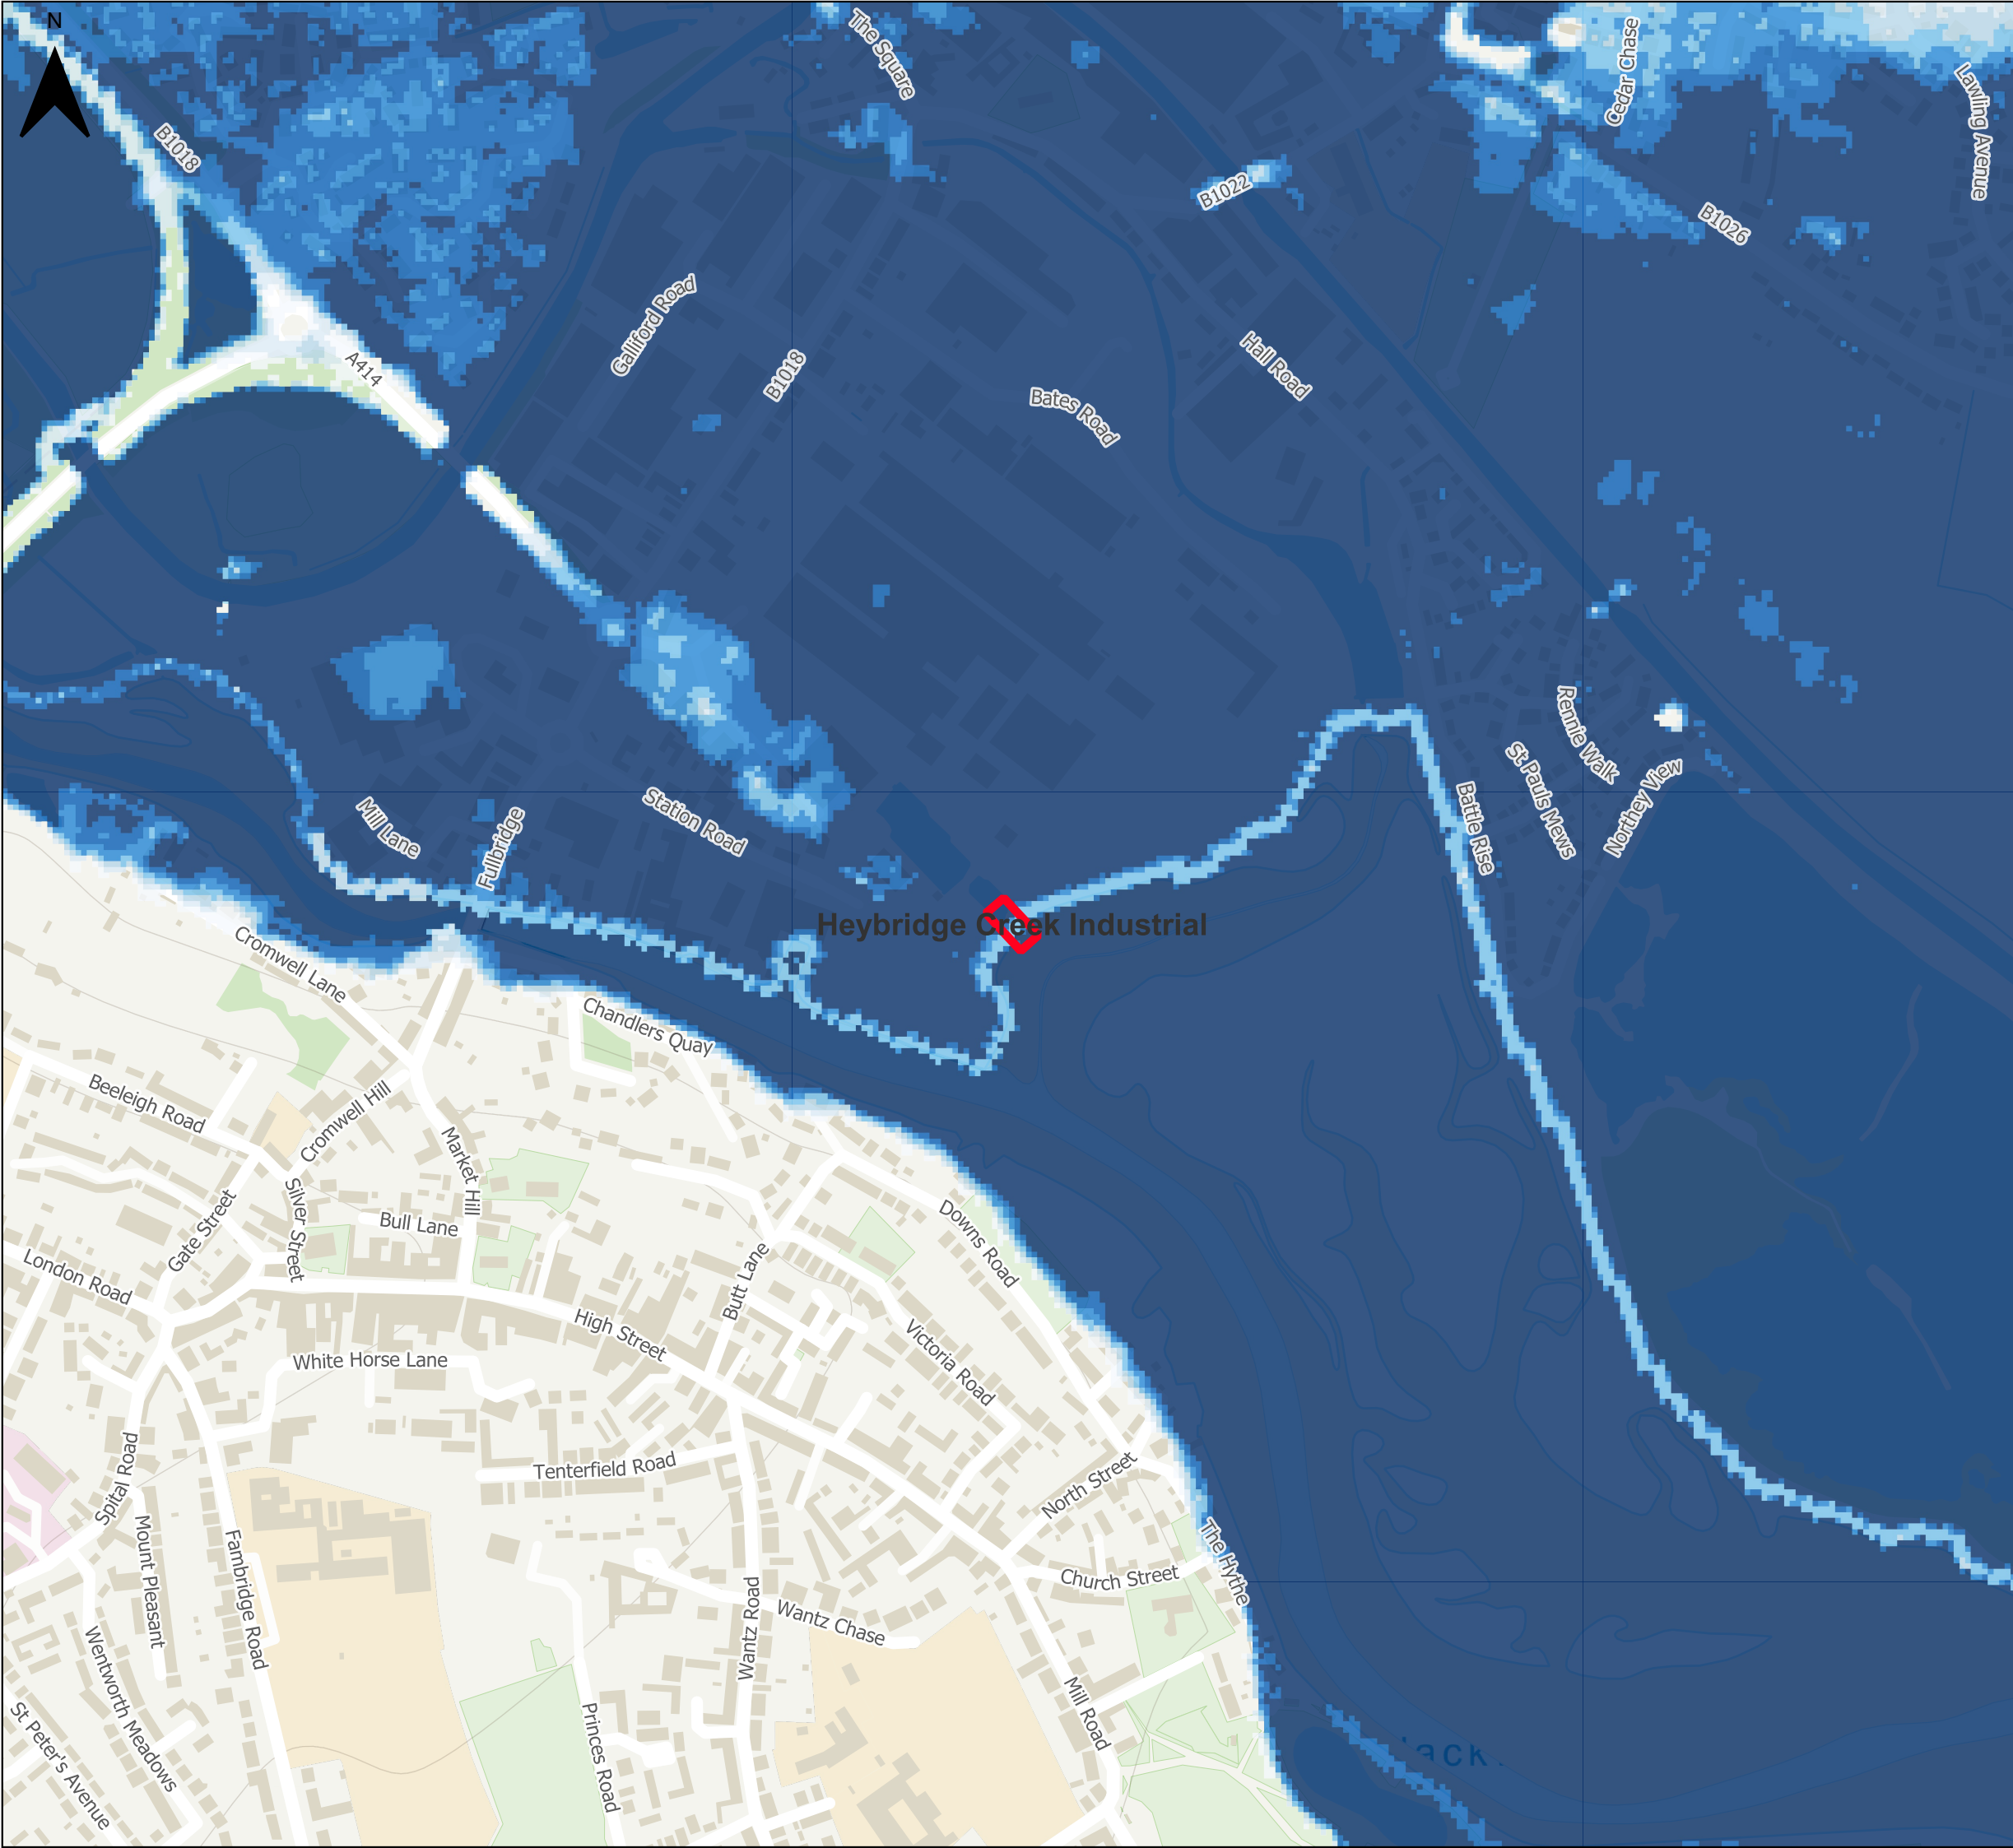
Heybridge Creek Industrial

- Maldon District Boundary
- Breach Locations
- Breach Hazard 0.5% AEP Plus Climate Change (2121-year event)**
- No hazard
- Very low hazard - Caution
- Danger for some
- Danger for most
- Danger for all

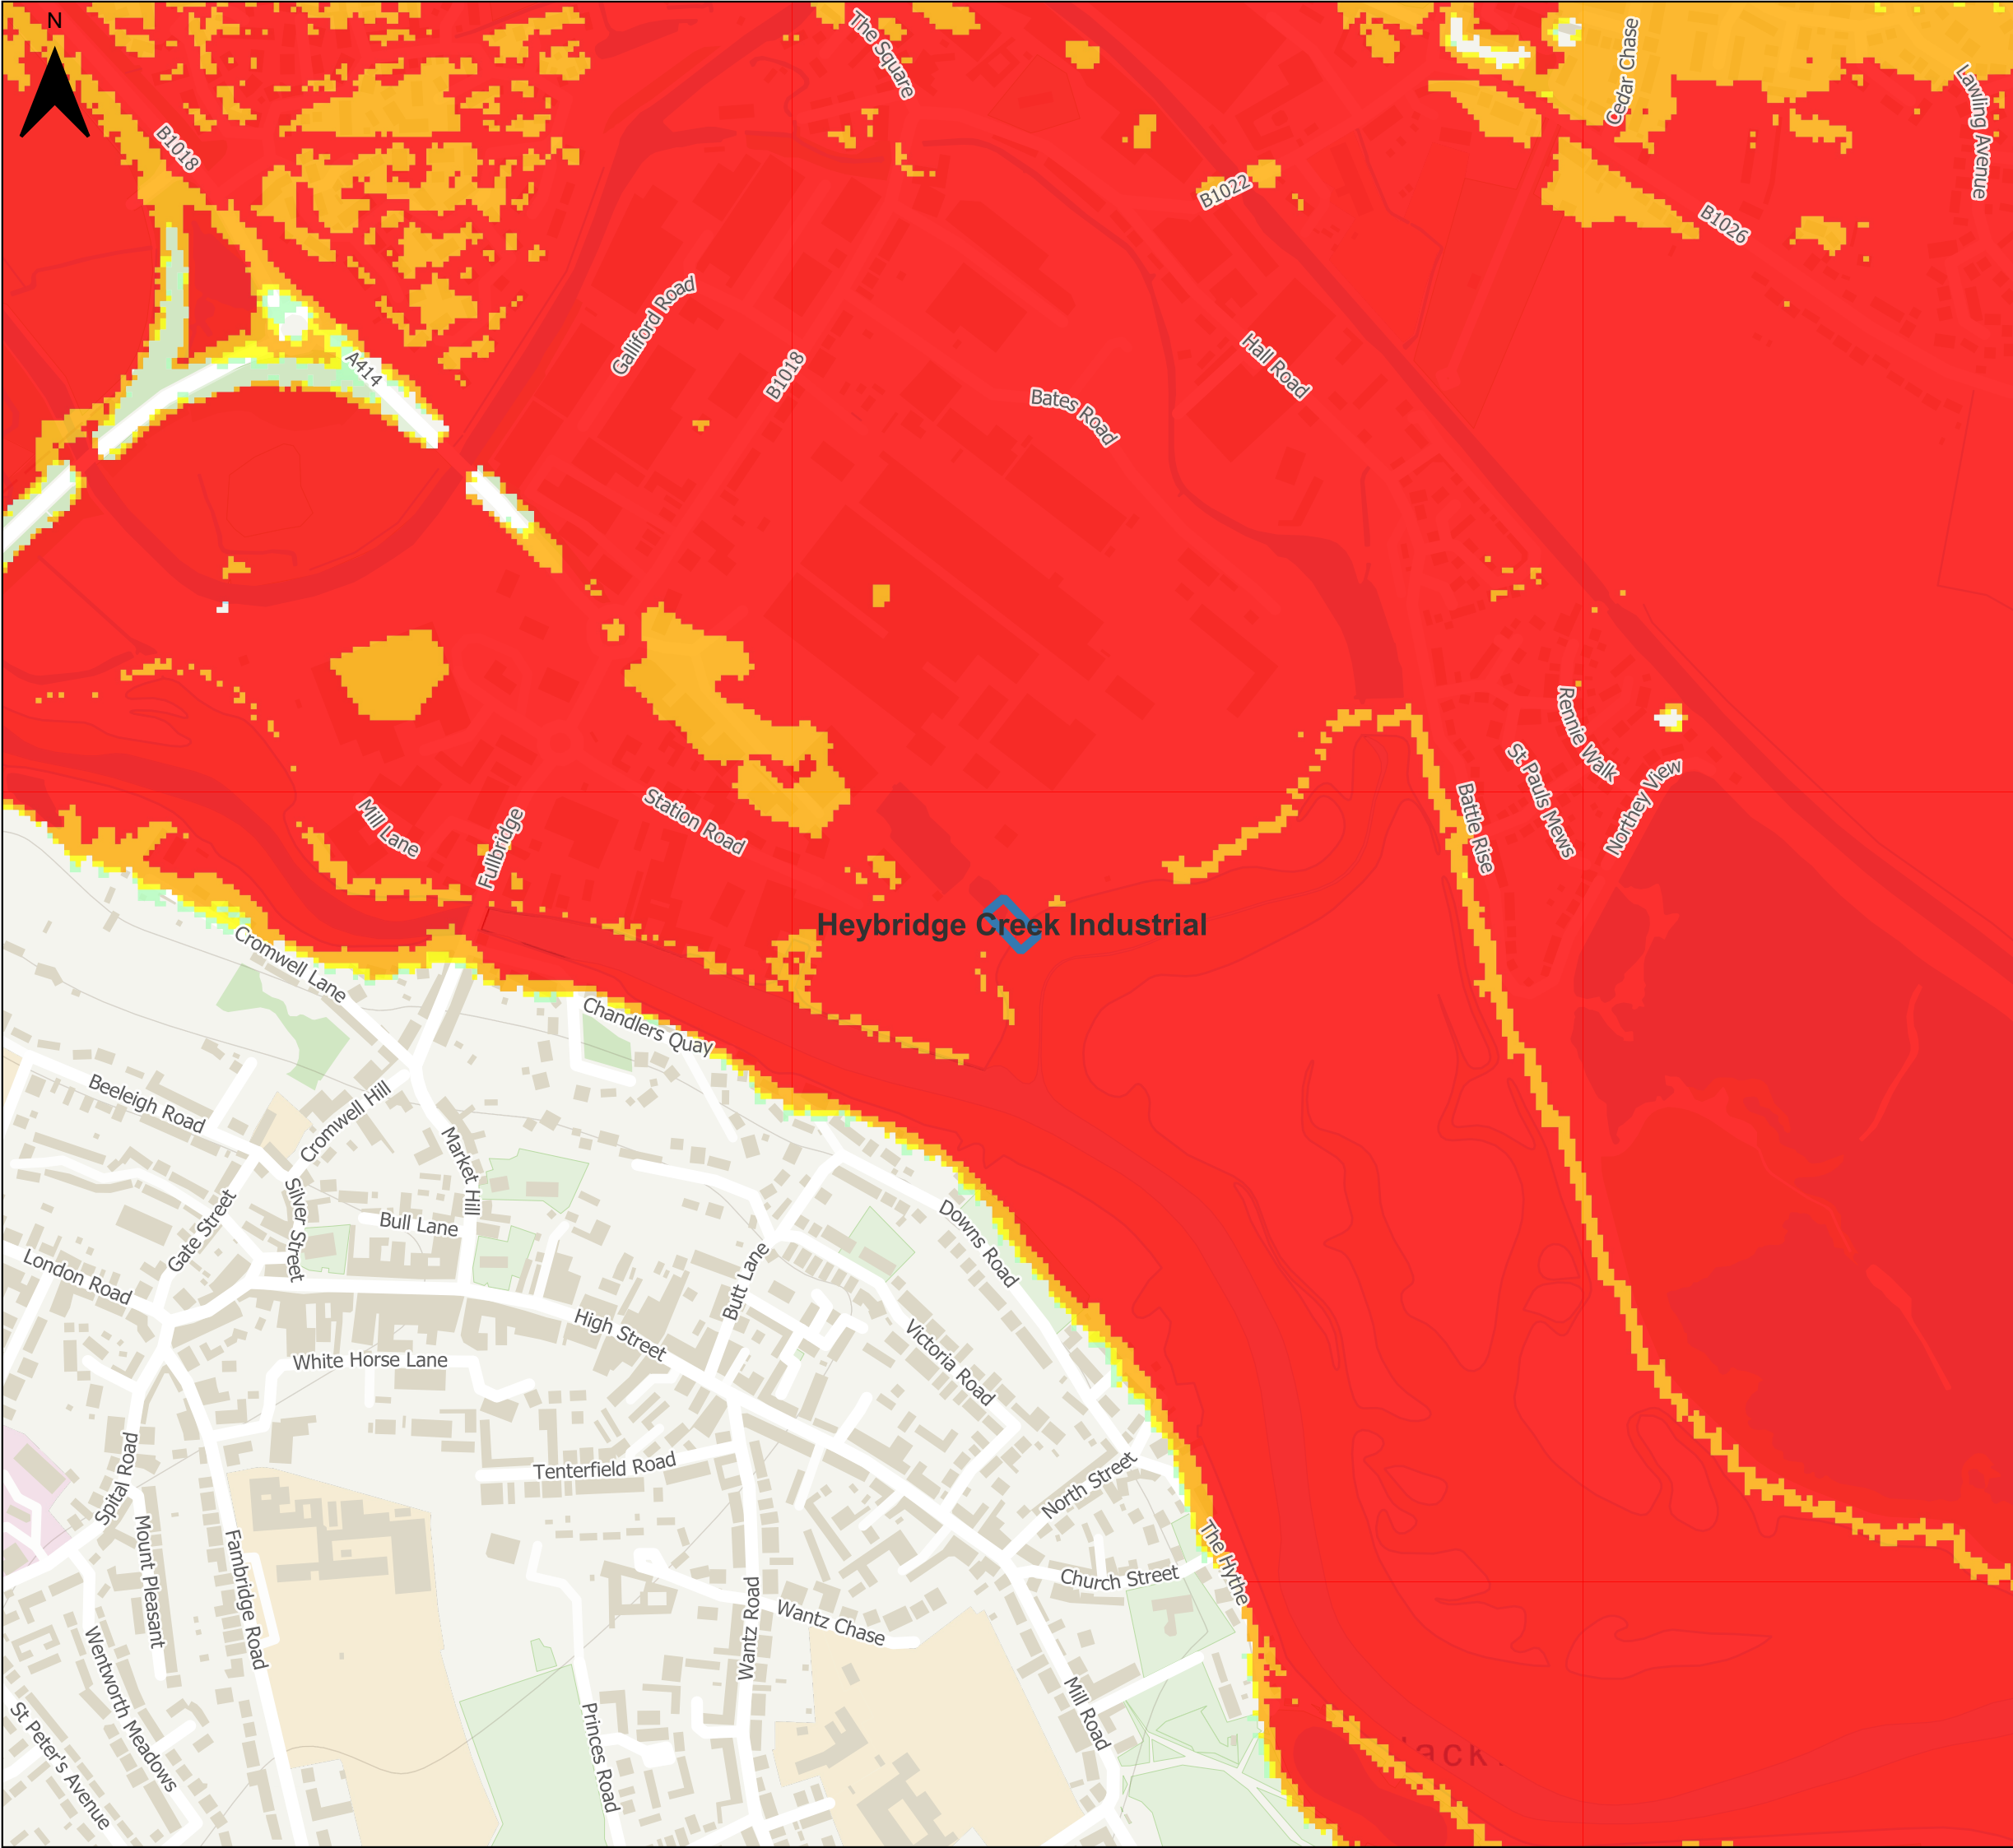
Heybridge

- Breach Depth (m) 0.5% AEP Plus Climate Change (2121-year event)**
- ≤ 0.3

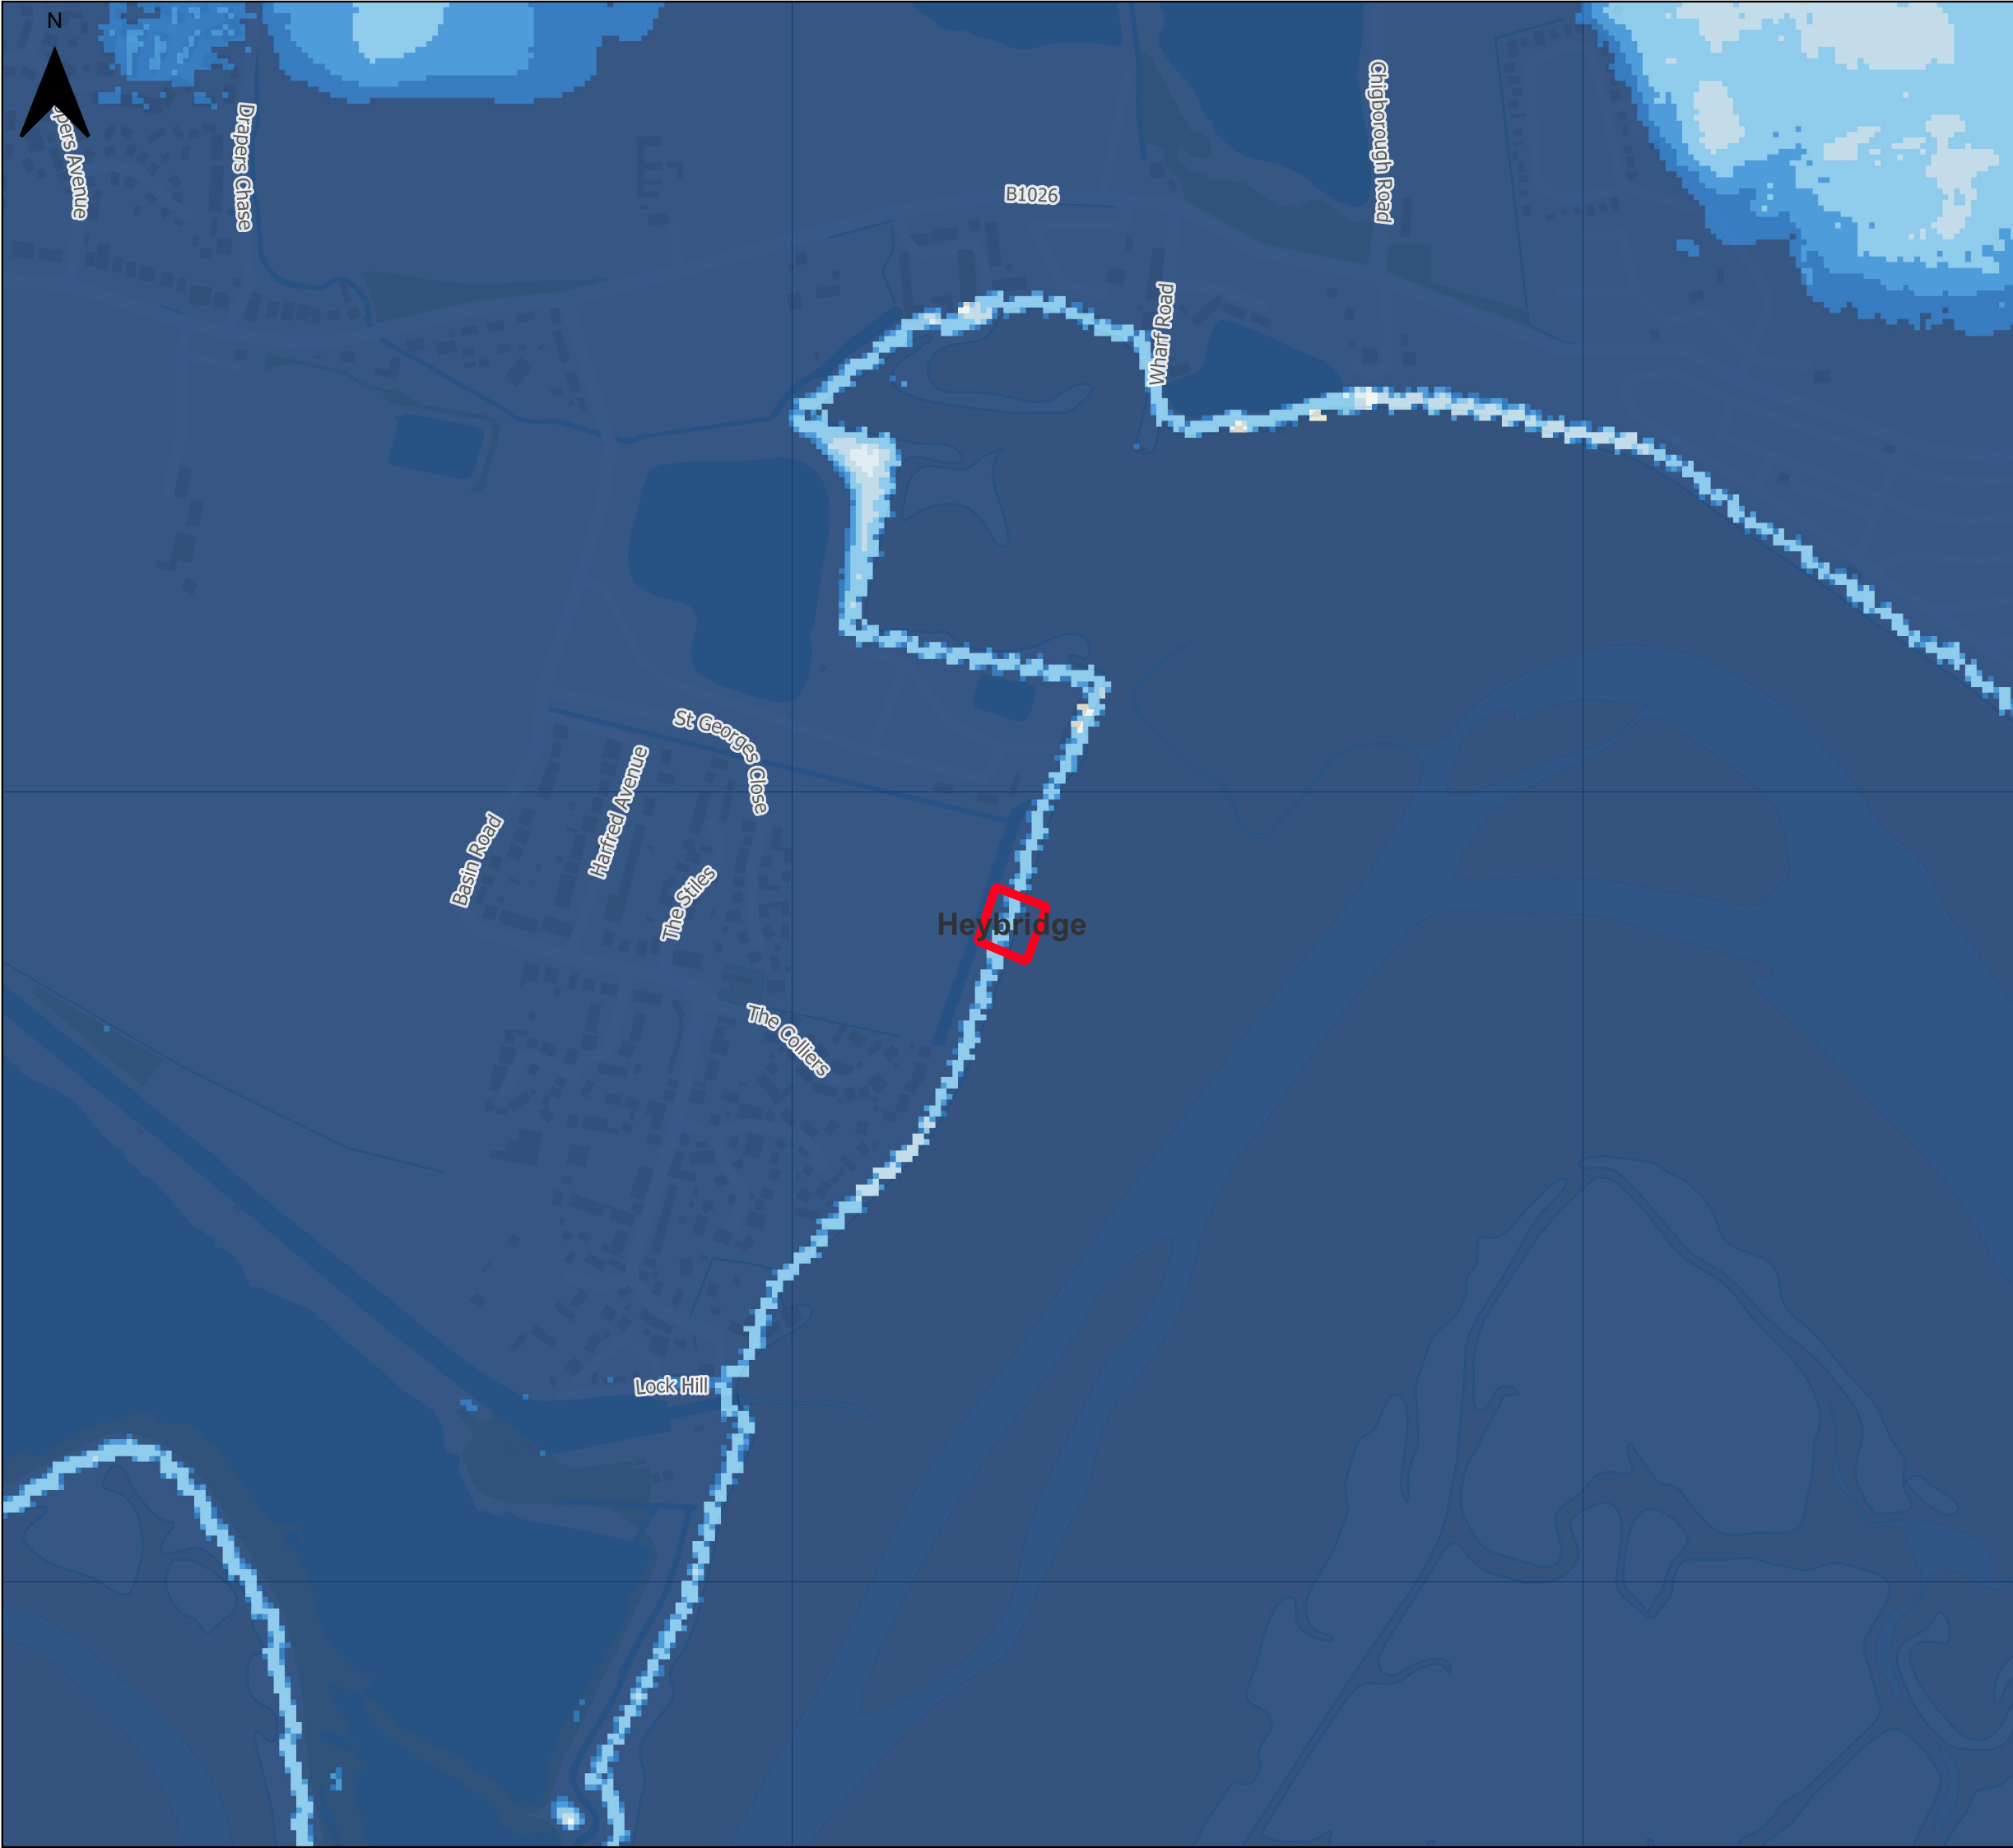
Heybridge

- Breach Hazard 0.5% AEP Plus
Climate Change (2121-year event)**
- No hazard

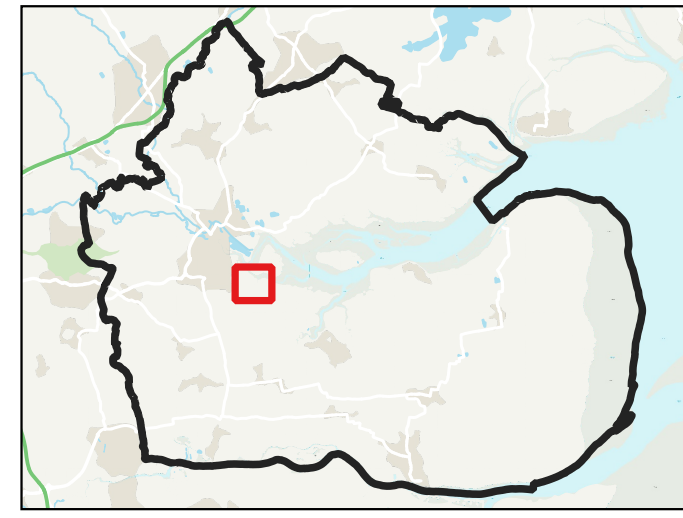
Limbourn Creek

Breach Hazard 0.5% AEP Plus Climate Change (2121-year event)
