Maldon District Council Level 1 Strategic Flood Risk Assessment

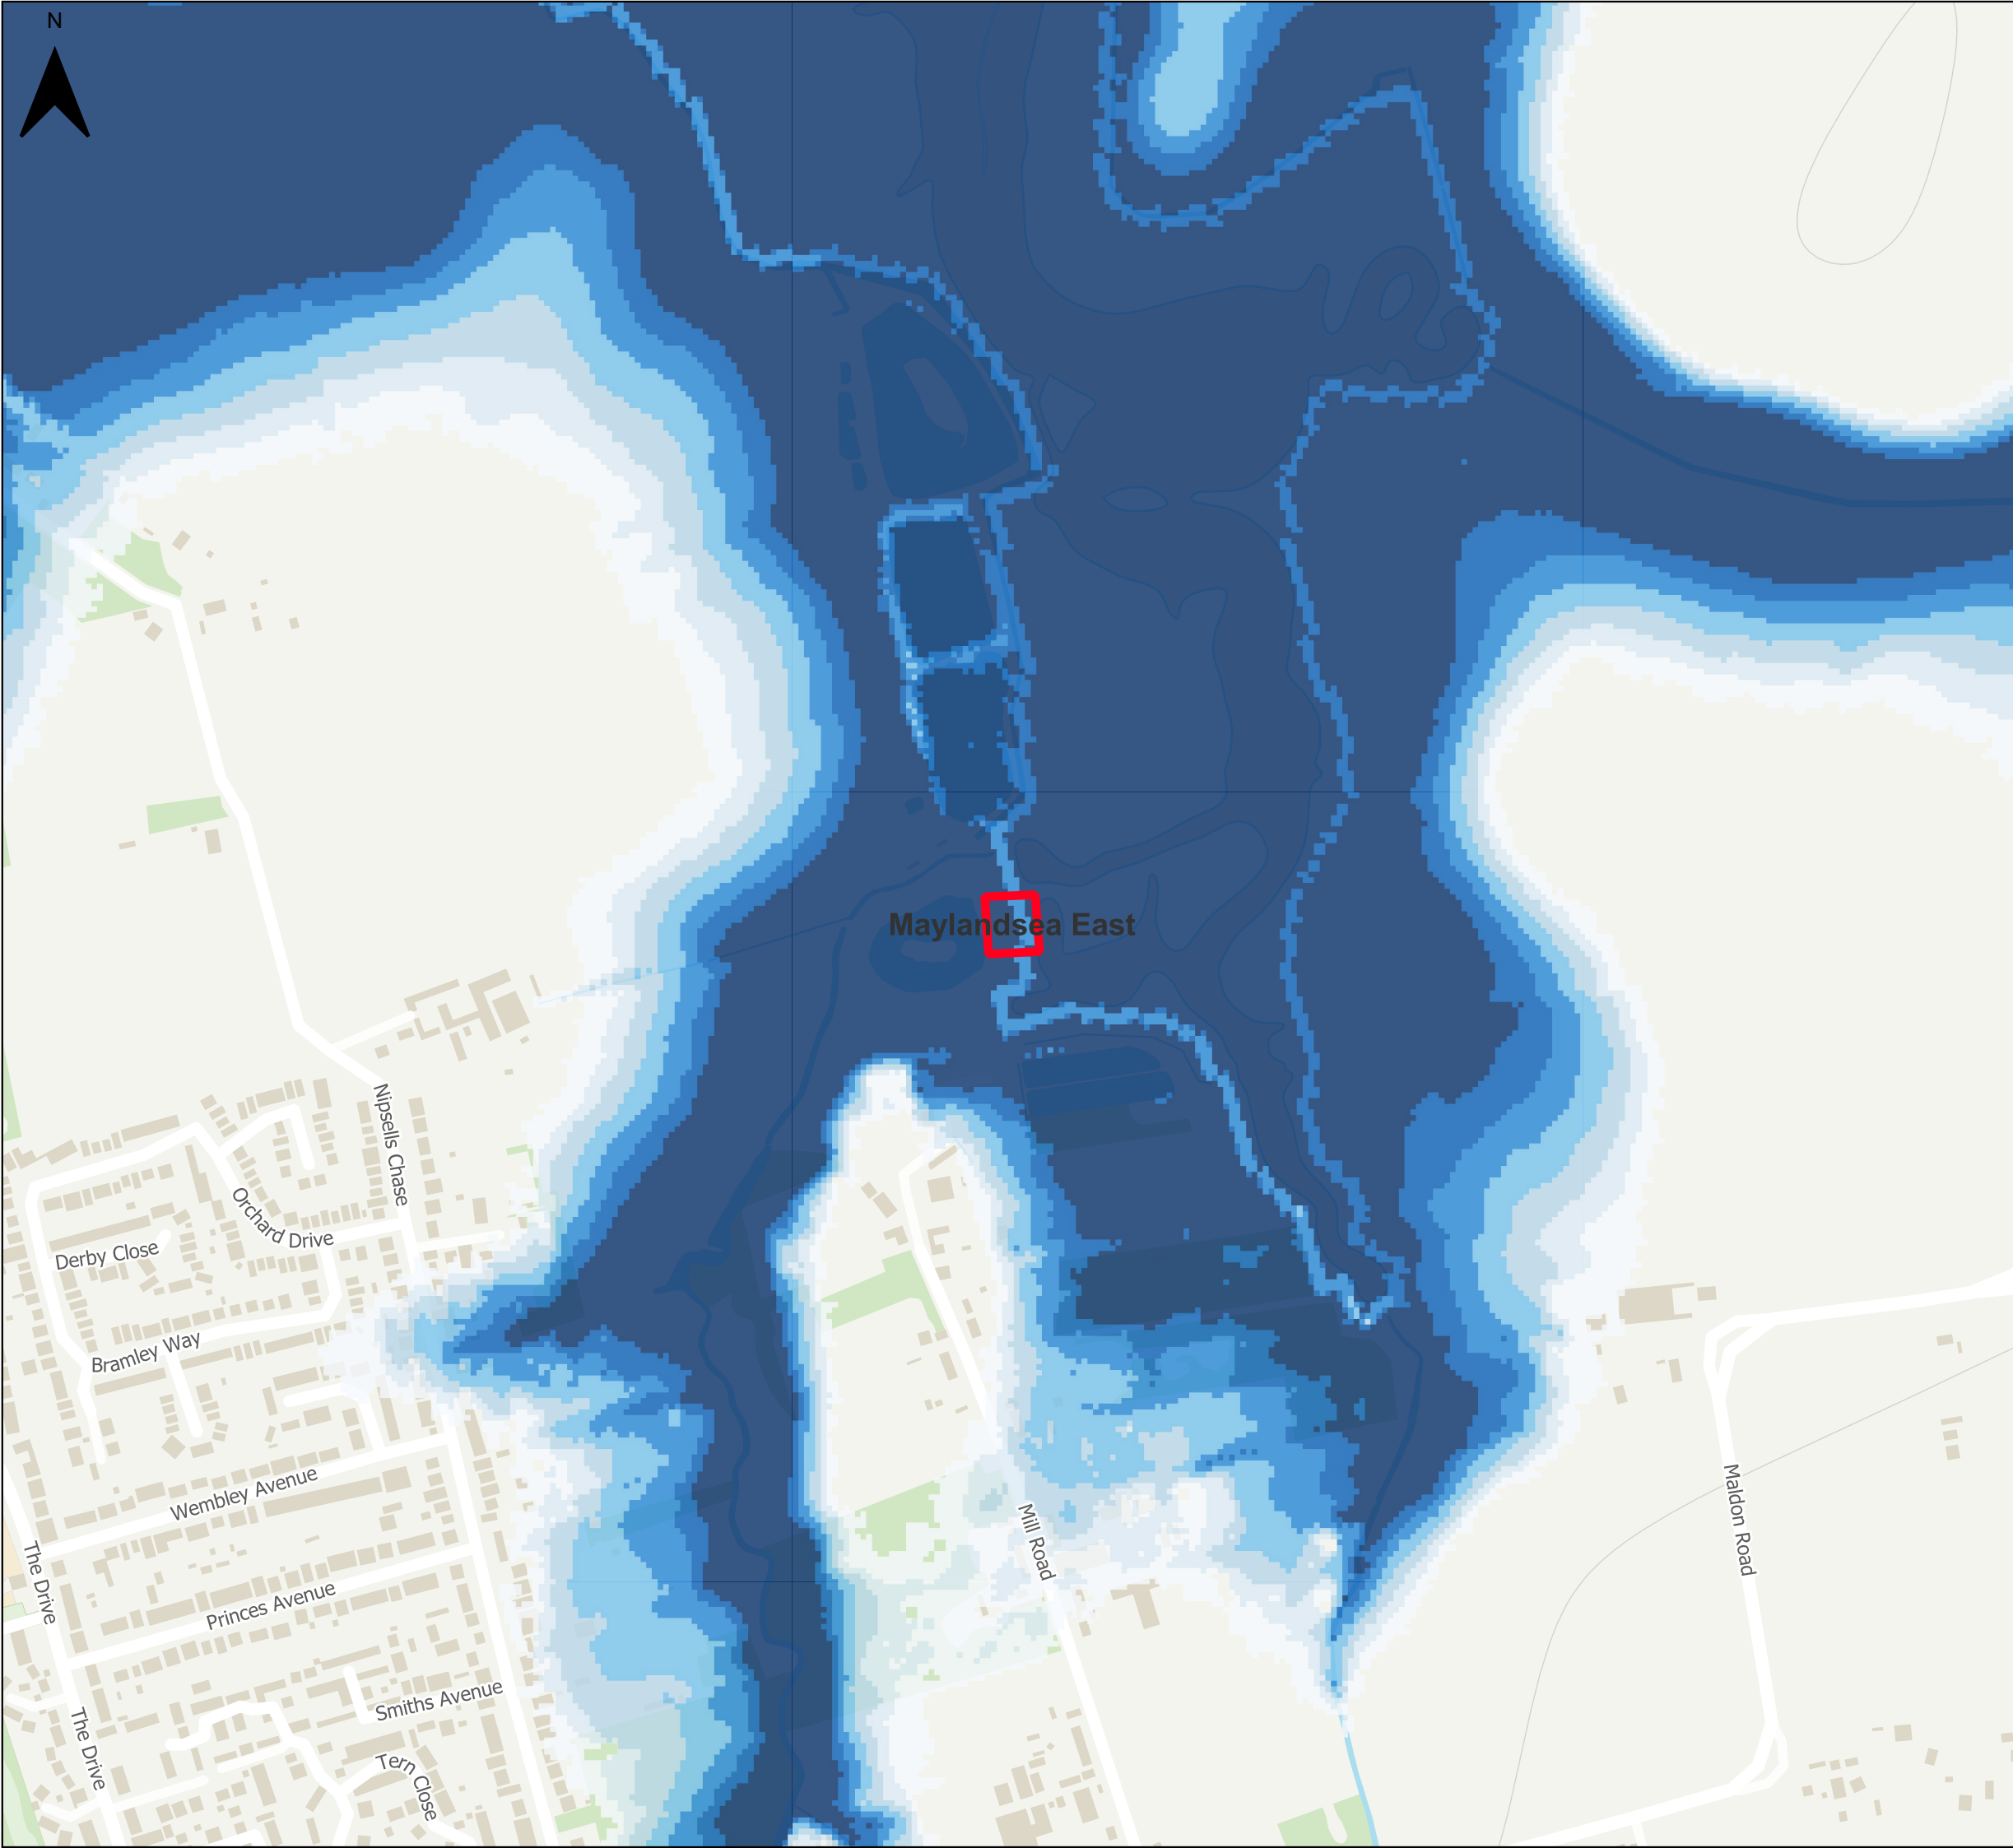
Maylandsea East

- Breach Depth (m) 0.5% AEP Plus Climate Change (2121-year event)**
- <= 0.3

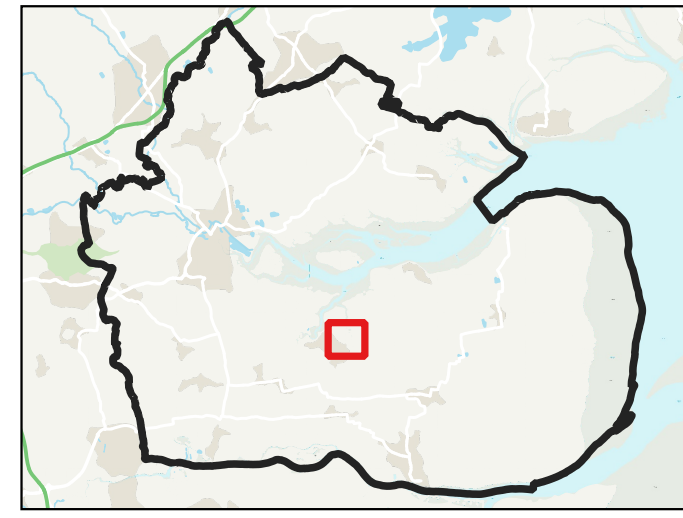
Maylandsea East

- Maldon District Boundary
- Breach Locations
- Breach Hazard 0.5% AEP Plus Climate Change (2121-year event)**
 - No hazard
 - Very low hazard - Caution
 - Danger for some
 - Danger for most
 - Danger for all

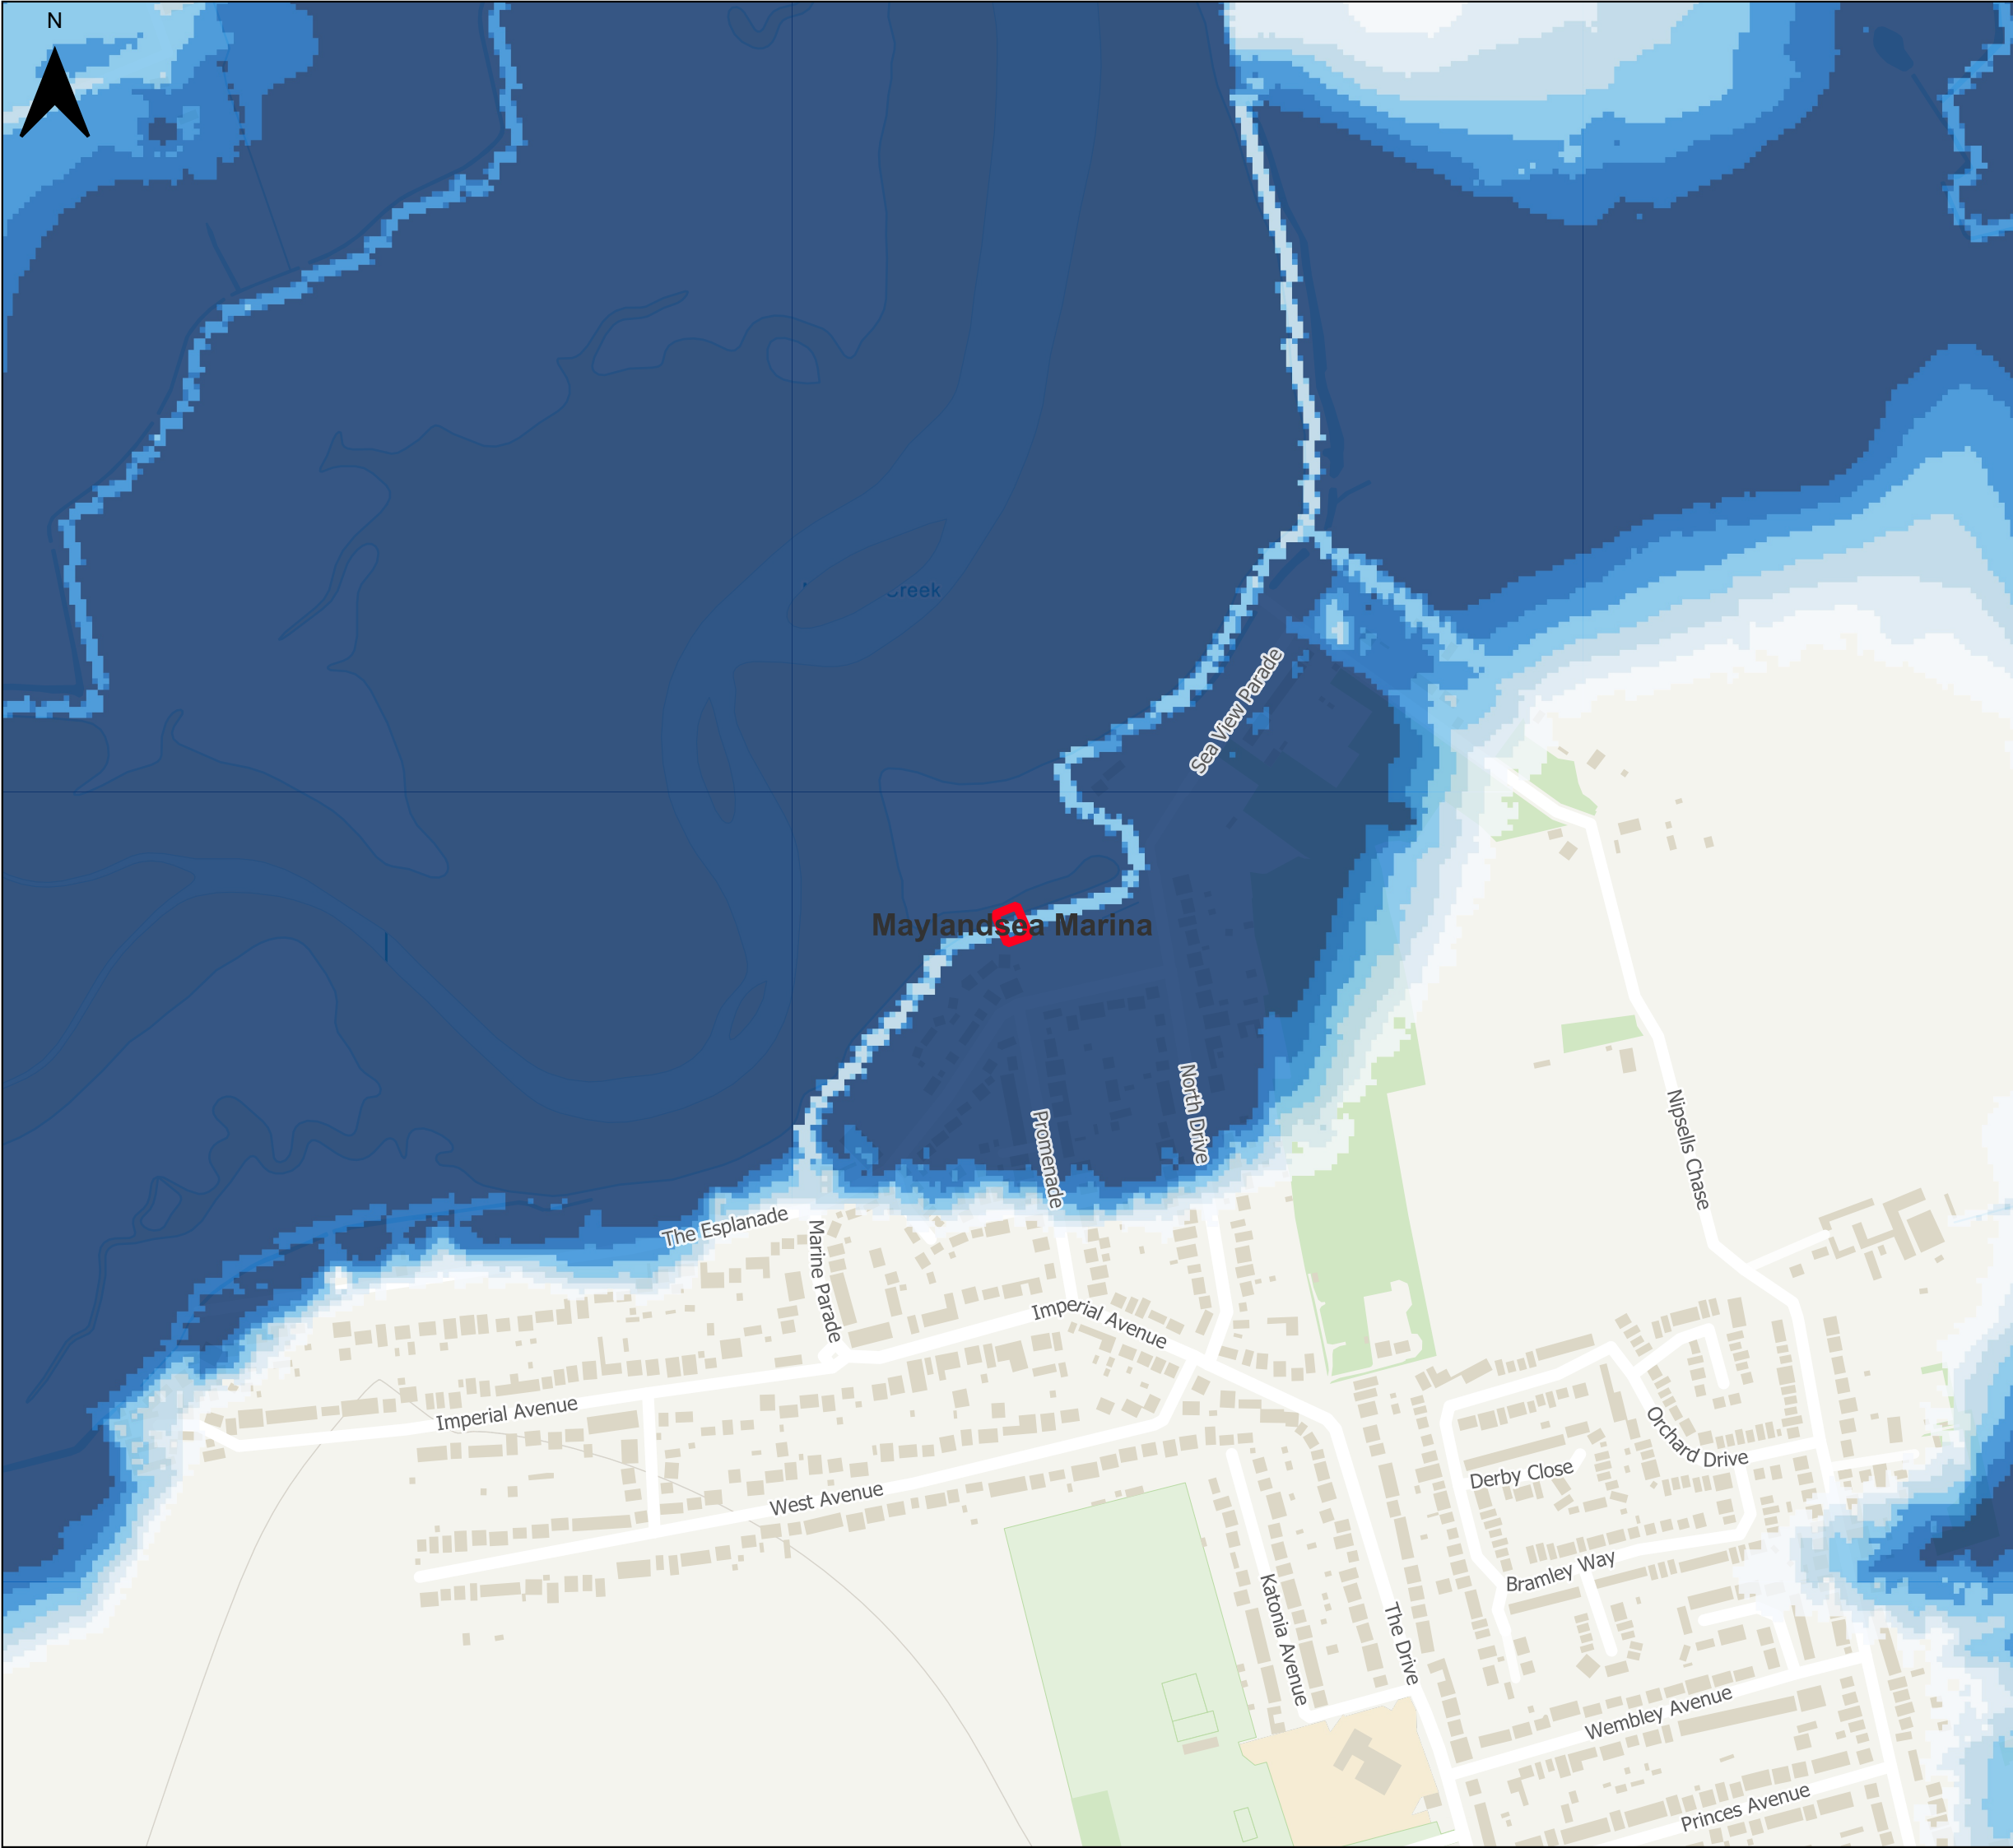
Maylandsea Marina

- Breach Hazard 0.5% AEP Plus Climate Change (2121-year event)**
- No hazard

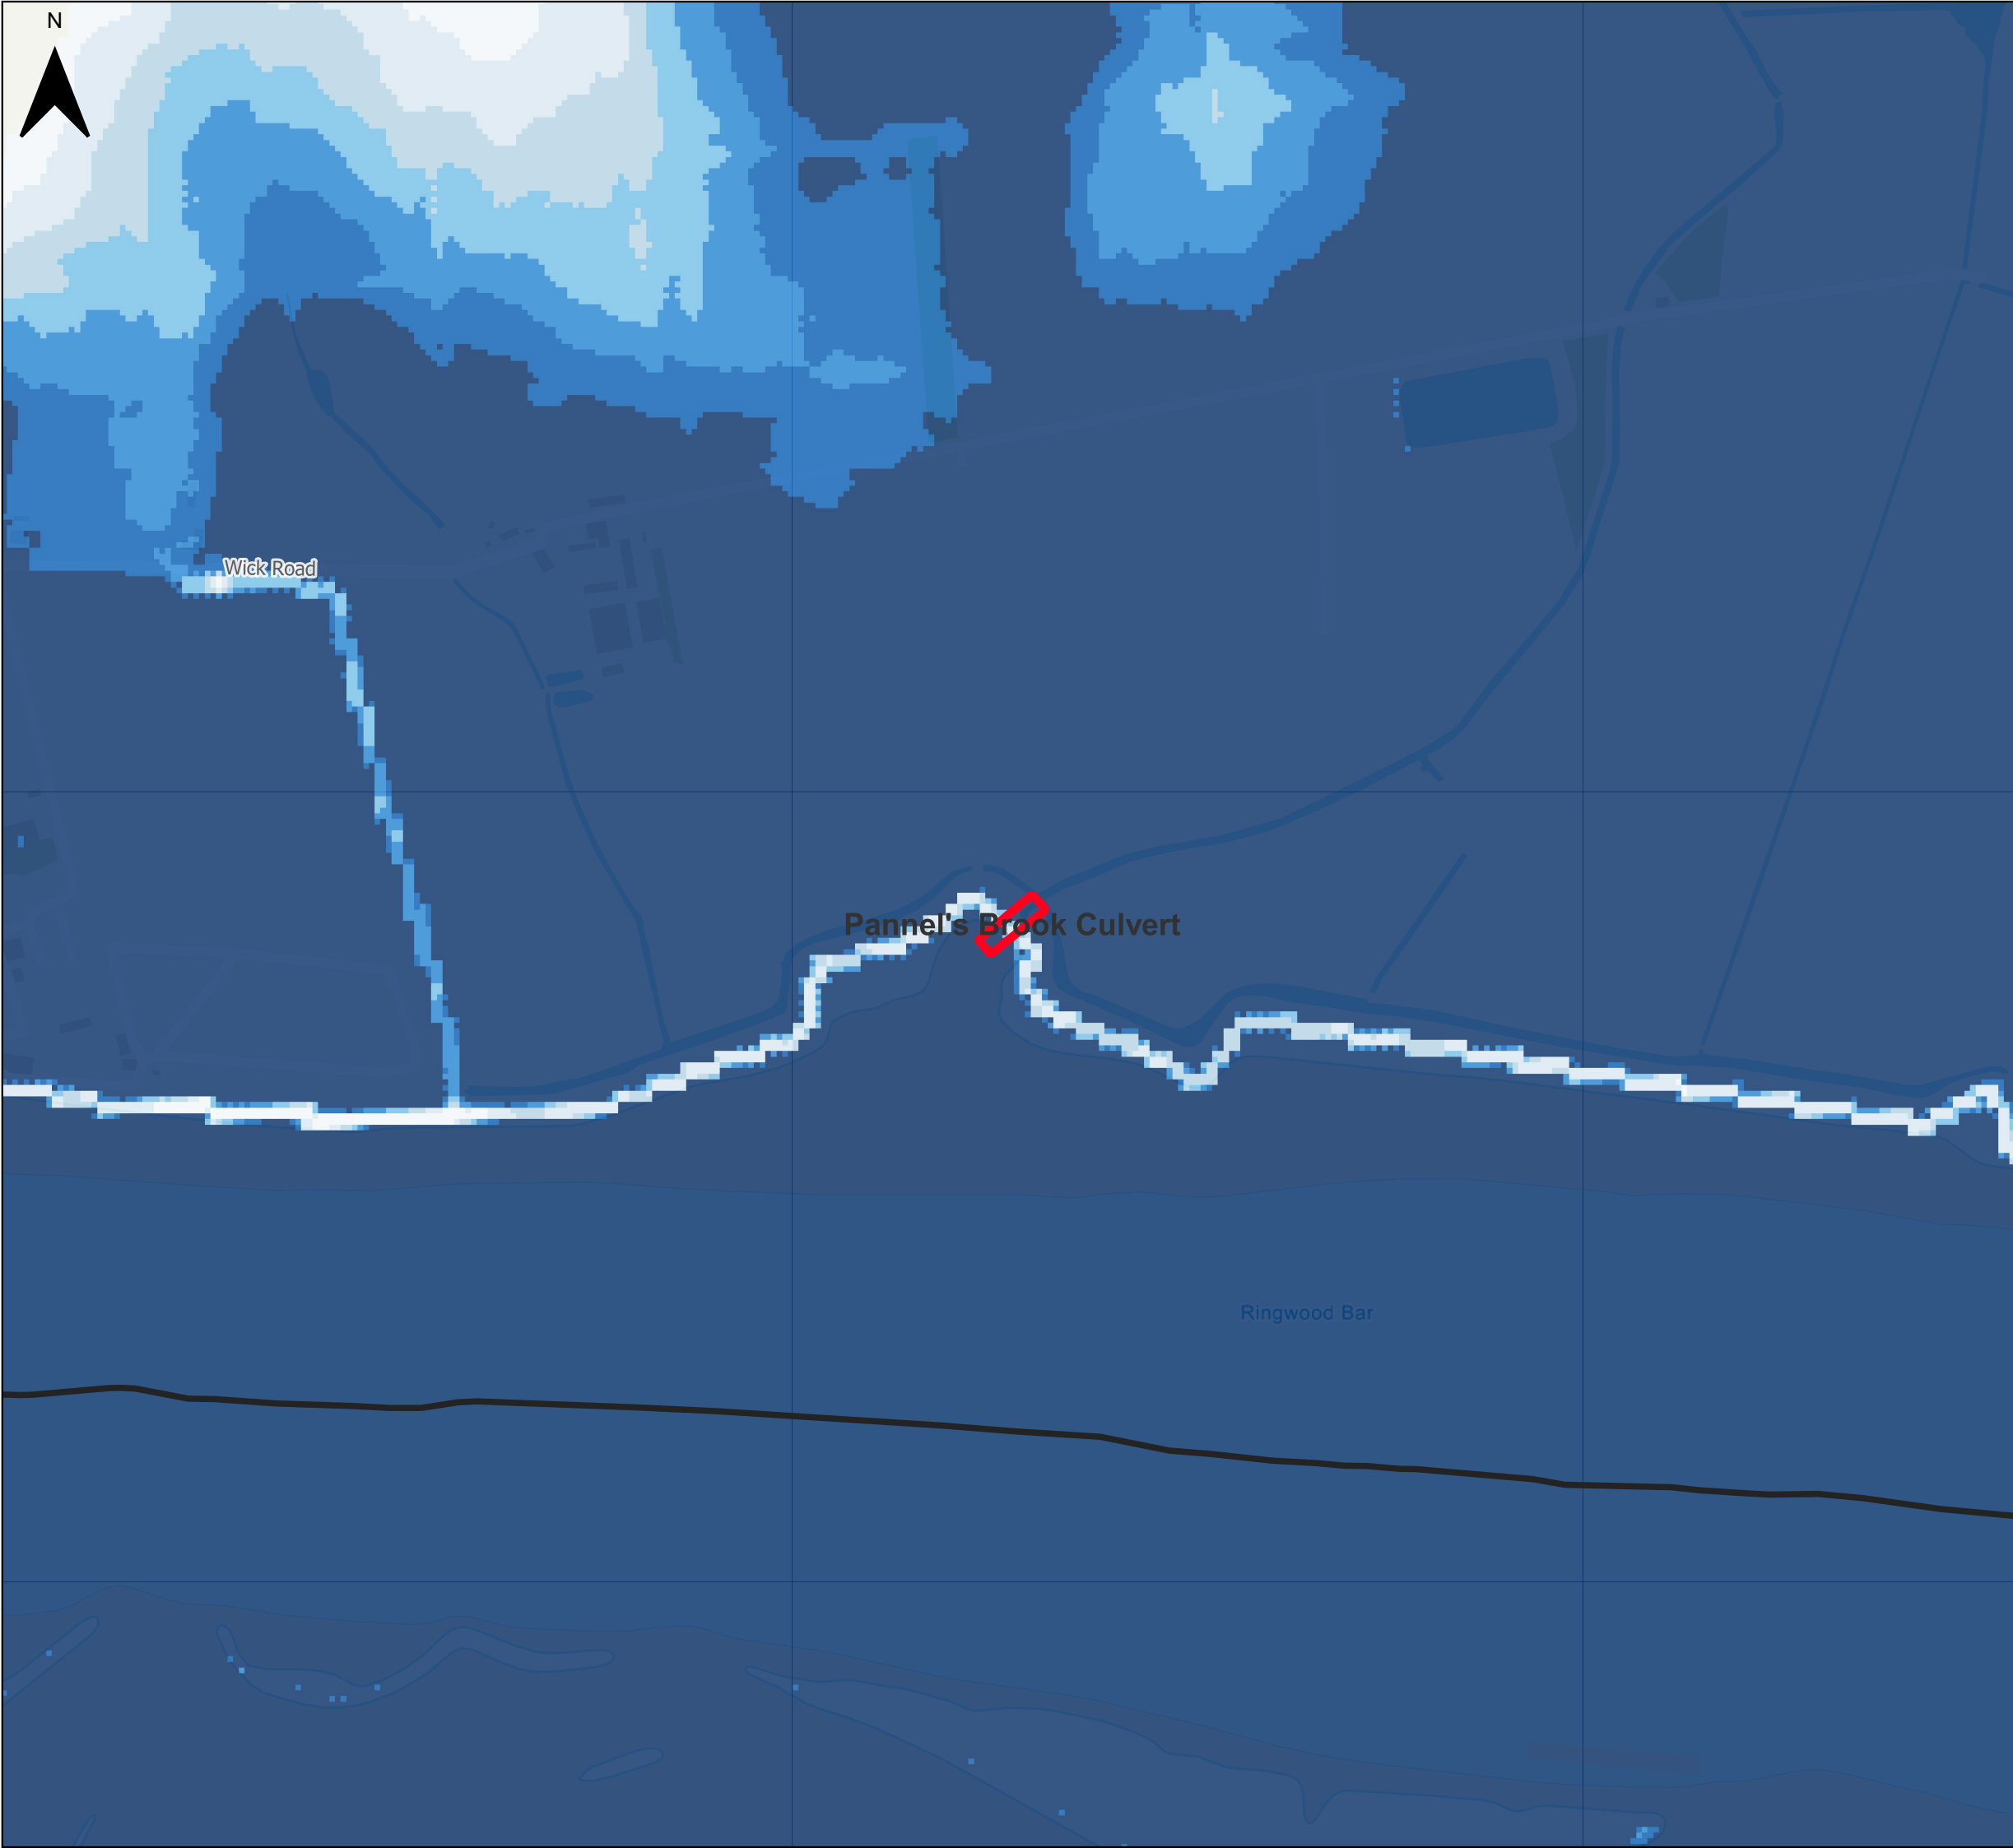
Pannel's Brook Culvert

- Maldon District Boundary
- Breach Locations
- Breach Depth (m) 0.5% AEP Plus
Climate Change (2121-year event)**
- <= 0.3
- 0.3 - 0.6
- 0.6 - 0.9
- 0.9 - 1.2
- 1.2 - 1.5
- 1.5 - 1.8
- > 1.8
